Yellow River		co-0807-005	Severity Score 1.75																																				
<u>Common:</u> 7.5mi SE of Libertyville <u>Drainage:</u> Blackwater Bay <u>GPS:</u> 31.140787696, -86.408113426 <u>Land owner:</u> RB: USA/ LB: James & Patricia Caton		<u>County:</u> Covington <u>State:</u> Alabama <u>PLSS:</u> 2N-16E-13 <u>Parcel No.:</u> 2/3

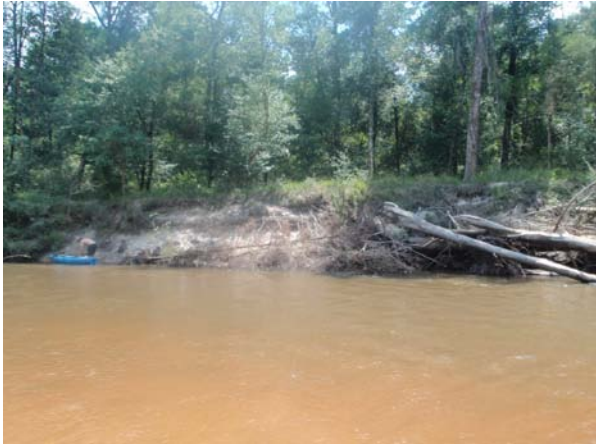
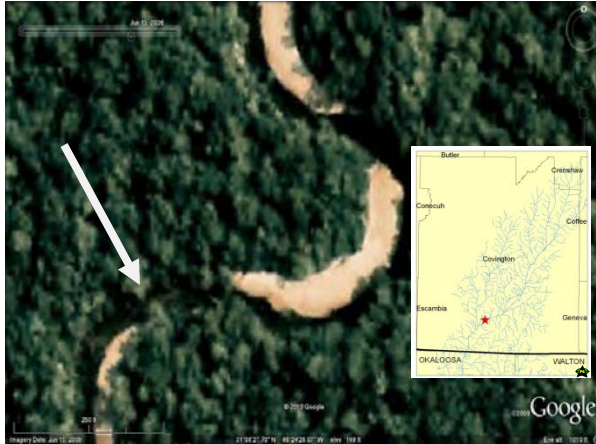
Notes: Some erosion and fresh deposits across the channel. Top of left bank is vegetated with grasses which have shallow roots making this site more prone to erosion.
