| Turkey Creek | | | wa-1028-002 | | Severity Score<br>4.5 | |
| <u>Common:</u> 5mi NE of Mossy Head<br><u>Drainage:</u> Shoal River <u>GPS:</u> 30.824039425, -86.255678894<br><u>Land owner:</u> Unknown | | | <u>County:</u> Walton<br><u>PLSS(T-R-S):</u> 4N-20W-28<br><u>Parcel No.:</u> Unknown | | <u>State:</u> Florida | |

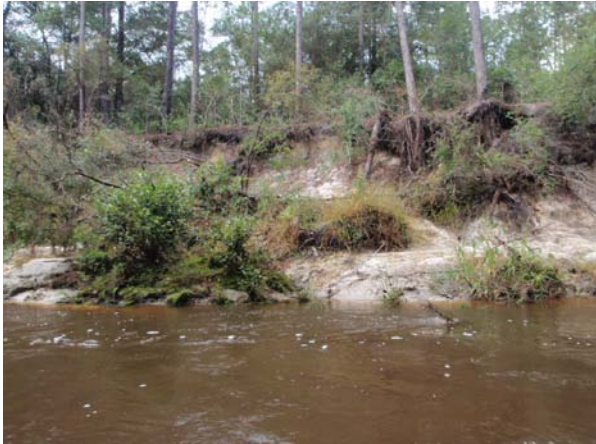
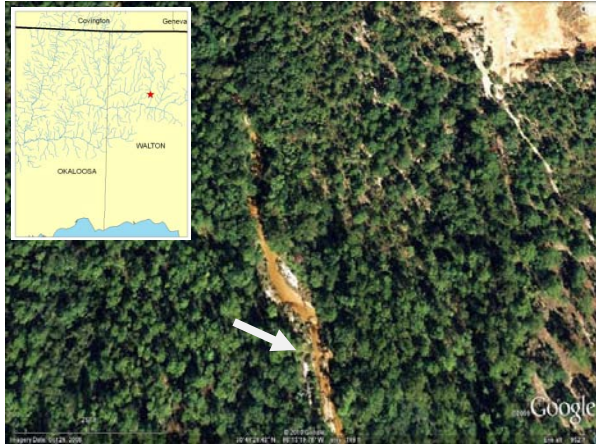
| Turkey Creek | | | wa-1028-002 | | Severity Score<br>4.5 | |
|---|---|---|--|---|---|--|
| RB | | | | | | |

| Turkey Creek | | | wa-1028-002 | | Severity Score<br>4.5 | |
|---|---|---|--|---|---|--|
| Bank Erosion | Active | 1 | Rare and Imperiled | No | N/A | |
| BEHI | High | 1 | Land Use/Cover | Yes | VACANT RESIDENTIAL/ STREAMS AND WATERWAYS | |
| RB: Riparian Buffer | 0-29 ft | 0.75 | | | | |
| RB: Floodplain Access | None | 0.75 | | | | |

Notes: Joyce Cordell is noted as a possible land owner. Logging road 0.3mi west of site?  
60ft site reach.
