Unnamed tributary		co-0731-r-004	Sedimentation Risk Index 34																																																																		
<u>Common:</u> 4.5mi NW of Florala <u>Drainage:</u> Horsehead Creek <i>GPS:</i> 31.030550, -86.399066 <u>Land owner:</u> James & Judy McGee -US, Diane Mock -DS		<u>County:</u> Covington <i>State:</i> Alabama <u>PLSS (T-R-S):</u> 1N-16E-24/25 <u>Parcel No.:</u> 5; 3.01 <u>Road Name:</u> Union Church Rd

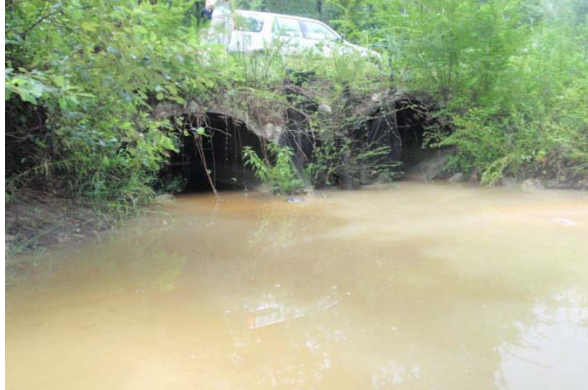
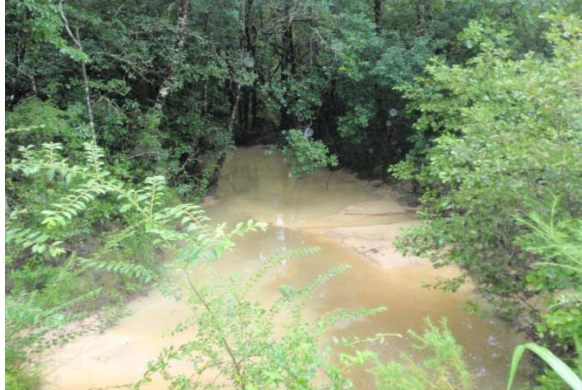
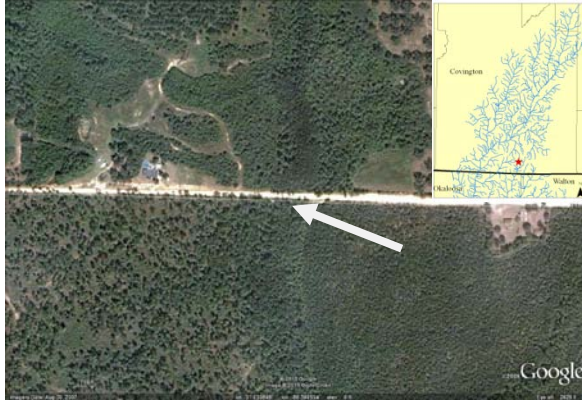
Crossing Structure: DS		DS																																																																			
<table border="1"> <thead> <tr> <th>Risk Factor</th> <th>Ranking</th> <th>Score</th> </tr> </thead> <tbody> <tr><td>US Channel Morph</td><td>DA</td><td>3</td></tr> <tr><td>DS Channel Morph</td><td>C</td><td>5</td></tr> <tr><td>DS Bank Alteration</td><td>HIGH</td><td>1</td></tr> <tr><td>Upstream Skew Angle</td><td>5-30°</td><td>3</td></tr> <tr><td>Crossing fill condition</td><td>Fair/Rip Rap</td><td>3</td></tr> <tr><td>Inlet/Outlet Condition</td><td>Sed Islands/Scouring</td><td>3</td></tr> <tr><td>Road Approach Material</td><td>All Sand/Clay</td><td>3</td></tr> <tr><td>Potential Eroded Volume Mean</td><td>>40 y³</td><td>1</td></tr> <tr><td>Approach Slope Mean</td><td>2.1-4%</td><td>3</td></tr> <tr><td>Soil K Factor</td><td><0.20</td><td>5</td></tr> <tr><td>Upstream Rt Outlet</td><td>Vegetated</td><td>1</td></tr> <tr><td>Upstream Lt Outlet</td><td>Vegetated</td><td>1</td></tr> <tr><td>Upstream Rt Ditch</td><td>Bare soil</td><td>0</td></tr> <tr><td>Upstream Lt Ditch</td><td>Bare soil</td><td>0</td></tr> <tr><td>Downstream Rt Outlet</td><td>Bare soil</td><td>0</td></tr> <tr><td>Downstream Lt Outlet</td><td>Bare soil</td><td>0</td></tr> <tr><td>Downstream Rt Ditch</td><td>Bare soil</td><td>0</td></tr> <tr><td>Downstream Lt Ditch</td><td>Bare soil</td><td>0</td></tr> <tr><td>Outlet Total</td><td>Partially Improved Outlet System</td><td>3</td></tr> <tr><td>Ditches Total</td><td>Unimproved Drainage System</td><td>1</td></tr> <tr><td>SRI Total</td><td>High Risk</td><td>34</td></tr> </tbody> </table>		Risk Factor	Ranking	Score	US Channel Morph	DA	3	DS Channel Morph	C	5	DS Bank Alteration	HIGH	1	Upstream Skew Angle	5-30°	3	Crossing fill condition	Fair/Rip Rap	3	Inlet/Outlet Condition	Sed Islands/Scouring	3	Road Approach Material	All Sand/Clay	3	Potential Eroded Volume Mean	>40 y ³	1	Approach Slope Mean	2.1-4%	3	Soil K Factor	<0.20	5	Upstream Rt Outlet	Vegetated	1	Upstream Lt Outlet	Vegetated	1	Upstream Rt Ditch	Bare soil	0	Upstream Lt Ditch	Bare soil	0	Downstream Rt Outlet	Bare soil	0	Downstream Lt Outlet	Bare soil	0	Downstream Rt Ditch	Bare soil	0	Downstream Lt Ditch	Bare soil	0	Outlet Total	Partially Improved Outlet System	3	Ditches Total	Unimproved Drainage System	1	SRI Total	High Risk	34

Notes: High sediment load DS.
