Unnamed tributary		wa-0626-r-005	Sedimentation Risk Index 34																																																																		
<u>Common:</u> 6.6mi SE of Florala <u>Drainage:</u> Long Creek <i>GPS:</i> 30.911070, -86.306770 <u>Land owner:</u> Ricky & Jacqueline Adams- US, Joe & Cheryl Gillam-DS East, Thomas & Doris Bell- DS West		<u>County:</u> Walton <u>State:</u> Florida <u>PLSS(T-R-S):</u> 5N-21-23/26 <u>Parcel No.:</u> 4.001; 1.001; 1 <u>Road Name:</u> Campground Rd

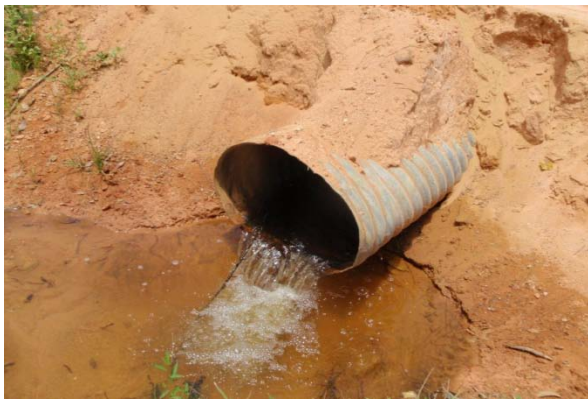
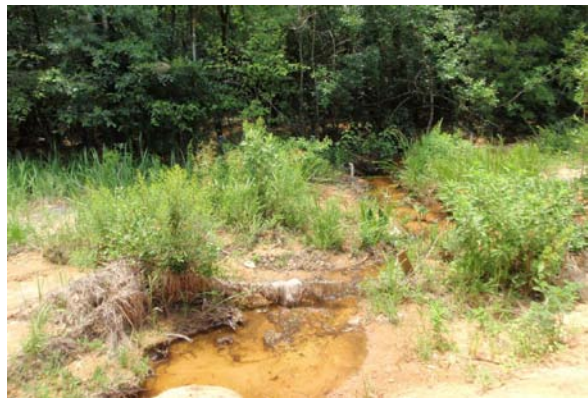
Crossing Structure: DS		DS																																																																			
<table border="1"> <thead> <tr> <th>Risk Factor</th> <th>Ranking</th> <th>Score</th> </tr> </thead> <tbody> <tr><td>US Channel Morph</td><td>PONDED</td><td>1</td></tr> <tr><td>DS Channel Morph</td><td>E</td><td>5</td></tr> <tr><td>DS Bank Alteration</td><td>HIGH</td><td>1</td></tr> <tr><td>Upstream Skew Angle</td><td><5°</td><td>5</td></tr> <tr><td>Crossing fill condition</td><td>Poor/Bare soil</td><td>1</td></tr> <tr><td>Inlet/Outlet Condition</td><td>No Impairment</td><td>5</td></tr> <tr><td>Road Approach Material</td><td>All Sand/Clay</td><td>3</td></tr> <tr><td>Potential Eroded Volume Mean</td><td><21 y³</td><td>5</td></tr> <tr><td>Approach Slope Mean</td><td>>4%</td><td>1</td></tr> <tr><td>Soil K Factor</td><td><0.20</td><td>5</td></tr> <tr><td>Upstream Rt Outlet</td><td>Bare soil</td><td>0</td></tr> <tr><td>Upstream Lt Outlet</td><td>Bare soil</td><td>0</td></tr> <tr><td>Upstream Rt Ditch</td><td>Bare soil</td><td>0</td></tr> <tr><td>Upstream Lt Ditch</td><td>Bare soil</td><td>0</td></tr> <tr><td>Downstream Rt Outlet</td><td>Bare soil</td><td>0</td></tr> <tr><td>Downstream Lt Outlet</td><td>Bare soil</td><td>0</td></tr> <tr><td>Downstream Rt Ditch</td><td>Bare soil</td><td>0</td></tr> <tr><td>Downstream Lt Ditch</td><td>Bare soil</td><td>0</td></tr> <tr><td>Outlet Total</td><td>Unimproved Outlet System</td><td>1</td></tr> <tr><td>Ditches Total</td><td>Unimproved Drainage System</td><td>1</td></tr> <tr><td>SRI Total</td><td>High Risk</td><td>34</td></tr> </tbody> </table>		Risk Factor	Ranking	Score	US Channel Morph	PONDED	1	DS Channel Morph	E	5	DS Bank Alteration	HIGH	1	Upstream Skew Angle	<5°	5	Crossing fill condition	Poor/Bare soil	1	Inlet/Outlet Condition	No Impairment	5	Road Approach Material	All Sand/Clay	3	Potential Eroded Volume Mean	<21 y ³	5	Approach Slope Mean	>4%	1	Soil K Factor	<0.20	5	Upstream Rt Outlet	Bare soil	0	Upstream Lt Outlet	Bare soil	0	Upstream Rt Ditch	Bare soil	0	Upstream Lt Ditch	Bare soil	0	Downstream Rt Outlet	Bare soil	0	Downstream Lt Outlet	Bare soil	0	Downstream Rt Ditch	Bare soil	0	Downstream Lt Ditch	Bare soil	0	Outlet Total	Unimproved Outlet System	1	Ditches Total	Unimproved Drainage System	1	SRI Total	High Risk	34

Notes: Second culvert 50 ft west of first, blocked
