Poley Creek		co-1102-r-009	Sedimentation Risk Index 44																																																																		
<u>Common:</u> 2.2mi SE of Five Points <u>Drainage:</u> Lightwood Knot <u>GPS:</u> 31.420291457, -86.273888041 <u>Land owner:</u> Paul Langford		<u>County:</u> Covington <u>State:</u> Alabama <u>PLSS (T-R-S):</u> 5N-18E-8 <u>Parcel No.:</u> 7 <u>Road Name:</u> Mitchell Rd

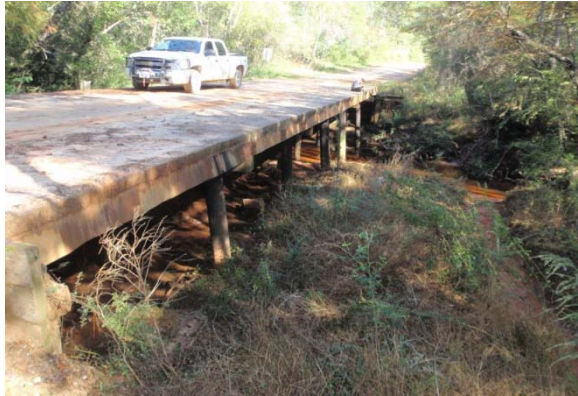
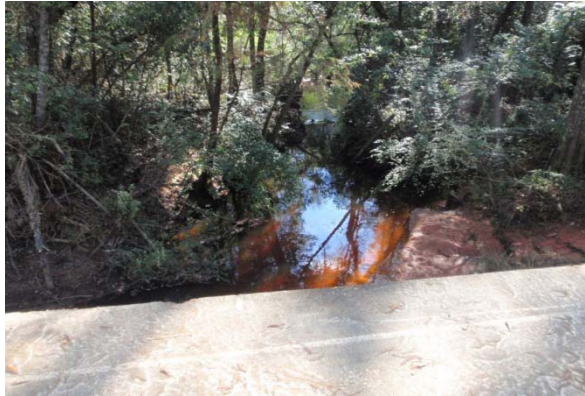
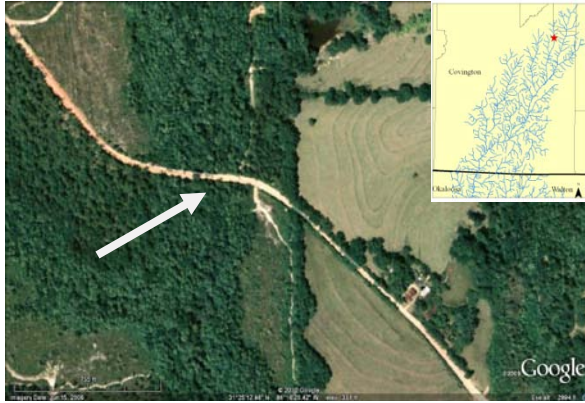
Crossing Structure: DS		DS																																																																			
<table border="1"> <thead> <tr> <th>Risk Factor</th> <th>Ranking</th> <th>Score</th> </tr> </thead> <tbody> <tr><td>US Channel Morph</td><td>C</td><td>5</td></tr> <tr><td>DS Channel Morph</td><td>C</td><td>5</td></tr> <tr><td>DS Bank Alteration</td><td>MINOR/PARTIAL</td><td>3</td></tr> <tr><td>Upstream Skew Angle</td><td><5°</td><td>5</td></tr> <tr><td>Crossing fill condition</td><td>Good/Vegetated</td><td>5</td></tr> <tr><td>Inlet/Outlet Condition</td><td>No Impairment</td><td>5</td></tr> <tr><td>Road Approach Material</td><td>All Sand/Clay</td><td>3</td></tr> <tr><td>Potential Eroded Volume Mean</td><td>>40 y³</td><td>1</td></tr> <tr><td>Approach Slope Mean</td><td>2.1-4%</td><td>3</td></tr> <tr><td>Soil K Factor</td><td><0.20</td><td>5</td></tr> <tr><td>Upstream Rt Outlet</td><td>Vegetated</td><td>1</td></tr> <tr><td>Upstream Lt Outlet</td><td>Vegetated</td><td>1</td></tr> <tr><td>Upstream Rt Ditch</td><td>Bare soil</td><td>0</td></tr> <tr><td>Upstream Lt Ditch</td><td>Bare soil</td><td>0</td></tr> <tr><td>Downstream Rt Outlet</td><td>Bare soil</td><td>0</td></tr> <tr><td>Downstream Lt Outlet</td><td>Bare soil</td><td>0</td></tr> <tr><td>Downstream Rt Ditch</td><td>Bare soil</td><td>0</td></tr> <tr><td>Downstream Lt Ditch</td><td>Bare soil</td><td>0</td></tr> <tr><td>Outlet Total</td><td>Partially Improved Outlet System</td><td>3</td></tr> <tr><td>Ditches Total</td><td>Unimproved Drainage System</td><td>1</td></tr> <tr><td>SRI Total</td><td>Medium Risk</td><td>44</td></tr> </tbody> </table>		Risk Factor	Ranking	Score	US Channel Morph	C	5	DS Channel Morph	C	5	DS Bank Alteration	MINOR/PARTIAL	3	Upstream Skew Angle	<5°	5	Crossing fill condition	Good/Vegetated	5	Inlet/Outlet Condition	No Impairment	5	Road Approach Material	All Sand/Clay	3	Potential Eroded Volume Mean	>40 y ³	1	Approach Slope Mean	2.1-4%	3	Soil K Factor	<0.20	5	Upstream Rt Outlet	Vegetated	1	Upstream Lt Outlet	Vegetated	1	Upstream Rt Ditch	Bare soil	0	Upstream Lt Ditch	Bare soil	0	Downstream Rt Outlet	Bare soil	0	Downstream Lt Outlet	Bare soil	0	Downstream Rt Ditch	Bare soil	0	Downstream Lt Ditch	Bare soil	0	Outlet Total	Partially Improved Outlet System	3	Ditches Total	Unimproved Drainage System	1	SRI Total	Medium Risk	44
