Boiling Creek		sr-0414-r-004		Sedimentation Risk Index 44																																																																			
<u>Common:</u> 6.5mi S of Harold <u>Drainage:</u> Yellow River <u>GPS:</u> 30.564953, -86.869203 <u>Land owner:</u> US Government- Eglin AFB		<u>County:</u> Santa Rosa <u>PLSS(T-R-S):</u> 1N-26-29 <u>Parcel No.:</u> 1 <u>Road Name:</u> RR 211- Eglin AFB		<u>State:</u> Florida

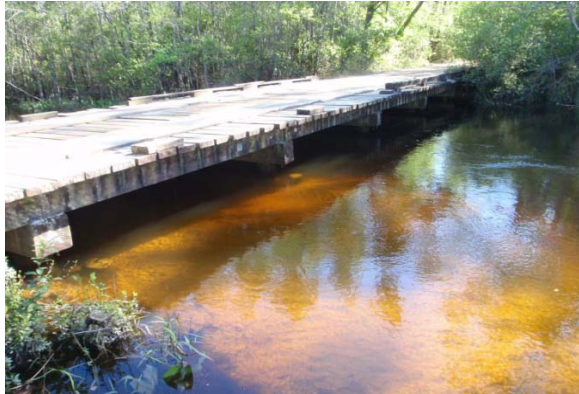
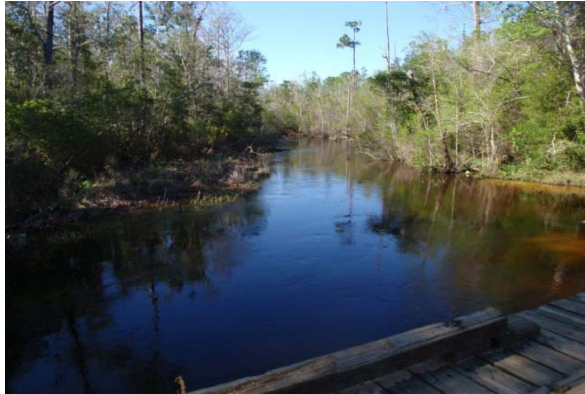
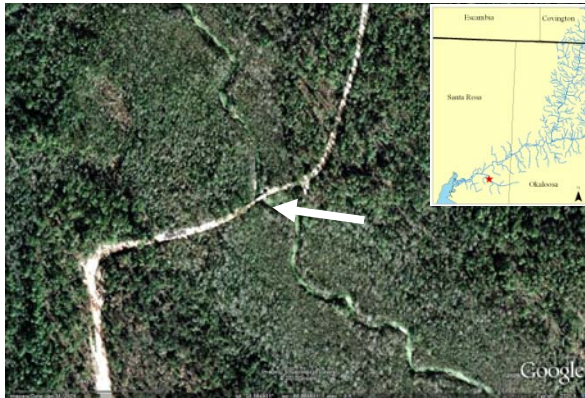
Crossing Structure: DS		US																																																																					
<table border="1"> <thead> <tr> <th>Risk Factor</th> <th>Ranking</th> <th>Score</th> </tr> </thead> <tbody> <tr><td>US Channel Morph</td><td>C</td><td>5</td></tr> <tr><td>DS Channel Morph</td><td>C</td><td>5</td></tr> <tr><td>DS Bank Alteration</td><td>NATURAL</td><td>5</td></tr> <tr><td>Upstream Skew Angle</td><td><5°</td><td>5</td></tr> <tr><td>Crossing fill condition</td><td>Poor/Bare soil</td><td>1</td></tr> <tr><td>Inlet/Outlet Condition</td><td>No Impairment</td><td>5</td></tr> <tr><td>Road Approach Material</td><td>All Sand/Clay</td><td>3</td></tr> <tr><td>Potential Eroded Volume Mean</td><td>>40 y³</td><td>1</td></tr> <tr><td>Approach Slope Mean</td><td><2%</td><td>5</td></tr> <tr><td>Soil K Factor</td><td><0.20</td><td>5</td></tr> <tr><td>Upstream Rt Outlet</td><td>Bare soil</td><td>0</td></tr> <tr><td>Upstream Lt Outlet</td><td>Bare soil</td><td>0</td></tr> <tr><td>Upstream Rt Ditch</td><td>Bare soil</td><td>0</td></tr> <tr><td>Upstream Lt Ditch</td><td>Bare soil</td><td>0</td></tr> <tr><td>Downstream Rt Outlet</td><td>Bare soil</td><td>0</td></tr> <tr><td>Downstream Lt Outlet</td><td>Vegetated</td><td>1</td></tr> <tr><td>Downstream Rt Ditch</td><td>Bare soil</td><td>0</td></tr> <tr><td>Downstream Lt Ditch</td><td>Bare soil</td><td>0</td></tr> <tr><td>Outlet Total</td><td>Partially Improved Outlet System</td><td>3</td></tr> <tr><td>Ditches Total</td><td>Unimproved Drainage System</td><td>1</td></tr> <tr><td>SRI Total</td><td>Medium Risk</td><td>44</td></tr> </tbody> </table>		Risk Factor	Ranking	Score	US Channel Morph	C	5	DS Channel Morph	C	5	DS Bank Alteration	NATURAL	5	Upstream Skew Angle	<5°	5	Crossing fill condition	Poor/Bare soil	1	Inlet/Outlet Condition	No Impairment	5	Road Approach Material	All Sand/Clay	3	Potential Eroded Volume Mean	>40 y ³	1	Approach Slope Mean	<2%	5	Soil K Factor	<0.20	5	Upstream Rt Outlet	Bare soil	0	Upstream Lt Outlet	Bare soil	0	Upstream Rt Ditch	Bare soil	0	Upstream Lt Ditch	Bare soil	0	Downstream Rt Outlet	Bare soil	0	Downstream Lt Outlet	Vegetated	1	Downstream Rt Ditch	Bare soil	0	Downstream Lt Ditch	Bare soil	0	Outlet Total	Partially Improved Outlet System	3	Ditches Total	Unimproved Drainage System	1	SRI Total	Medium Risk	44

Notes: US RT outlet leads directly to US channel for approx. 100 ft. Public swimming hole, canoe launch. Frequented for missions by Eglin.
