Unnamed tributary		co-0812-r-008	Sedimentation Risk Index 48																																																																		
<u>Common:</u> 8.6mi N of Florala <u>Drainage:</u> Clear Creek <u>GPS:</u> 31.128061, -86.344464 <u>Land owner:</u> Rodney Helms		<u>County:</u> Covington <u>State:</u> Alabama <u>PLSS (T-R-S):</u> 2N-17E-22 <u>Parcel No.:</u> 3 <u>Road Name:</u> Booker Rd

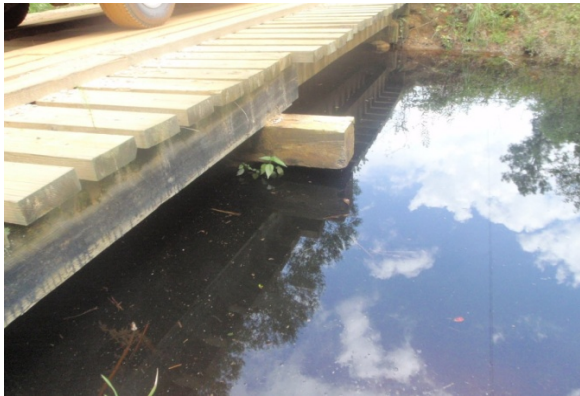
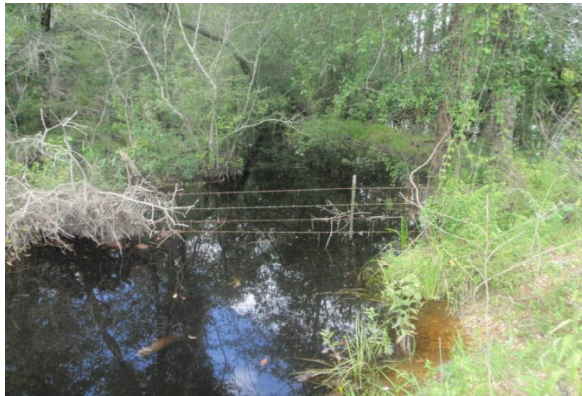
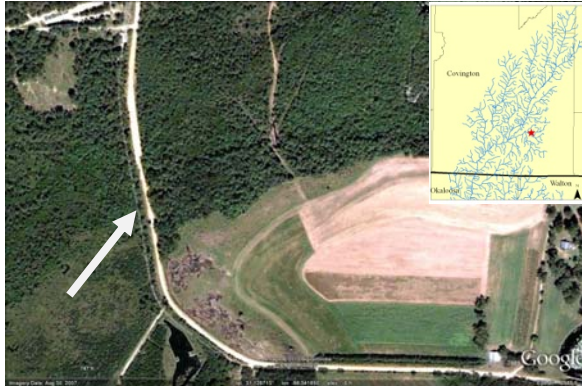
Crossing Structure: DS		US																																																																			
<table border="1"> <thead> <tr> <th>Risk Factor</th> <th>Ranking</th> <th>Score</th> </tr> </thead> <tbody> <tr><td>US Channel Morph</td><td>DA</td><td>3</td></tr> <tr><td>DS Channel Morph</td><td>DA</td><td>3</td></tr> <tr><td>DS Bank Alteration</td><td>HIGH</td><td>1</td></tr> <tr><td>Upstream Skew Angle</td><td><5°</td><td>5</td></tr> <tr><td>Crossing fill condition</td><td>Good/Vegetated</td><td>5</td></tr> <tr><td>Inlet/Outlet Condition</td><td>No Impairment</td><td>5</td></tr> <tr><td>Road Approach Material</td><td>All Sand/Clay</td><td>3</td></tr> <tr><td>Potential Eroded Volume Mean</td><td><21 y³</td><td>5</td></tr> <tr><td>Approach Slope Mean</td><td><2%</td><td>5</td></tr> <tr><td>Soil K Factor</td><td><0.20</td><td>5</td></tr> <tr><td>Upstream Rt Outlet</td><td>Vegetated</td><td>1</td></tr> <tr><td>Upstream Lt Outlet</td><td>Vegetated</td><td>1</td></tr> <tr><td>Upstream Rt Ditch</td><td>Vegetated</td><td>1</td></tr> <tr><td>Upstream Lt Ditch</td><td>Bare soil</td><td>0</td></tr> <tr><td>Downstream Rt Outlet</td><td>Vegetated</td><td>1</td></tr> <tr><td>Downstream Lt Outlet</td><td>Vegetated</td><td>1</td></tr> <tr><td>Downstream Rt Ditch</td><td>Bare soil</td><td>0</td></tr> <tr><td>Downstream Lt Ditch</td><td>Vegetated</td><td>1</td></tr> <tr><td>Outlet Total</td><td>Improved Outlet System</td><td>5</td></tr> <tr><td>Ditches Total</td><td>Partially Improved Drainage System</td><td>3</td></tr> <tr><td>SRI Total</td><td>Low Risk</td><td>48</td></tr> </tbody> </table>		Risk Factor	Ranking	Score	US Channel Morph	DA	3	DS Channel Morph	DA	3	DS Bank Alteration	HIGH	1	Upstream Skew Angle	<5°	5	Crossing fill condition	Good/Vegetated	5	Inlet/Outlet Condition	No Impairment	5	Road Approach Material	All Sand/Clay	3	Potential Eroded Volume Mean	<21 y ³	5	Approach Slope Mean	<2%	5	Soil K Factor	<0.20	5	Upstream Rt Outlet	Vegetated	1	Upstream Lt Outlet	Vegetated	1	Upstream Rt Ditch	Vegetated	1	Upstream Lt Ditch	Bare soil	0	Downstream Rt Outlet	Vegetated	1	Downstream Lt Outlet	Vegetated	1	Downstream Rt Ditch	Bare soil	0	Downstream Lt Ditch	Vegetated	1	Outlet Total	Improved Outlet System	5	Ditches Total	Partially Improved Drainage System	3	SRI Total	Low Risk	48

Notes: Fencing across US
