Gum Creek		wa-0727-r-005	Sedimentation Risk Index 40																																																																		
<u>Common:</u> 4.4mi E of Mossy Head <u>Drainage:</u> Shoal River <u>GPS:</u> 30.755371184, -86.241644652 <u>Land owner:</u> Estate and Gumersindo Rodriguez-DS, Fredrick W. Lauer-US		<u>County:</u> Walton <u>State:</u> Florida <u>PLSS (T-R-S):</u> 3N-20-16-28060 <u>Parcel No.:</u> 6.80020; 5.10290 <u>Road Name:</u> Blue Ridge Blvd

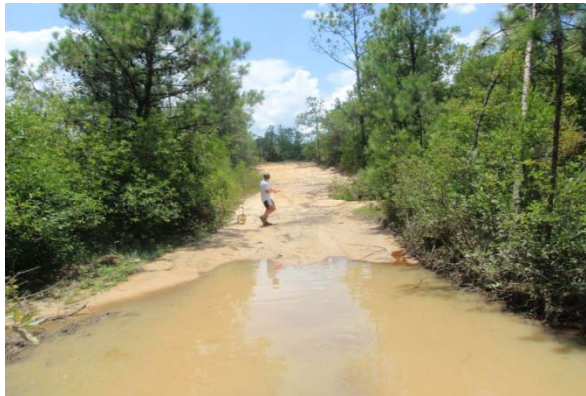
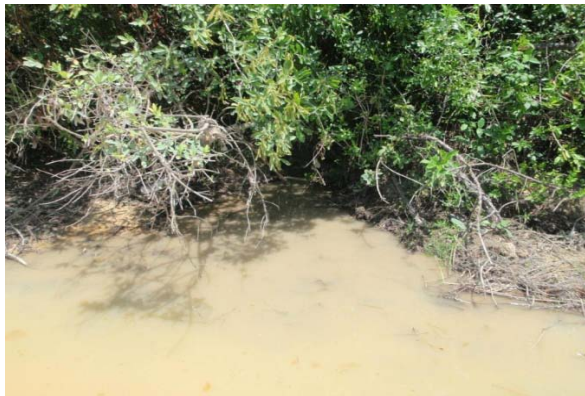
Notes: Potentially a culvert below flooding? Unimproved road, high prism fill.

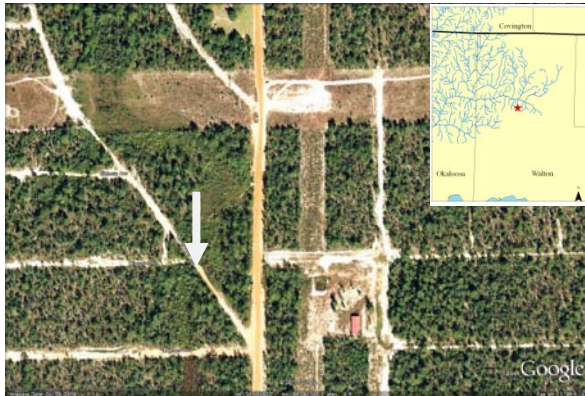
Risk Factor	Ranking	Score																																																																			
US Channel Morph	WETLAND	5																																																																			
DS Channel Morph	WETLAND	5																																																																			
DS Bank Alteration	NATURAL	5																																																																			
Upstream Skew Angle	<5°	5																																																																			
Crossing fill condition	Poor/Bare soil	1																																																																			
Inlet/Outlet Condition	No Impairment	5																																																																			
Road Approach Material	All Native Soil	1																																																																			
Potential Eroded Volume Mean	21-40 y ³	3																																																																			
Approach Slope Mean	2.1-4%	3

Soil K Factor	<0.20	5																																																																			
Upstream Rt Outlet	Bare soil	0																																																																			
Upstream Lt Outlet	Bare soil	0																																																																			
Upstream Rt Ditch	Bare soil	0																																																																			
Upstream Lt Ditch	Bare soil	0																																																																			
Downstream Rt Outlet	Bare soil	0																																																																			
Downstream Lt Outlet	Bare soil	0																																																																			
Downstream Rt Ditch	Bare soil	0																																																																			
Downstream Lt Ditch	Bare soil	0																																																																			
Outlet Total	Unimproved Outlet System	1
