Unnamed tributary		ok-0429-r-014	Sedimentation Risk Index 22																																																																		
<u>Common:</u> 5.1mi SW of Laurel Hill <u>Drainage:</u> Murder Creek <u>GPS:</u> 30.910200, -86.517086 <u>Land owner:</u> Dean & Deborah Clary		<u>County:</u> Okaloosa <u>State:</u> Florida <u>PLSS(T-R-S):</u> 5N-23-23 <u>Parcel No.:</u> 5.001 <u>Road Name:</u> W Plympton Road

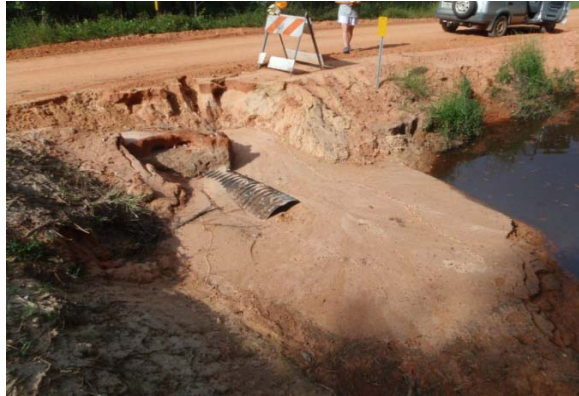
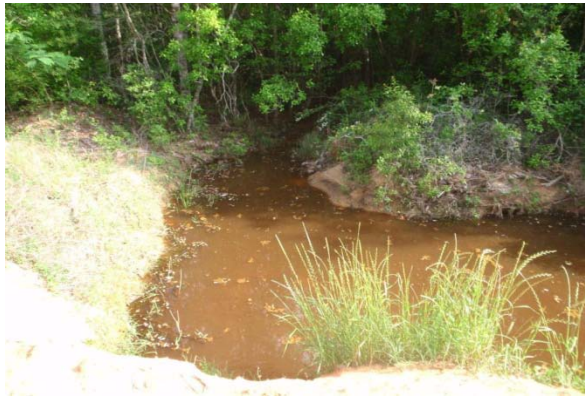
Crossing Structure: DS		DS																																																																			
<table border="1"> <thead> <tr> <th>Risk Factor</th> <th>Ranking</th> <th>Score</th> </tr> </thead> <tbody> <tr><td>US Channel Morph</td><td>PONDED</td><td>1</td></tr> <tr><td>DS Channel Morph</td><td>PONDED</td><td>1</td></tr> <tr><td>DS Bank Alteration</td><td>HIGH</td><td>1</td></tr> <tr><td>Upstream Skew Angle</td><td>>30°</td><td>1</td></tr> <tr><td>Crossing fill condition</td><td>Poor/Bare soil</td><td>1</td></tr> <tr><td>Inlet/Outlet Condition</td><td>Blocked</td><td>1</td></tr> <tr><td>Road Approach Material</td><td>All Sand/Clay</td><td>3</td></tr> <tr><td>Potential Eroded Volume Mean</td><td>>40 y³</td><td>1</td></tr> <tr><td>Approach Slope Mean</td><td>2.1-4%</td><td>3</td></tr> <tr><td>Soil K Factor</td><td><0.20</td><td>5</td></tr> <tr><td>Upstream Rt Outlet</td><td>Vegetated</td><td>1</td></tr> <tr><td>Upstream Lt Outlet</td><td>Vegetated</td><td>1</td></tr> <tr><td>Upstream Rt Ditch</td><td>Bare soil</td><td>0</td></tr> <tr><td>Upstream Lt Ditch</td><td>Bare soil</td><td>0</td></tr> <tr><td>Downstream Rt Outlet</td><td>Bare soil</td><td>0</td></tr> <tr><td>Downstream Lt Outlet</td><td>Bare soil</td><td>0</td></tr> <tr><td>Downstream Rt Ditch</td><td>Bare soil</td><td>0</td></tr> <tr><td>Downstream Lt Ditch</td><td>Bare soil</td><td>0</td></tr> <tr><td>Outlet Total</td><td>Partially Improved Outlet System</td><td>3</td></tr> <tr><td>Ditches Total</td><td>Unimproved Drainage System</td><td>1</td></tr> <tr><td>SRI Total</td><td>High Risk</td><td>22</td></tr> </tbody> </table>		Risk Factor	Ranking	Score	US Channel Morph	PONDED	1	DS Channel Morph	PONDED	1	DS Bank Alteration	HIGH	1	Upstream Skew Angle	>30°	1	Crossing fill condition	Poor/Bare soil	1	Inlet/Outlet Condition	Blocked	1	Road Approach Material	All Sand/Clay	3	Potential Eroded Volume Mean	>40 y ³	1	Approach Slope Mean	2.1-4%	3	Soil K Factor	<0.20	5	Upstream Rt Outlet	Vegetated	1	Upstream Lt Outlet	Vegetated	1	Upstream Rt Ditch	Bare soil	0	Upstream Lt Ditch	Bare soil	0	Downstream Rt Outlet	Bare soil	0	Downstream Lt Outlet	Bare soil	0	Downstream Rt Ditch	Bare soil	0	Downstream Lt Ditch	Bare soil	0	Outlet Total	Partially Improved Outlet System	3	Ditches Total	Unimproved Drainage System	1	SRI Total	High Risk	22

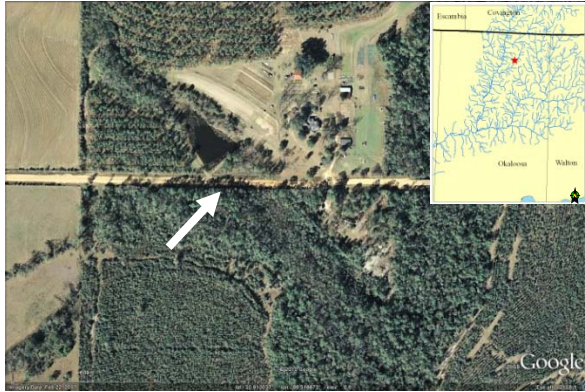
Risk Factor	Ranking	Score																																																																			
US Channel Morph	PONDED	1																																																																			
DS Channel Morph	PONDED	1																																																																			
DS Bank Alteration	HIGH	1																																																																			
Upstream Skew Angle	>30°	1																																																																			
Crossing fill condition	Poor/Bare soil	1																																																																			
Inlet/Outlet Condition	Blocked	1																																																																			
Road Approach Material	All Sand/Clay	3																																																																			
Potential Eroded Volume Mean	>40 y ³	1																																																																			
Approach Slope Mean	2.1-4%	3

Soil K Factor	<0.20	5																																																																			
Upstream Rt Outlet	Vegetated	1																																																																			
Upstream Lt Outlet	Vegetated	1																																																																			
Upstream Rt Ditch	Bare soil	0																																																																			
Upstream Lt Ditch	Bare soil	0																																																																			
Downstream Rt Outlet	Bare soil	0																																																																			
Downstream Lt Outlet	Bare soil	0																																																																			
Downstream Rt Ditch	Bare soil	0																																																																			
Downstream Lt Ditch	Bare soil	0																																																																			
Outlet Total	Partially Improved Outlet System	3
