Unnamed tributary		co-0810-r-011	Sedimentation Risk Index 40																																																																		
<u>Common:</u> 13.0mi NW of Florala <u>Drainage:</u> Five Runs Creek <u>GPS:</u> 31.136572, -86.483358 <u>Land owner:</u> USA-Conecuh Nat. Forest		<u>County:</u> Covington <u>State:</u> Alabama <u>PLSS (T-R-S):</u> 2N-16E-18 <u>Parcel No.:</u> 1 <u>Road Name:</u> Shiloh Cemetery Rd

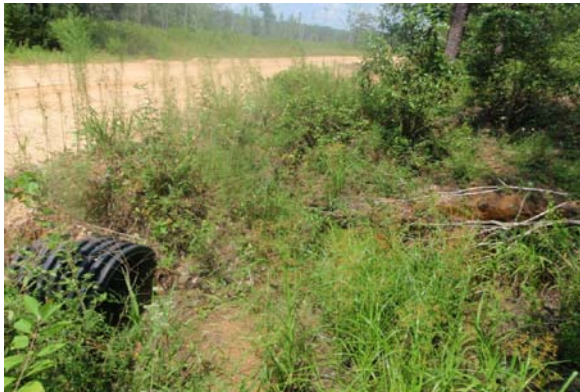
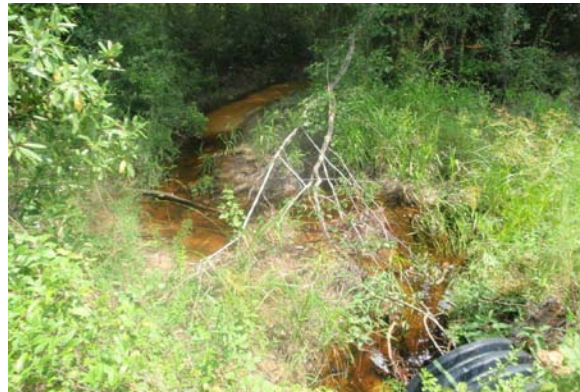
Crossing Structure: US		US																																																																			
<table border="1"> <thead> <tr> <th>Risk Factor</th> <th>Ranking</th> <th>Score</th> </tr> </thead> <tbody> <tr><td>US Channel Morph</td><td>DA</td><td>3</td></tr> <tr><td>DS Channel Morph</td><td>DA</td><td>3</td></tr> <tr><td>DS Bank Alteration</td><td>HIGH</td><td>1</td></tr> <tr><td>Upstream Skew Angle</td><td>5-30°</td><td>3</td></tr> <tr><td>Crossing fill condition</td><td>Poor/Bare soil</td><td>1</td></tr> <tr><td>Inlet/Outlet Condition</td><td>Sed Islands/Scouring</td><td>3</td></tr> <tr><td>Road Approach Material</td><td>All Sand/Clay</td><td>3</td></tr> <tr><td>Potential Eroded Volume Mean</td><td><21 y³</td><td>5</td></tr> <tr><td>Approach Slope Mean</td><td><2%</td><td>5</td></tr> <tr><td>Soil K Factor</td><td><0.20</td><td>5</td></tr> <tr><td>Upstream Rt Outlet</td><td>Vegetated</td><td>1</td></tr> <tr><td>Upstream Lt Outlet</td><td>Vegetated</td><td>1</td></tr> <tr><td>Upstream Rt Ditch</td><td>Synthetic</td><td>1</td></tr> <tr><td>Upstream Lt Ditch</td><td>Bare soil</td><td>0</td></tr> <tr><td>Downstream Rt Outlet</td><td>Vegetated</td><td>1</td></tr> <tr><td>Downstream Lt Outlet</td><td>Vegetated</td><td>1</td></tr> <tr><td>Downstream Rt Ditch</td><td>Bare soil</td><td>0</td></tr> <tr><td>Downstream Lt Ditch</td><td>Bare soil</td><td>0</td></tr> <tr><td>Outlet Total</td><td>Improved Outlet System</td><td>5</td></tr> <tr><td>Ditches Total</td><td>Partially Improved Drainage System</td><td>3</td></tr> <tr><td>SRI Total</td><td>Medium Risk</td><td>40</td></tr> </tbody> </table>		Risk Factor	Ranking	Score	US Channel Morph	DA	3	DS Channel Morph	DA	3	DS Bank Alteration	HIGH	1	Upstream Skew Angle	5-30°	3	Crossing fill condition	Poor/Bare soil	1	Inlet/Outlet Condition	Sed Islands/Scouring	3	Road Approach Material	All Sand/Clay	3	Potential Eroded Volume Mean	<21 y ³	5	Approach Slope Mean	<2%	5	Soil K Factor	<0.20	5	Upstream Rt Outlet	Vegetated	1	Upstream Lt Outlet	Vegetated	1	Upstream Rt Ditch	Synthetic	1	Upstream Lt Ditch	Bare soil	0	Downstream Rt Outlet	Vegetated	1	Downstream Lt Outlet	Vegetated	1	Downstream Rt Ditch	Bare soil	0	Downstream Lt Ditch	Bare soil	0	Outlet Total	Improved Outlet System	5	Ditches Total	Partially Improved Drainage System	3	SRI Total	Medium Risk	40

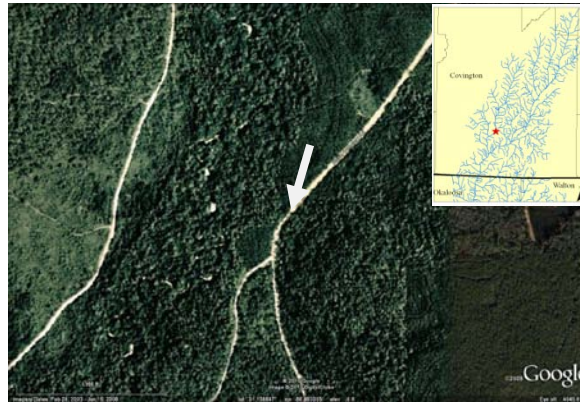
Risk Factor	Ranking	Score																																																																			
US Channel Morph	DA	3																																																																			
DS Channel Morph	DA	3																																																																			
DS Bank Alteration	HIGH	1																																																																			
Upstream Skew Angle	5-30°	3																																																																			
Crossing fill condition	Poor/Bare soil	1																																																																			
Inlet/Outlet Condition	Sed Islands/Scouring	3																																																																			
Road Approach Material	All Sand/Clay	3																																																																			
Potential Eroded Volume Mean	<21 y ³	5																																																																			
Approach Slope Mean	<2%	5

Soil K Factor	<0.20	5																																																																			
Upstream Rt Outlet	Vegetated	1																																																																			
Upstream Lt Outlet	Vegetated	1																																																																			
Upstream Rt Ditch	Synthetic	1																																																																			
Upstream Lt Ditch	Bare soil	0																																																																			
Downstream Rt Outlet	Vegetated	1																																																																			
Downstream Lt Outlet	Vegetated	1																																																																			
Downstream Rt Ditch	Bare soil	0																																																																			
Downstream Lt Ditch	Bare soil	0																																																																			
Outlet Total	Improved Outlet System	5

Ditches Total	Partially Improved Drainage System	3																																																																			
SRI Total	Medium Risk	40																																																																			
Additional Site Features <u>Crossing Type and Quantity:</u> Culvert, 2 <u>Crossing Materials:</u> PVC <u>Soil Types:</u> BoC,FoA,IbA,LyA,RaA <u>Rt Approach Prism Fill:</u> 0.5in <u>Lt Approach Prism Fill:</u> 0.5in		<table border="1"> <thead> <tr> <th>Feature</th> <th>Within Range</th> <th>Descriptive Field</th> </tr> </thead> <tbody> <tr> <td>303(d)</td> <td>No</td> <td>N/A</td> </tr> <tr> <td>Wetland Species</td> <td>No</td> <td>N/A</td> </tr> <tr> <td>Rare and Imperiled</td> <td>No</td> <td>N/A</td> </tr> <tr> <td>Land Use/Cover</td> <td>Yes</td> <td>N/A/ EAST GULF COASTAL PLAIN INTERIOR UPLAND LONGLEAF PINE WOODLAND-LOBLOLLY MODIFIER</td> </tr> <tr> <td>Candidate Mussels</td> <td>No</td> <td>N/A</td> </tr> <tr> <td>Sturgeon C.H.</td> <td>No</td> <td>N/A</td> </tr> </tbody> </table>		Feature	Within Range	Descriptive Field	303(d)	No	N/A	Wetland Species	No	N/A	Rare and Imperiled	No	N/A	Land Use/Cover	Yes	N/A/ EAST GULF COASTAL PLAIN INTERIOR UPLAND LONGLEAF PINE WOODLAND-LOBLOLLY MODIFIER	Candidate Mussels	No	N/A	Sturgeon C.H.	No	N/A
