Shoal River			wa-1009-002		Severity Score 5.5	
<u>Common:</u> 2.6mi N of Oakwood Hills Development near Mossy Head <u>Drainage:</u> Yellow River <u>GPS:</u> 30.786979658, -86.262246396 <u>Land owner:</u> NWFL Girl Scouts			<u>County:</u> Walton <u>PLSS(T-R-S):</u> 3N-20W-5 <u>Parcel No.:</u> 1		<u>State:</u> Florida

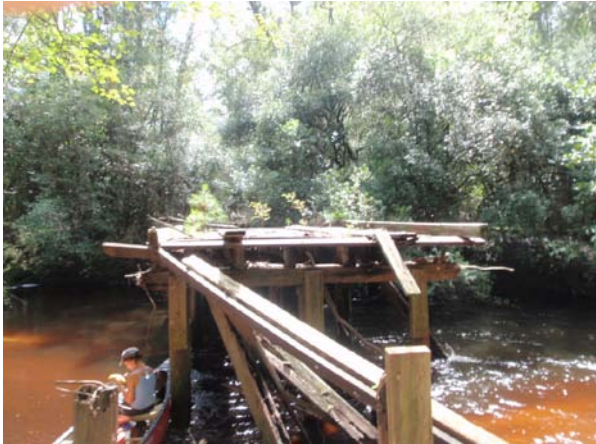
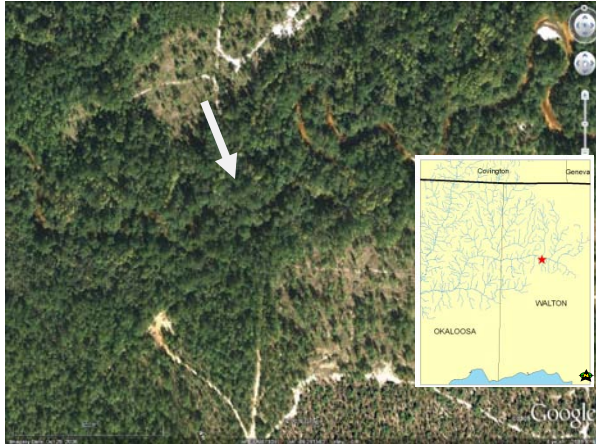
Notes: Hurricane Ivan damaged bridge structure- formerly Girl Scout Rd.

Pieces of bridge were found DS washed into trees .
