Unnamed tributary		co-0811-r-001		Sedimentation Risk Index 54																																																																			
<u>Common:</u> 8.9mi NW of Florala <u>Drainage:</u> Yellow River <i>GPS:</i> 31.088983, -86.440317 <u>Land owner:</u> William Hicks & Phyllis Hicks Moody-DS, Lora Smith - US		<u>County:</u> Covington <u>PLSS (T-R-S):</u> 2N-16E-34/1N-16E-3 <u>Parcel No.:</u> 8; 4.03 <u>Road Name:</u> Yellow River Ranch Rd		<u>State:</u> Alabama

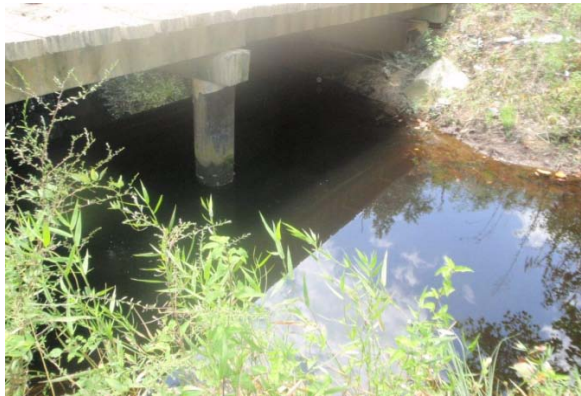
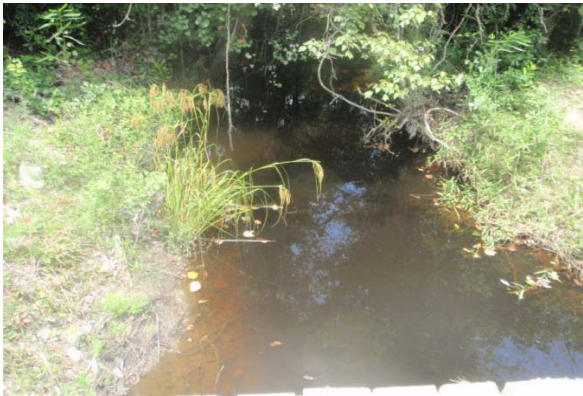
Crossing Structure: US		DS																																																																					
<table border="1"> <thead> <tr> <th>Risk Factor</th> <th>Ranking</th> <th>Score</th> </tr> </thead> <tbody> <tr><td>US Channel Morph</td><td>B</td><td>5</td></tr> <tr><td>DS Channel Morph</td><td>B</td><td>5</td></tr> <tr><td>DS Bank Alteration</td><td>MINOR/PARTIAL</td><td>3</td></tr> <tr><td>Upstream Skew Angle</td><td><5°</td><td>5</td></tr> <tr><td>Crossing fill condition</td><td>Good/Vegetated</td><td>5</td></tr> <tr><td>Inlet/Outlet Condition</td><td>No Impairment</td><td>5</td></tr> <tr><td>Road Approach Material</td><td>All Sand/Clay</td><td>3</td></tr> <tr><td>Potential Eroded Volume Mean</td><td><21 y³</td><td>5</td></tr> <tr><td>Approach Slope Mean</td><td><2%</td><td>5</td></tr> <tr><td>Soil K Factor</td><td><0.20</td><td>5</td></tr> <tr><td>Upstream Rt Outlet</td><td>Vegetated</td><td>1</td></tr> <tr><td>Upstream Lt Outlet</td><td>Vegetated</td><td>1</td></tr> <tr><td>Upstream Rt Ditch</td><td>Vegetated</td><td>1</td></tr> <tr><td>Upstream Lt Ditch</td><td>Vegetated</td><td>1</td></tr> <tr><td>Downstream Rt Outlet</td><td>Vegetated</td><td>1</td></tr> <tr><td>Downstream Lt Outlet</td><td>Vegetated</td><td>1</td></tr> <tr><td>Downstream Rt Ditch</td><td>Bare soil</td><td>0</td></tr> <tr><td>Downstream Lt Ditch</td><td>Vegetated</td><td>1</td></tr> <tr><td>Outlet Total</td><td>Improved Outlet System</td><td>5</td></tr> <tr><td>Ditches Total</td><td>Partially Improved Drainage System</td><td>3</td></tr> <tr><td>SRI Total</td><td>Low Risk</td><td>54</td></tr> </tbody> </table>		Risk Factor	Ranking	Score	US Channel Morph	B	5	DS Channel Morph	B	5	DS Bank Alteration	MINOR/PARTIAL	3	Upstream Skew Angle	<5°	5	Crossing fill condition	Good/Vegetated	5	Inlet/Outlet Condition	No Impairment	5	Road Approach Material	All Sand/Clay	3	Potential Eroded Volume Mean	<21 y ³	5	Approach Slope Mean	<2%	5	Soil K Factor	<0.20	5	Upstream Rt Outlet	Vegetated	1	Upstream Lt Outlet	Vegetated	1	Upstream Rt Ditch	Vegetated	1	Upstream Lt Ditch	Vegetated	1	Downstream Rt Outlet	Vegetated	1	Downstream Lt Outlet	Vegetated	1	Downstream Rt Ditch	Bare soil	0	Downstream Lt Ditch	Vegetated	1	Outlet Total	Improved Outlet System	5	Ditches Total	Partially Improved Drainage System	3	SRI Total	Low Risk	54
