Shoal River		ok-0422-001		Severity Score 1.5	
<u>Common:</u> 5.3mi SW of Crestview <u>Drainage:</u> Yellow River <u>GPS:</u> 30.69467494, -86.61382983 <u>Land owner:</u> USA		<u>County:</u> Okaloosa <u>PLSS:</u> 2N-24W-11 <u>Parcel No.:</u> 1		<u>State:</u> Florida

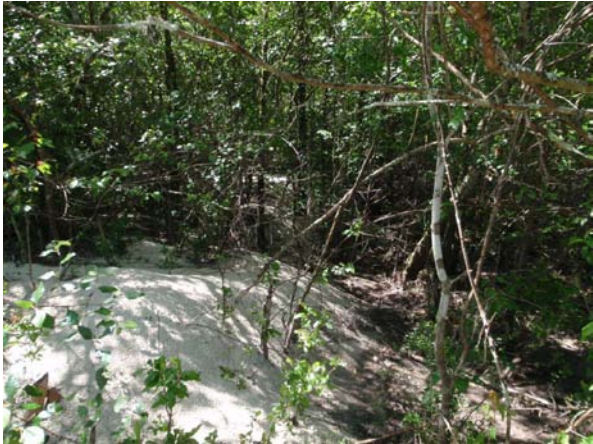
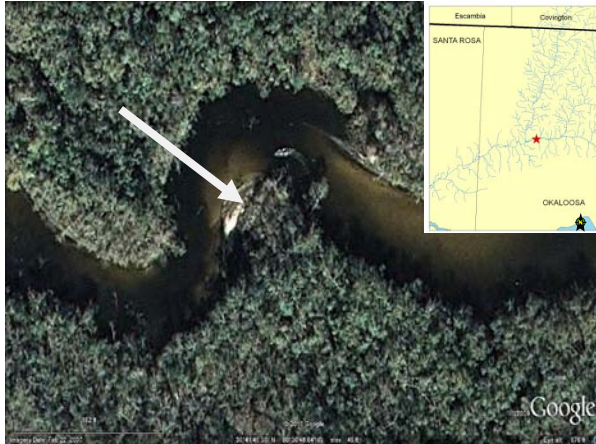
Notes: Aggradational Site: Large, fresh deposit extended into forest- 4 in of fine sand and about 1 inch of coarse sand result of recent heavy rains and flooding.
