Gum Creek		wa-0716-r-010	Sedimentation Risk Index <b>26</b>																																																																		
<u>Common:</u> 4.4mi E of Mossy Head <u>Drainage:</u> Shoal River <u>GPS:</u> 30.753482, -86.241856 <u>Land owner:</u> Margaret Rocque-US, James & Janice Shackelford-DS		<u>County:</u> Walton <u>State:</u> Florida <u>PLSS(T-R-S):</u> 3N-20-16-28060 <u>Parcel No.:</u> 48.0160; 49.0340 <u>Road Name:</u> E Dogwood Dr

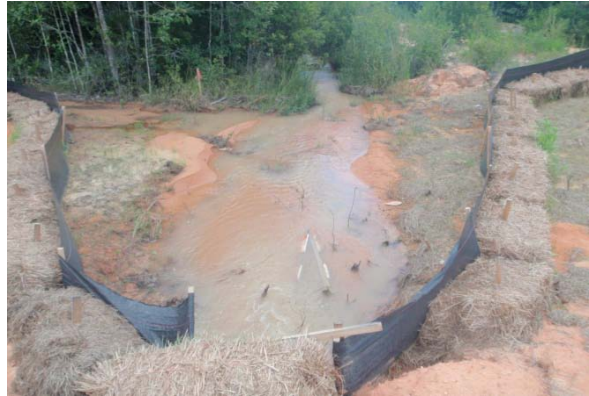
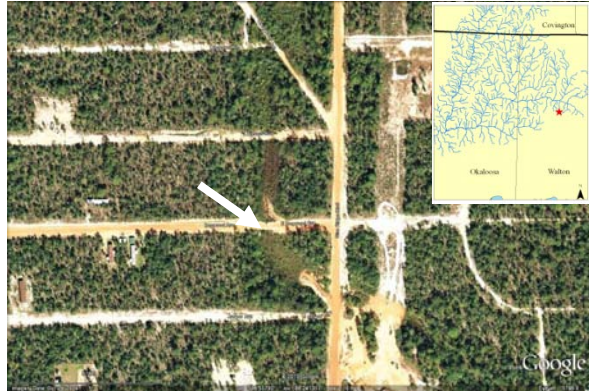
Crossing Structure: DS		DS																																																																			
<table border="1"> <thead> <tr> <th>Risk Factor</th> <th>Ranking</th> <th>Score</th> </tr> </thead> <tbody> <tr><td>US Channel Morph</td><td>DA</td><td>3</td></tr> <tr><td>DS Channel Morph</td><td>DA</td><td>3</td></tr> <tr><td>DS Bank Alteration</td><td>HIGH</td><td>1</td></tr> <tr><td>Upstream Skew Angle</td><td>&lt;5°</td><td>5</td></tr> <tr><td>Crossing fill condition</td><td>Poor/Bare soil</td><td>1</td></tr> <tr><td>Inlet/Outlet Condition</td><td>Sed Islands/Scouring</td><td>3</td></tr> <tr><td>Road Approach Material</td><td>All Sand/Clay</td><td>3</td></tr> <tr><td>Potential Eroded Volume Mean</td><td>&lt;21 y<sup>3</sup></td><td>5</td></tr> <tr><td>Approach Slope Mean</td><td>&gt;4%</td><td>1</td></tr> <tr><td>Soil K Factor</td><td>&lt;0.20</td><td>5</td></tr> <tr><td>Upstream Rt Outlet</td><td>Other</td><td>0</td></tr> <tr><td>Upstream Lt Outlet</td><td>Other</td><td>0</td></tr> <tr><td>Upstream Rt Ditch</td><td>Bare soil</td><td>0</td></tr> <tr><td>Upstream Lt Ditch</td><td>Bare soil</td><td>0</td></tr> <tr><td>Downstream Rt Outlet</td><td>Other</td><td>0</td></tr> <tr><td>Downstream Lt Outlet</td><td>Other</td><td>0</td></tr> <tr><td>Downstream Rt Ditch</td><td>Vegetated</td><td>1</td></tr> <tr><td>Downstream Lt Ditch</td><td>Vegetated</td><td>1</td></tr> <tr><td>Outlet Total</td><td>Unimproved Outlet System</td><td>1</td></tr> <tr><td>Ditches Total</td><td>Partially Improved Drainage System</td><td>3</td></tr> <tr><td><b>SRI Total</b></td><td><b>High Risk</b></td><td><b>34</b></td></tr> </tbody> </table>		Risk Factor	Ranking	Score	US Channel Morph	DA	3	DS Channel Morph	DA	3	DS Bank Alteration	HIGH	1	Upstream Skew Angle	<5°	5	Crossing fill condition	Poor/Bare soil	1	Inlet/Outlet Condition	Sed Islands/Scouring	3	Road Approach Material	All Sand/Clay	3	Potential Eroded Volume Mean	<21 y <sup>3</sup>	5	Approach Slope Mean	>4%	1	Soil K Factor	<0.20	5	Upstream Rt Outlet	Other	0	Upstream Lt Outlet	Other	0	Upstream Rt Ditch	Bare soil	0	Upstream Lt Ditch	Bare soil	0	Downstream Rt Outlet	Other	0	Downstream Lt Outlet	Other	0	Downstream Rt Ditch	Vegetated	1	Downstream Lt Ditch	Vegetated	1	Outlet Total	Unimproved Outlet System	1	Ditches Total	Partially Improved Drainage System	3	<b>SRI Total</b>	<b>High Risk</b>	<b>34</b>

Risk Factor	Ranking	Score																																																																			
US Channel Morph	DA	3																																																																			
DS Channel Morph	DA	3																																																																			
DS Bank Alteration	HIGH	1																																																																			
Upstream Skew Angle	<5°	5																																																																			
Crossing fill condition	Poor/Bare soil	1																																																																			
Inlet/Outlet Condition	Sed Islands/Scouring	3																																																																			
Road Approach Material	All Sand/Clay	3																																																																			
Potential Eroded Volume Mean	<21 y <sup>3</sup>	5																																																																			
Approach Slope Mean	>4%	1

Soil K Factor	<0.20	5																																																																			
Upstream Rt Outlet	Other	0																																																																			
Upstream Lt Outlet	Other	0																																																																			
Upstream Rt Ditch	Bare soil	0																																																																			
Upstream Lt Ditch	Bare soil	0																																																																			
Downstream Rt Outlet	Other	0																																																																			
Downstream Lt Outlet	Other	0																																																																			
Downstream Rt Ditch	Vegetated	1																																																																			
Downstream Lt Ditch	Vegetated	1																																																																			
Outlet Total	Unimproved Outlet System	1

Ditches Total	Partially Improved Drainage System	3																																																																			
<b>SRI Total</b>	<b>High Risk</b>	<b>34</b>																																																																			
<b>Additional Site Features</b> <u>Crossing Type and Quantity:</u> Culvert, 1 <u>Crossing Materials:</u> Metal <u>Soil Types:</u> 17,18 <u>Rt Approach Prism Fill:</u> 0.5in <u>Lt Approach Prism Fill:</u> 0.25in		<table border="1"> <thead> <tr> <th>Feature</th> <th>Within Range</th> <th>Descriptive Field</th> </tr> </thead> <tbody> <tr> <td>303(d)</td> <td>No</td> <td>N/A</td> </tr> <tr> <td>Wetland Species</td> <td>Yes</td> <td>1-3 FOCAL SPECIES IN UPLAND AREAS</td> </tr> <tr> <td>Rare and Imperiled</td> <td>No</td> <td>N/A</td> </tr> <tr> <td>Land Use/Cover</td> <td>Yes</td> <td>N/A/ HYDRIC PINE FLATWOODS</td> </tr> <tr> <td>Candidate Mussels</td> <td>No</td> <td>N/A</td> </tr> <tr> <td>Sturgeon C.H.</td> <td>No</td> <td>N/A</td> </tr> </tbody> </table>		Feature	Within Range	Descriptive Field	303(d)	No	N/A	Wetland Species	Yes	1-3 FOCAL SPECIES IN UPLAND AREAS	Rare and Imperiled	No	N/A	Land Use/Cover	Yes	N/A/ HYDRIC PINE FLATWOODS	Candidate Mussels	No	N/A	Sturgeon C.H.	No	N/A

Notes: BMPs
