Unnamed tributary		wa-0617-r-005	Sedimentation Risk Index 36																																																																		
<u>Common:</u> 4.3mi E of Laurel Hill <u>Drainage:</u> Pond Creek GPS: 30.953947, -86.388783 <u>Land owner:</u> Timothy & Nelda Fleming-DS, Rose in Bloom Inc-US		<u>County:</u> Walton <u>PLSS(T-R-S):</u> 5N-21-06; 5N-22-01 <u>Parcel No.:</u> 15; 10 <u>Road Name:</u> County Line Rd

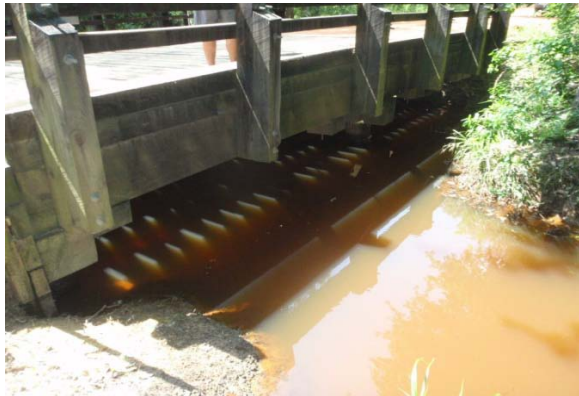
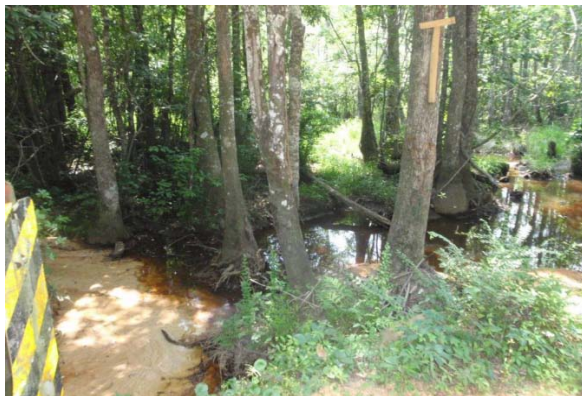
Crossing Structure: DS		US																																																																			
<table border="1"> <thead> <tr> <th>Risk Factor</th> <th>Ranking</th> <th>Score</th> </tr> </thead> <tbody> <tr><td>US Channel Morph</td><td>WETLAND</td><td>5</td></tr> <tr><td>DS Channel Morph</td><td>DA</td><td>3</td></tr> <tr><td>DS Bank Alteration</td><td>MINOR/PARTIAL</td><td>3</td></tr> <tr><td>Upstream Skew Angle</td><td>5-30°</td><td>3</td></tr> <tr><td>Crossing fill condition</td><td>Poor/Bare soil</td><td>1</td></tr> <tr><td>Inlet/Outlet Condition</td><td>No Impairment</td><td>5</td></tr> <tr><td>Road Approach Material</td><td>All Sand/Clay</td><td>3</td></tr> <tr><td>Potential Eroded Volume Mean</td><td>>40 y³</td><td>1</td></tr> <tr><td>Approach Slope Mean</td><td>>4%</td><td>1</td></tr> <tr><td>Soil K Factor</td><td><0.20</td><td>5</td></tr> <tr><td>Upstream Rt Outlet</td><td>Bare soil</td><td>0</td></tr> <tr><td>Upstream Lt Outlet</td><td>Vegetated</td><td>1</td></tr> <tr><td>Upstream Rt Ditch</td><td>Synthetic</td><td>1</td></tr> <tr><td>Upstream Lt Ditch</td><td>Bare soil</td><td>0</td></tr> <tr><td>Downstream Rt Outlet</td><td>Vegetated</td><td>1</td></tr> <tr><td>Downstream Lt Outlet</td><td>Vegetated</td><td>1</td></tr> <tr><td>Downstream Rt Ditch</td><td>Bare soil</td><td>0</td></tr> <tr><td>Downstream Lt Ditch</td><td>Bare soil</td><td>0</td></tr> <tr><td>Outlet Total</td><td>Partially Improved Outlet System</td><td>3</td></tr> <tr><td>Ditches Total</td><td>Partially Improved Drainage System</td><td>3</td></tr> <tr><td>SRI Total</td><td>High Risk</td><td>36</td></tr> </tbody> </table>		Risk Factor	Ranking	Score	US Channel Morph	WETLAND	5	DS Channel Morph	DA	3	DS Bank Alteration	MINOR/PARTIAL	3	Upstream Skew Angle	5-30°	3	Crossing fill condition	Poor/Bare soil	1	Inlet/Outlet Condition	No Impairment	5	Road Approach Material	All Sand/Clay	3	Potential Eroded Volume Mean	>40 y ³	1	Approach Slope Mean	>4%	1	Soil K Factor	<0.20	5	Upstream Rt Outlet	Bare soil	0	Upstream Lt Outlet	Vegetated	1	Upstream Rt Ditch	Synthetic	1	Upstream Lt Ditch	Bare soil	0	Downstream Rt Outlet	Vegetated	1	Downstream Lt Outlet	Vegetated	1	Downstream Rt Ditch	Bare soil	0	Downstream Lt Ditch	Bare soil	0	Outlet Total	Partially Improved Outlet System	3	Ditches Total	Partially Improved Drainage System	3	SRI Total	High Risk	36
