Titi Creek		ok-0409-r-002	Sedimentation Risk Index 46																																																																		
<u>Common:</u> 6.3mi SE of Crestview <u>Drainage:</u> Shoal River <u>GPS:</u> 30.701603275, -86.492143871 <u>Land owner:</u> US Government- Eglin AFB		<u>County:</u> Okaloosa <u>State:</u> Florida <u>PLSS(T-R-S):</u> 2N-22-01 <u>Parcel No.:</u> 1 <u>Road Name:</u> RR207 Eglin AFB

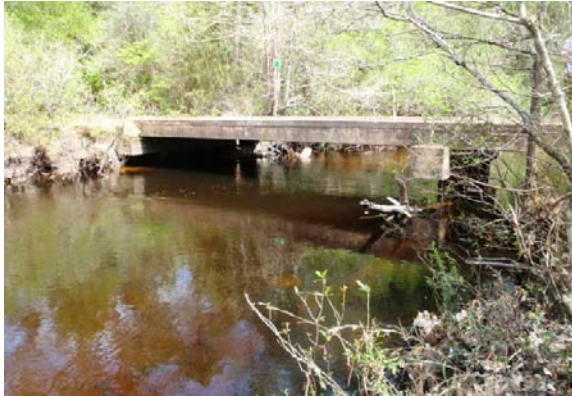
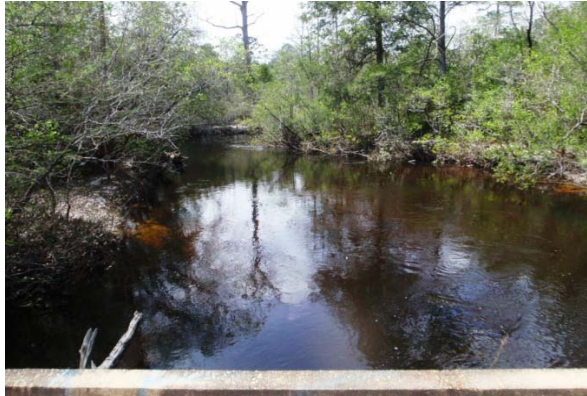
Crossing Structure: DS		DS																																																																			
<table border="1"> <thead> <tr> <th>Risk Factor</th> <th>Ranking</th> <th>Score</th> </tr> </thead> <tbody> <tr><td>US Channel Morph</td><td>E</td><td>5</td></tr> <tr><td>DS Channel Morph</td><td>E</td><td>5</td></tr> <tr><td>DS Bank Alteration</td><td>NATURAL</td><td>5</td></tr> <tr><td>Upstream Skew Angle</td><td><5°</td><td>5</td></tr> <tr><td>Crossing fill condition</td><td>Fair/Riprap</td><td>3</td></tr> <tr><td>Inlet/Outlet Condition</td><td>No Impairment</td><td>5</td></tr> <tr><td>Road Approach Material</td><td>All Sand/Clay</td><td>3</td></tr> <tr><td>Potential Eroded Volume Mean</td><td>>40 y³</td><td>1</td></tr> <tr><td>Approach Slope Mean</td><td><2%</td><td>5</td></tr> <tr><td>Soil K Factor</td><td><0.20</td><td>5</td></tr> <tr><td>Upstream Rt Outlet</td><td>Vegetated</td><td>1</td></tr> <tr><td>Upstream Lt Outlet</td><td>Vegetated</td><td>1</td></tr> <tr><td>Upstream Rt Ditch</td><td>Bare soil</td><td>0</td></tr> <tr><td>Upstream Lt Ditch</td><td>Bare soil</td><td>0</td></tr> <tr><td>Downstream Rt Outlet</td><td>Vegetated</td><td>1</td></tr> <tr><td>Downstream Lt Outlet</td><td>Bare soil</td><td>0</td></tr> <tr><td>Downstream Rt Ditch</td><td>Bare soil</td><td>0</td></tr> <tr><td>Downstream Lt Ditch</td><td>Bare soil</td><td>0</td></tr> <tr><td>Outlet Total</td><td>Partially Improved Outlet System</td><td>3</td></tr> <tr><td>Ditches Total</td><td>Unimproved Drainage System</td><td>1</td></tr> <tr><td>SRI Total</td><td>Low Risk</td><td>46</td></tr> </tbody> </table>				Risk Factor	Ranking	Score	US Channel Morph	E	5	DS Channel Morph	E	5	DS Bank Alteration	NATURAL	5	Upstream Skew Angle	<5°	5	Crossing fill condition	Fair/Riprap	3	Inlet/Outlet Condition	No Impairment	5	Road Approach Material	All Sand/Clay	3	Potential Eroded Volume Mean	>40 y ³	1	Approach Slope Mean	<2%	5	Soil K Factor	<0.20	5	Upstream Rt Outlet	Vegetated	1	Upstream Lt Outlet	Vegetated	1	Upstream Rt Ditch	Bare soil	0	Upstream Lt Ditch	Bare soil	0	Downstream Rt Outlet	Vegetated	1	Downstream Lt Outlet	Bare soil	0	Downstream Rt Ditch	Bare soil	0	Downstream Lt Ditch	Bare soil	0	Outlet Total	Partially Improved Outlet System	3	Ditches Total	Unimproved Drainage System	1	SRI Total	Low Risk	46

Notes: DS Lt Outlet aggregate boat launch.
