Unnamed tributary		co-0901-r-014	Sedimentation Risk Index <b>34</b>																																																																		
<u>Common:</u> 7.9mi SE of Andalusia <u>Drainage:</u> Poplar Creek <u>GPS:</u> 31.185399140, -86.402745904 <u>Land owner:</u> Opal Couch		<u>County:</u> Covington <u>State:</u> Alabama <u>PLSS (T-R-S):</u> 3N-16E-36 <u>Parcel No.:</u> 1 <u>Road Name:</u> Nature Rd

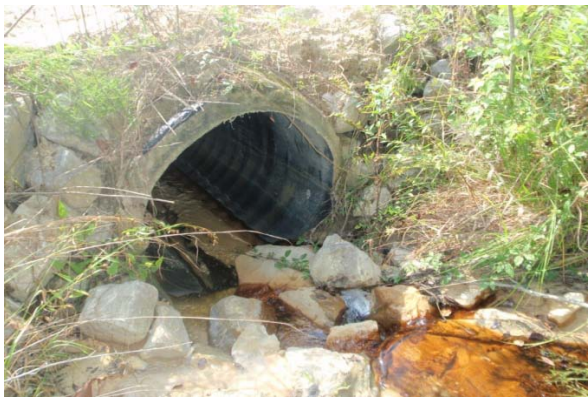
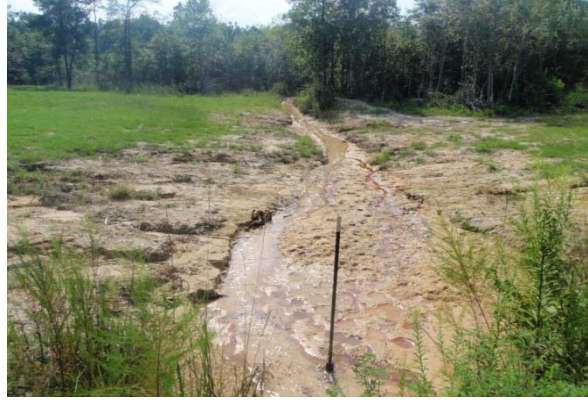
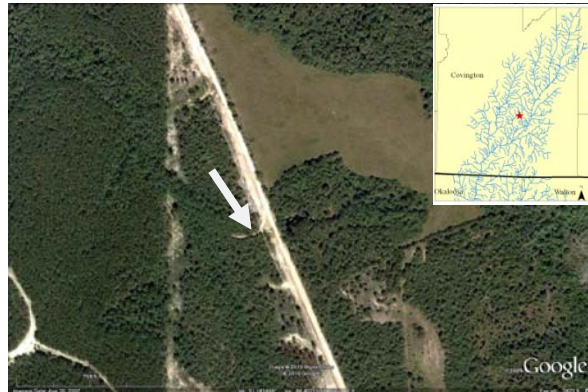
Crossing Structure: US		US																																																																			
<table border="1"> <thead> <tr> <th>Risk Factor</th> <th>Ranking</th> <th>Score</th> </tr> </thead> <tbody> <tr><td>US Channel Morph</td><td>C</td><td>5</td></tr> <tr><td>DS Channel Morph</td><td>C</td><td>5</td></tr> <tr><td>DS Bank Alteration</td><td>HIGH</td><td>1</td></tr> <tr><td>Upstream Skew Angle</td><td>&gt;30°</td><td>1</td></tr> <tr><td>Crossing fill condition</td><td>Poor/Bare soil</td><td>1</td></tr> <tr><td>Inlet/Outlet Condition</td><td>Sed Islands/Scouring</td><td>3</td></tr> <tr><td>Road Approach Material</td><td>All Sand/Clay</td><td>3</td></tr> <tr><td>Potential Eroded Volume Mean</td><td>&lt;21 y<sup>3</sup></td><td>5</td></tr> <tr><td>Approach Slope Mean</td><td>2.1-4%</td><td>3</td></tr> <tr><td>Soil K Factor</td><td>&lt;0.20</td><td>5</td></tr> <tr><td>Upstream Rt Outlet</td><td>Bare soil</td><td>0</td></tr> <tr><td>Upstream Lt Outlet</td><td>Bare soil</td><td>0</td></tr> <tr><td>Upstream Rt Ditch</td><td>Bare soil</td><td>0</td></tr> <tr><td>Upstream Lt Ditch</td><td>Bare soil</td><td>0</td></tr> <tr><td>Downstream Rt Outlet</td><td>Bare soil</td><td>0</td></tr> <tr><td>Downstream Lt Outlet</td><td>Bare soil</td><td>0</td></tr> <tr><td>Downstream Rt Ditch</td><td>Bare soil</td><td>0</td></tr> <tr><td>Downstream Lt Ditch</td><td>Bare soil</td><td>0</td></tr> <tr><td>Outlet Total</td><td>Unimproved Outlet System</td><td>1</td></tr> <tr><td>Ditches Total</td><td>Unimproved Drainage System</td><td>1</td></tr> <tr><td><b>SRI Total</b></td><td><b>High Risk</b></td><td><b>34</b></td></tr> </tbody> </table>		Risk Factor	Ranking	Score	US Channel Morph	C	5	DS Channel Morph	C	5	DS Bank Alteration	HIGH	1	Upstream Skew Angle	>30°	1	Crossing fill condition	Poor/Bare soil	1	Inlet/Outlet Condition	Sed Islands/Scouring	3	Road Approach Material	All Sand/Clay	3	Potential Eroded Volume Mean	<21 y <sup>3</sup>	5	Approach Slope Mean	2.1-4%	3	Soil K Factor	<0.20	5	Upstream Rt Outlet	Bare soil	0	Upstream Lt Outlet	Bare soil	0	Upstream Rt Ditch	Bare soil	0	Upstream Lt Ditch	Bare soil	0	Downstream Rt Outlet	Bare soil	0	Downstream Lt Outlet	Bare soil	0	Downstream Rt Ditch	Bare soil	0	Downstream Lt Ditch	Bare soil	0	Outlet Total	Unimproved Outlet System	1	Ditches Total	Unimproved Drainage System	1	<b>SRI Total</b>	<b>High Risk</b>	<b>34</b>

Notes: Cattle access.
