Unnamed tributary		co-0729-r-006	Sedimentation Risk Index 42																																																																		
<u>Common:</u> 3.2mi NW of Laurel Hill <u>Drainage:</u> Big Creek <u>GPS:</u> 30.997012, -86.499121 <u>Land owner:</u> Dwight Steele		<u>County:</u> Covington <u>State:</u> Alabama <u>PLSS (T-R-S):</u> 6N-23W-24 <u>Parcel No.:</u> 2 <u>Road Name:</u> Steele Rd

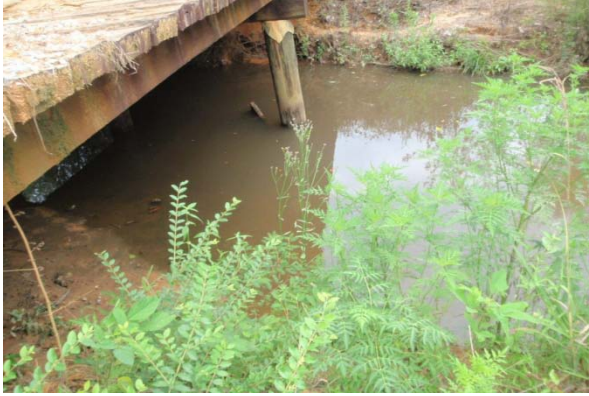
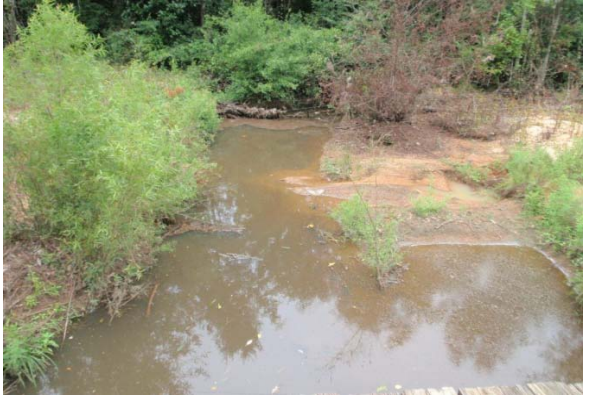
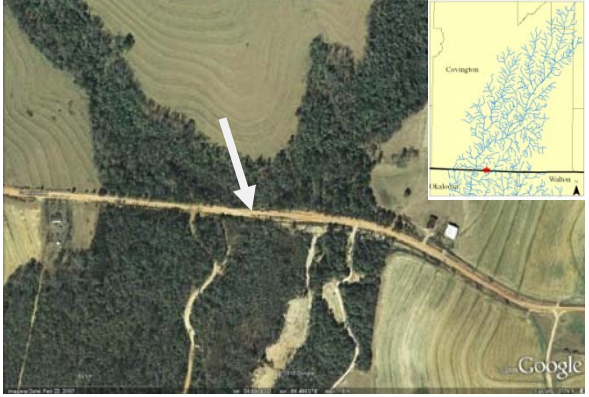
Crossing Structure: US		US																																																																			
<table border="1"> <thead> <tr> <th>Risk Factor</th> <th>Ranking</th> <th>Score</th> </tr> </thead> <tbody> <tr><td>US Channel Morph</td><td>C</td><td>5</td></tr> <tr><td>DS Channel Morph</td><td>E</td><td>5</td></tr> <tr><td>DS Bank Alteration</td><td>MINOR/PARTIAL</td><td>3</td></tr> <tr><td>Upstream Skew Angle</td><td><5°</td><td>5</td></tr> <tr><td>Crossing fill condition</td><td>Poor/Bare soil</td><td>1</td></tr> <tr><td>Inlet/Outlet Condition</td><td>No Impairment</td><td>5</td></tr> <tr><td>Road Approach Material</td><td>All Sand/Clay</td><td>3</td></tr> <tr><td>Potential Eroded Volume Mean</td><td>21-40 y³</td><td>3</td></tr> <tr><td>Approach Slope Mean</td><td>>4%</td><td>1</td></tr> <tr><td>Soil K Factor</td><td><0.20</td><td>5</td></tr> <tr><td>Upstream Rt Outlet</td><td>Vegetated</td><td>1</td></tr> <tr><td>Upstream Lt Outlet</td><td>Bare soil</td><td>0</td></tr> <tr><td>Upstream Rt Ditch</td><td>Vegetated</td><td>1</td></tr> <tr><td>Upstream Lt Ditch</td><td>Bare soil</td><td>0</td></tr> <tr><td>Downstream Rt Outlet</td><td>Vegetated</td><td>1</td></tr> <tr><td>Downstream Lt Outlet</td><td>Bare soil</td><td>0</td></tr> <tr><td>Downstream Rt Ditch</td><td>Vegetated</td><td>1</td></tr> <tr><td>Downstream Lt Ditch</td><td>Bare soil</td><td>0</td></tr> <tr><td>Outlet Total</td><td>Partially Improved Outlet System</td><td>3</td></tr> <tr><td>Ditches Total</td><td>Partially Improved Drainage System</td><td>3</td></tr> <tr><td>SRI Total</td><td>Medium Risk</td><td>42</td></tr> </tbody> </table>		Risk Factor	Ranking	Score	US Channel Morph	C	5	DS Channel Morph	E	5	DS Bank Alteration	MINOR/PARTIAL	3	Upstream Skew Angle	<5°	5	Crossing fill condition	Poor/Bare soil	1	Inlet/Outlet Condition	No Impairment	5	Road Approach Material	All Sand/Clay	3	Potential Eroded Volume Mean	21-40 y ³	3	Approach Slope Mean	>4%	1	Soil K Factor	<0.20	5	Upstream Rt Outlet	Vegetated	1	Upstream Lt Outlet	Bare soil	0	Upstream Rt Ditch	Vegetated	1	Upstream Lt Ditch	Bare soil	0	Downstream Rt Outlet	Vegetated	1	Downstream Lt Outlet	Bare soil	0	Downstream Rt Ditch	Vegetated	1	Downstream Lt Ditch	Bare soil	0	Outlet Total	Partially Improved Outlet System	3	Ditches Total	Partially Improved Drainage System	3	SRI Total	Medium Risk	42

Notes: Outlet sediment loading severe US.
