Baggett Creek		ok-0617-r-001	Sedimentation Risk Index 46																																																																		
<u>Common:</u> 6.4mi W of Crestview <u>Drainage:</u> Yellow River <i>GPS:</i> 30.749119, -86.677778 <u>Land owner:</u> Benjamin & Mary Plenge- DS, Ouida Keyser-US		<u>County:</u> Okaloosa <i>State:</i> Florida <u>PLSS(T-R-S):</u> 3N-24-19 <u>Parcel No.:</u> 2.006, 1 <u>Road Name:</u> Keyser Mill Rd

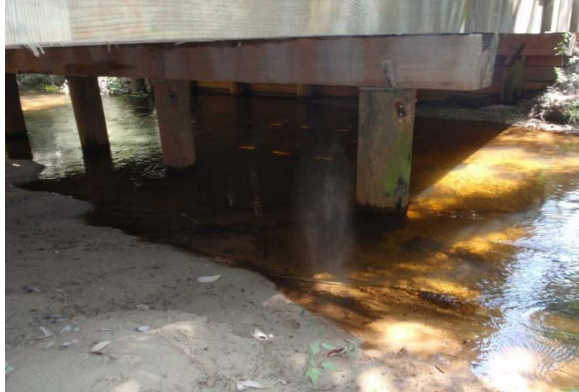
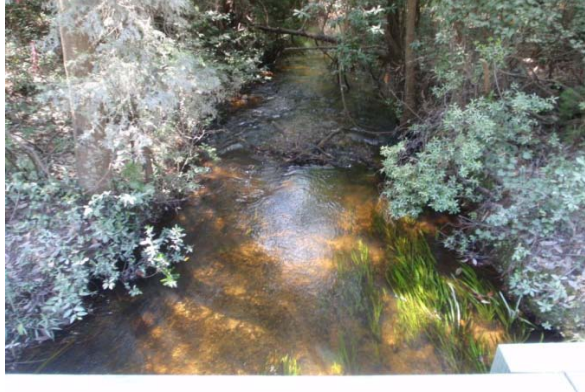
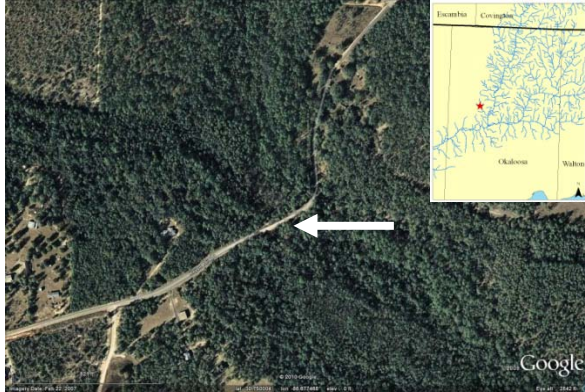
Crossing Structure: DS		DS																																																																			
<table border="1"> <thead> <tr> <th>Risk Factor</th> <th>Ranking</th> <th>Score</th> </tr> </thead> <tbody> <tr><td>US Channel Morph</td><td>C</td><td>5</td></tr> <tr><td>DS Channel Morph</td><td>C</td><td>5</td></tr> <tr><td>DS Bank Alteration</td><td>MINOR/PARTIAL</td><td>3</td></tr> <tr><td>Upstream Skew Angle</td><td><5°</td><td>5</td></tr> <tr><td>Crossing fill condition</td><td>Fair/Rip Rap</td><td>3</td></tr> <tr><td>Inlet/Outlet Condition</td><td>No Impairment</td><td>5</td></tr> <tr><td>Road Approach Material</td><td>All Aggregate</td><td>5</td></tr> <tr><td>Potential Eroded Volume Mean</td><td>21-40 y³</td><td>3</td></tr> <tr><td>Approach Slope Mean</td><td>>4%</td><td>1</td></tr> <tr><td>Soil K Factor</td><td><0.20</td><td>5</td></tr> <tr><td>Upstream Rt Outlet</td><td>Other</td><td>0</td></tr> <tr><td>Upstream Lt Outlet</td><td>Vegetated</td><td>1</td></tr> <tr><td>Upstream Rt Ditch</td><td>Bare soil</td><td>0</td></tr> <tr><td>Upstream Lt Ditch</td><td>Bare soil</td><td>0</td></tr> <tr><td>Downstream Rt Outlet</td><td>Vegetated</td><td>1</td></tr> <tr><td>Downstream Lt Outlet</td><td>Vegetated</td><td>1</td></tr> <tr><td>Downstream Rt Ditch</td><td>Bare soil</td><td>0</td></tr> <tr><td>Downstream Lt Ditch</td><td>Vegetated</td><td>1</td></tr> <tr><td>Outlet Total</td><td>Partially Improved Outlet System</td><td>3</td></tr> <tr><td>Ditches Total</td><td>Partially Improved Drainage System</td><td>3</td></tr> <tr><td>SRI Total</td><td>Low Risk</td><td>46</td></tr> </tbody> </table>		Risk Factor	Ranking	Score	US Channel Morph	C	5	DS Channel Morph	C	5	DS Bank Alteration	MINOR/PARTIAL	3	Upstream Skew Angle	<5°	5	Crossing fill condition	Fair/Rip Rap	3	Inlet/Outlet Condition	No Impairment	5	Road Approach Material	All Aggregate	5	Potential Eroded Volume Mean	21-40 y ³	3	Approach Slope Mean	>4%	1	Soil K Factor	<0.20	5	Upstream Rt Outlet	Other	0	Upstream Lt Outlet	Vegetated	1	Upstream Rt Ditch	Bare soil	0	Upstream Lt Ditch	Bare soil	0	Downstream Rt Outlet	Vegetated	1	Downstream Lt Outlet	Vegetated	1	Downstream Rt Ditch	Bare soil	0	Downstream Lt Ditch	Vegetated	1	Outlet Total	Partially Improved Outlet System	3	Ditches Total	Partially Improved Drainage System	3	SRI Total	Low Risk	46

Notes: US Rt outlet sand bag burm
