Yellow River		ok-0225-001	Severity Score 5.75																																																																	
<u>Common:</u> 14.3mi E of Milton <u>Drainage:</u> Yellow River <u>GPS:</u> 30.646932, -86.773719 <u>Land owner:</u> RB: NFWFMD / LB: USA		<u>County:</u> Okaloosa <u>State:</u> Florida <u>PLSS(T-R-S):</u> 2N-25W-29 <u>Parcel No.:</u> RB: 2/?AC / LB: 1/?AC

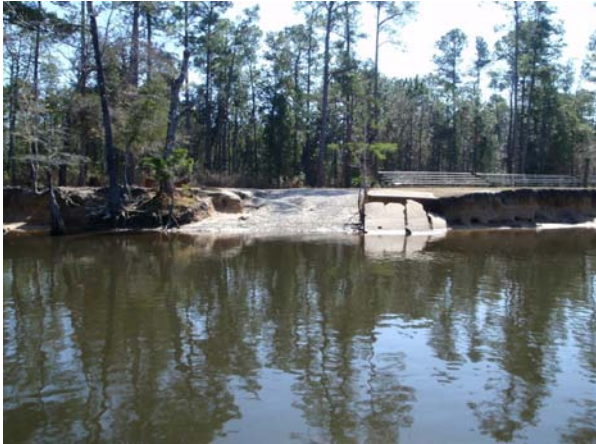
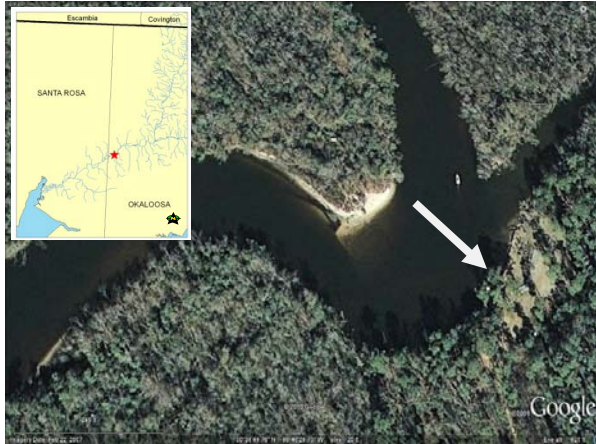
Risk Factor	Ranking	Score																																																																		
Channel Stability	Good	0.5																																																																		
Channel Alteration	None	0																																																																		
Bank Erosion	Historic	1																																																																		
BEHI	High	1																																																																		
Local NPSP	Moderate Potential	1																																																																		
Shoring Structures	Present	1.5																																																																		
Pipe Discharge	Not Present	0																																																																		
Water Odors	Not Present	0																																																																		
Fish Passage Barrier	Not Present	0

RB: Riparian Buffer	100+ ft	0																																																																		
LB: Riparian Buffer	0-29 ft	0.75																																																																		
RB: Floodplain Access	Full	0																																																																		
LB: Floodplain Access	Full	0																																																																		
<b>River Threat Index:</b>		<b>5.75</b>																																																																		
Feature	Within Range	Descriptive Field																																																																		
303(d)	No	N/A																																																																		
Wetland Species	Yes	4-6 FOCAL SPECIES IN WETLAND AREAS																																																																		
Rare and Imperiled	Yes	ALABAMA SHAD, ALLIGATOR GAR, BLUENOSE SHINER, GULF STURGEON, SPECKLED CHUB, IRONCOLOR SHINER, SPOTTED BULLHEAD, SPECKLED DARTER

Land Use/Cover	Yes	N/A/ STREAMS AND WATERWAYS																																																																		
Candidate Mussels	No	N/A																																																																		
Sturgeon C.H.	Yes	N/A																																																																		
		<b>Additional Site Features</b> <u>Stream Channel Woody Material:</u> Infrequent <u>Impoundments:</u> None <u>Substrate Composition:</u> Medium Sand and Clay <u>Bank Material:</u> Sand

Notes: Bleachers and garbage barrels present onshore. An unpaved Eglin AFB road leads to the site.
