Unnamed tributary		co-0810-r-001	Sedimentation Risk Index 38																																																																		
<u>Common:</u> 6.3mi NW of Laurel Hill <u>Drainage:</u> Yellow River <u>GPS:</u> 31.023509, -86.541454 <u>Land owner:</u> Charles Barton		<u>County:</u> Covington <u>PLSS (T-R-S):</u> 1N-15E-27 <u>Parcel No.:</u> 3 <u>Road Name:</u> Sanders Rd	<u>State:</u> Alabama

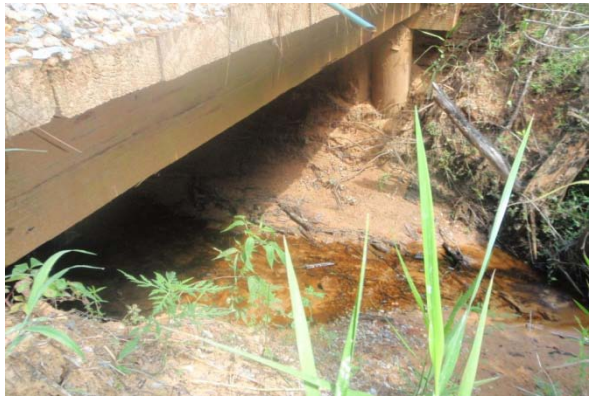
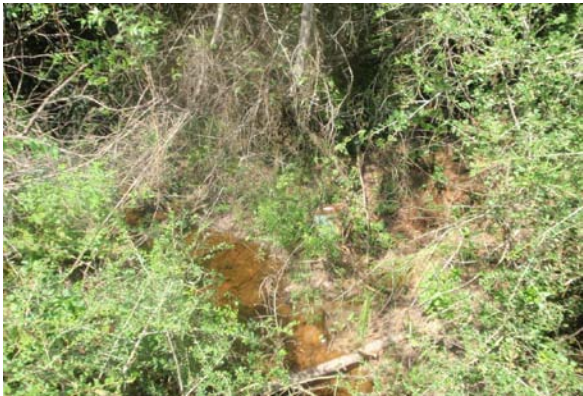
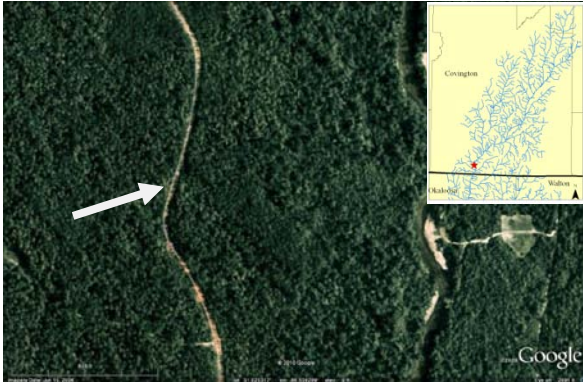
Crossing Structure: DS		US																																																																			
<table border="1"> <thead> <tr> <th>Risk Factor</th> <th>Ranking</th> <th>Score</th> </tr> </thead> <tbody> <tr><td>US Channel Morph</td><td>WETLAND</td><td>5</td></tr> <tr><td>DS Channel Morph</td><td>B</td><td>5</td></tr> <tr><td>DS Bank Alteration</td><td>HIGH</td><td>1</td></tr> <tr><td>Upstream Skew Angle</td><td>5-30°</td><td>3</td></tr> <tr><td>Crossing fill condition</td><td>Fair/Rip Rap</td><td>3</td></tr> <tr><td>Inlet/Outlet Condition</td><td>Sed Islands/Scouring</td><td>3</td></tr> <tr><td>Road Approach Material</td><td>All Native Soil</td><td>1</td></tr> <tr><td>Potential Eroded Volume Mean</td><td>>40 y³</td><td>1</td></tr> <tr><td>Approach Slope Mean</td><td><2%</td><td>5</td></tr> <tr><td>Soil K Factor</td><td><0.20</td><td>5</td></tr> <tr><td>Upstream Rt Outlet</td><td>Vegetated</td><td>1</td></tr> <tr><td>Upstream Lt Outlet</td><td>Vegetated</td><td>1</td></tr> <tr><td>Upstream Rt Ditch</td><td>Bare soil</td><td>0</td></tr> <tr><td>Upstream Lt Ditch</td><td>Bare soil</td><td>0</td></tr> <tr><td>Downstream Rt Outlet</td><td>Vegetated</td><td>1</td></tr> <tr><td>Downstream Lt Outlet</td><td>Vegetated</td><td>1</td></tr> <tr><td>Downstream Rt Ditch</td><td>Bare soil</td><td>0</td></tr> <tr><td>Downstream Lt Ditch</td><td>Bare soil</td><td>0</td></tr> <tr><td>Outlet Total</td><td>Improved Outlet System</td><td>5</td></tr> <tr><td>Ditches Total</td><td>Unimproved Drainage System</td><td>1</td></tr> <tr><td>SRI Total</td><td>Medium Risk</td><td>38</td></tr> </tbody> </table>		Risk Factor	Ranking	Score	US Channel Morph	WETLAND	5	DS Channel Morph	B	5	DS Bank Alteration	HIGH	1	Upstream Skew Angle	5-30°	3	Crossing fill condition	Fair/Rip Rap	3	Inlet/Outlet Condition	Sed Islands/Scouring	3	Road Approach Material	All Native Soil	1	Potential Eroded Volume Mean	>40 y ³	1	Approach Slope Mean	<2%	5	Soil K Factor	<0.20	5	Upstream Rt Outlet	Vegetated	1	Upstream Lt Outlet	Vegetated	1	Upstream Rt Ditch	Bare soil	0	Upstream Lt Ditch	Bare soil	0	Downstream Rt Outlet	Vegetated	1	Downstream Lt Outlet	Vegetated	1	Downstream Rt Ditch	Bare soil	0	Downstream Lt Ditch	Bare soil	0	Outlet Total	Improved Outlet System	5	Ditches Total	Unimproved Drainage System	1	SRI Total	Medium Risk	38

Notes: Low flow. Close proximity to YR main stem.
