Unnamed tributary		co-0831-r-011	Sedimentation Risk Index <b>42</b>																																																																		
<u>Common:</u> 6.6mi SW of Opp <u>Drainage:</u> Indian Creek <i>GPS:</i> 31.212997, -86.333344 <u>Land owner:</u> Clidie Lee Harper LE -US, Troy Riley Creane & Brett Riley -DS		<u>County:</u> Covington <u>State:</u> Alabama <u>PLSS (T-R-S):</u> 3N-17E-22 <u>Parcel No.:</u> 1; 9 <u>Road Name:</u> Henderson Bridge Rd

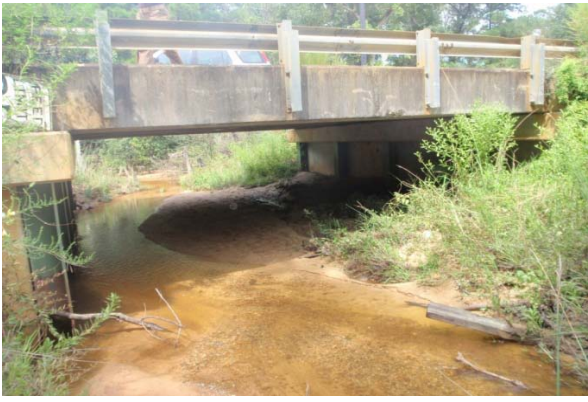
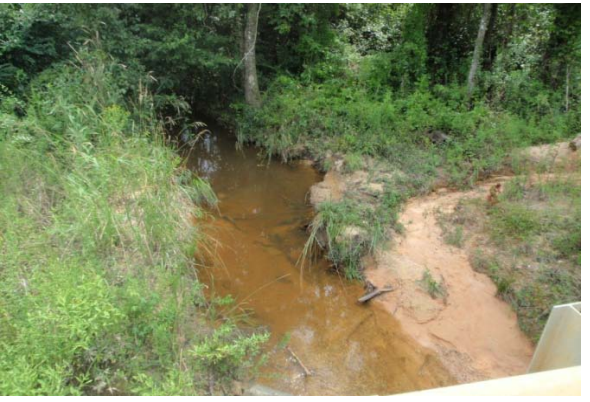
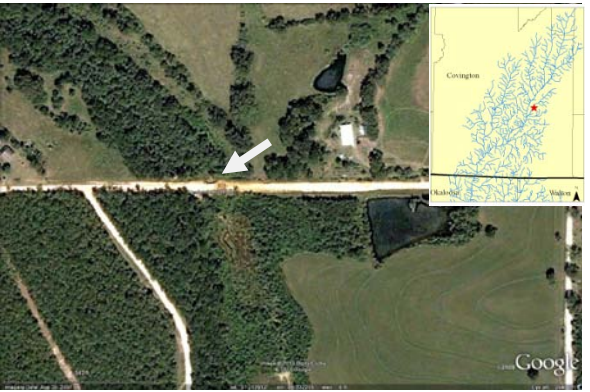
Crossing Structure: US		US																																																																			
<table border="1"> <thead> <tr> <th>Risk Factor</th> <th>Ranking</th> <th>Score</th> </tr> </thead> <tbody> <tr><td>US Channel Morph</td><td>C</td><td>5</td></tr> <tr><td>DS Channel Morph</td><td>E</td><td>5</td></tr> <tr><td>DS Bank Alteration</td><td>MINOR/PARTIAL</td><td>3</td></tr> <tr><td>Upstream Skew Angle</td><td>&lt;5°</td><td>5</td></tr> <tr><td>Crossing fill condition</td><td>Good/Vegetated</td><td>5</td></tr> <tr><td>Inlet/Outlet Condition</td><td>Sed Islands/Scouring</td><td>3</td></tr> <tr><td>Road Approach Material</td><td>All Sand/Clay</td><td>3</td></tr> <tr><td>Potential Eroded Volume Mean</td><td>21-40 y<sup>3</sup></td><td>3</td></tr> <tr><td>Approach Slope Mean</td><td>&gt;4%</td><td>1</td></tr> <tr><td>Soil K Factor</td><td>&lt;0.20</td><td>5</td></tr> <tr><td>Upstream Rt Outlet</td><td>Vegetated</td><td>1</td></tr> <tr><td>Upstream Lt Outlet</td><td>Bare soil</td><td>0</td></tr> <tr><td>Upstream Rt Ditch</td><td>Bare soil</td><td>0</td></tr> <tr><td>Upstream Lt Ditch</td><td>Bare soil</td><td>0</td></tr> <tr><td>Downstream Rt Outlet</td><td>Vegetated</td><td>1</td></tr> <tr><td>Downstream Lt Outlet</td><td>Bare soil</td><td>0</td></tr> <tr><td>Downstream Rt Ditch</td><td>Bare soil</td><td>0</td></tr> <tr><td>Downstream Lt Ditch</td><td>Bare soil</td><td>0</td></tr> <tr><td>Outlet Total</td><td>Partially Improved Outlet System</td><td>3</td></tr> <tr><td>Ditches Total</td><td>Unimproved Drainage System</td><td>1</td></tr> <tr><td><b>SRI Total</b></td><td><b>Medium Risk</b></td><td><b>42</b></td></tr> </tbody> </table>		Risk Factor	Ranking	Score	US Channel Morph	C	5	DS Channel Morph	E	5	DS Bank Alteration	MINOR/PARTIAL	3	Upstream Skew Angle	<5°	5	Crossing fill condition	Good/Vegetated	5	Inlet/Outlet Condition	Sed Islands/Scouring	3	Road Approach Material	All Sand/Clay	3	Potential Eroded Volume Mean	21-40 y <sup>3</sup>	3	Approach Slope Mean	>4%	1	Soil K Factor	<0.20	5	Upstream Rt Outlet	Vegetated	1	Upstream Lt Outlet	Bare soil	0	Upstream Rt Ditch	Bare soil	0	Upstream Lt Ditch	Bare soil	0	Downstream Rt Outlet	Vegetated	1	Downstream Lt Outlet	Bare soil	0	Downstream Rt Ditch	Bare soil	0	Downstream Lt Ditch	Bare soil	0	Outlet Total	Partially Improved Outlet System	3	Ditches Total	Unimproved Drainage System	1	<b>SRI Total</b>	<b>Medium Risk</b>	<b>42</b>

Notes: Lots of clay loading.
