Unnamed tributary		wa-0714-r-007	Sedimentation Risk Index 38																																																																		
<u>Common:</u> 10.3mi NW of DeFuniak Springs <u>Drainage:</u> Big Swamp Creek <u>GPS:</u> 30.855673, -86.191371 <u>Land owner:</u> J.B. & Betty Coon-DS, Unknown US		<u>County:</u> Walton <u>State:</u> Florida <u>PLSS(T-R-S):</u> 4N-20-12 <u>Parcel No.:</u> 5.001 <u>Road Name:</u> Bryan Rd

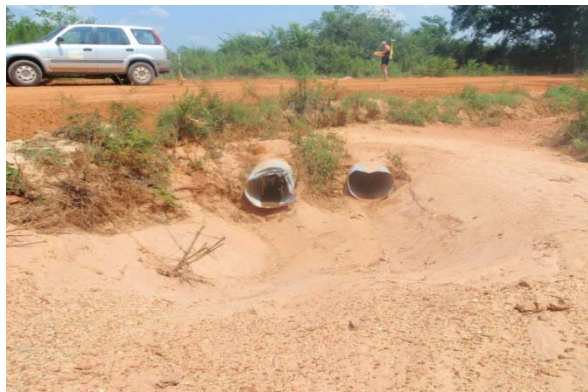
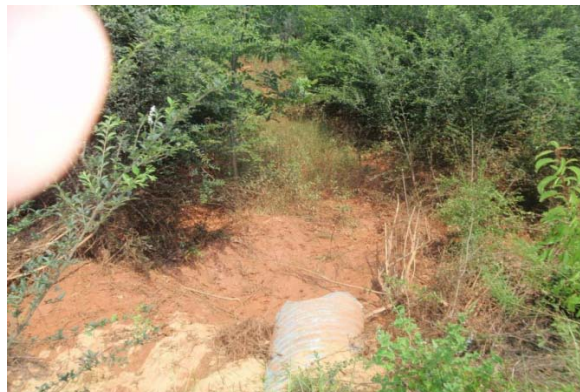
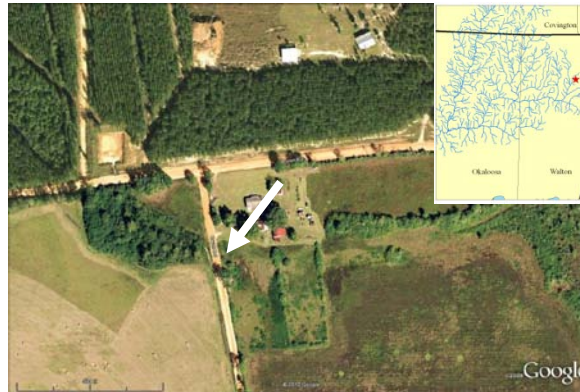
Crossing Structure: DS		US																																																																			
<table border="1"> <thead> <tr> <th>Risk Factor</th> <th>Ranking</th> <th>Score</th> </tr> </thead> <tbody> <tr><td>US Channel Morph</td><td>E</td><td>5</td></tr> <tr><td>DS Channel Morph</td><td>E</td><td>5</td></tr> <tr><td>DS Bank Alteration</td><td>HIGH</td><td>1</td></tr> <tr><td>Upstream Skew Angle</td><td><5°</td><td>5</td></tr> <tr><td>Crossing fill condition</td><td>Poor/Bare soil</td><td>1</td></tr> <tr><td>Inlet/Outlet Condition</td><td>Sed Islands/Scouring</td><td>3</td></tr> <tr><td>Road Approach Material</td><td>All Sand/Clay</td><td>3</td></tr> <tr><td>Potential Eroded Volume Mean</td><td>>40 y³</td><td>1</td></tr> <tr><td>Approach Slope Mean</td><td><2%</td><td>5</td></tr> <tr><td>Soil K Factor</td><td><0.20</td><td>5</td></tr> <tr><td>Upstream Rt Outlet</td><td>Vegetated</td><td>1</td></tr> <tr><td>Upstream Lt Outlet</td><td>Vegetated</td><td>1</td></tr> <tr><td>Upstream Rt Ditch</td><td>Bare soil</td><td>0</td></tr> <tr><td>Upstream Lt Ditch</td><td>Bare soil</td><td>0</td></tr> <tr><td>Downstream Rt Outlet</td><td>Bare soil</td><td>0</td></tr> <tr><td>Downstream Lt Outlet</td><td>Bare soil</td><td>0</td></tr> <tr><td>Downstream Rt Ditch</td><td>Bare soil</td><td>0</td></tr> <tr><td>Downstream Lt Ditch</td><td>Bare soil</td><td>0</td></tr> <tr><td>Outlet Total</td><td>Partially Improved Outlet System</td><td>3</td></tr> <tr><td>Ditches Total</td><td>Unimproved Drainage System</td><td>1</td></tr> <tr><td>SRI Total</td><td>Medium Risk</td><td>38</td></tr> </tbody> </table>		Risk Factor	Ranking	Score	US Channel Morph	E	5	DS Channel Morph	E	5	DS Bank Alteration	HIGH	1	Upstream Skew Angle	<5°	5	Crossing fill condition	Poor/Bare soil	1	Inlet/Outlet Condition	Sed Islands/Scouring	3	Road Approach Material	All Sand/Clay	3	Potential Eroded Volume Mean	>40 y ³	1	Approach Slope Mean	<2%	5	Soil K Factor	<0.20	5	Upstream Rt Outlet	Vegetated	1	Upstream Lt Outlet	Vegetated	1	Upstream Rt Ditch	Bare soil	0	Upstream Lt Ditch	Bare soil	0	Downstream Rt Outlet	Bare soil	0	Downstream Lt Outlet	Bare soil	0	Downstream Rt Ditch	Bare soil	0	Downstream Lt Ditch	Bare soil	0	Outlet Total	Partially Improved Outlet System	3	Ditches Total	Unimproved Drainage System	1	SRI Total	Medium Risk	38

Notes: Impounded system directly DS at next crossing.
