Unnamed tributary		wa-0722-r-007	Sedimentation Risk Index 50																																																																		
<u>Common:</u> 11 mi N of DeFuniak Springs <u>Drainage:</u> Gum Creek <u>GPS:</u> 30.867720, -86.084502 <u>Land owner:</u> T.R. Miller Mill Co		<u>County:</u> Walton <u>State:</u> Florida <u>PLSS (T-R-S):</u> 04N-18-06-11000 <u>Parcel No.:</u> 1.0 <u>Road Name:</u> T.R. Miller Rd

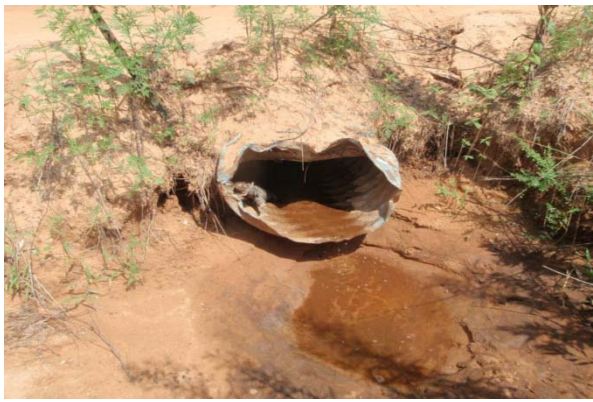
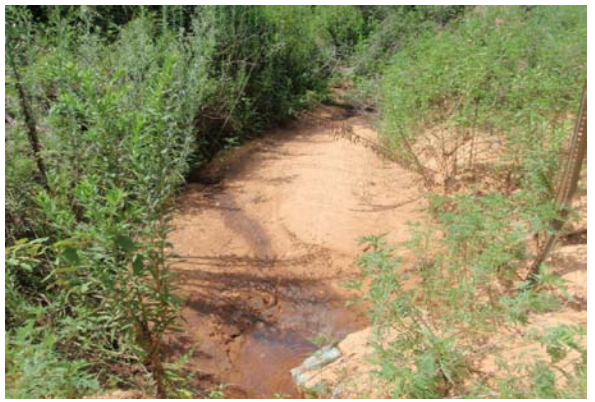
Crossing Structure: DS		DS																																																																			
<table border="1"> <thead> <tr> <th>Risk Factor</th> <th>Ranking</th> <th>Score</th> </tr> </thead> <tbody> <tr><td>US Channel Morph</td><td>C</td><td>5</td></tr> <tr><td>DS Channel Morph</td><td>C</td><td>5</td></tr> <tr><td>DS Bank Alteration</td><td>HIGH</td><td>1</td></tr> <tr><td>Upstream Skew Angle</td><td><5°</td><td>5</td></tr> <tr><td>Crossing fill condition</td><td>Good/Vegetated</td><td>5</td></tr> <tr><td>Inlet/Outlet Condition</td><td>No Impairment</td><td>5</td></tr> <tr><td>Road Approach Material</td><td>All Sand/Clay</td><td>3</td></tr> <tr><td>Potential Eroded Volume Mean</td><td><21 y³</td><td>5</td></tr> <tr><td>Approach Slope Mean</td><td><2%</td><td>5</td></tr> <tr><td>Soil K Factor</td><td><0.20</td><td>5</td></tr> <tr><td>Upstream Rt Outlet</td><td>Vegetated</td><td>1</td></tr> <tr><td>Upstream Lt Outlet</td><td>Vegetated</td><td>1</td></tr> <tr><td>Upstream Rt Ditch</td><td>Bare soil</td><td>0</td></tr> <tr><td>Upstream Lt Ditch</td><td>Bare soil</td><td>0</td></tr> <tr><td>Downstream Rt Outlet</td><td>Vegetated</td><td>1</td></tr> <tr><td>Downstream Lt Outlet</td><td>Vegetated</td><td>1</td></tr> <tr><td>Downstream Rt Ditch</td><td>Bare soil</td><td>0</td></tr> <tr><td>Downstream Lt Ditch</td><td>Bare soil</td><td>0</td></tr> <tr><td>Outlet Total</td><td>Improved Outlet System</td><td>5</td></tr> <tr><td>Ditches Total</td><td>Unimproved Drainage System</td><td>1</td></tr> <tr><td>SRI Total</td><td>Low Risk</td><td>50</td></tr> </tbody> </table>		Risk Factor	Ranking	Score	US Channel Morph	C	5	DS Channel Morph	C	5	DS Bank Alteration	HIGH	1	Upstream Skew Angle	<5°	5	Crossing fill condition	Good/Vegetated	5	Inlet/Outlet Condition	No Impairment	5	Road Approach Material	All Sand/Clay	3	Potential Eroded Volume Mean	<21 y ³	5	Approach Slope Mean	<2%	5	Soil K Factor	<0.20	5	Upstream Rt Outlet	Vegetated	1	Upstream Lt Outlet	Vegetated	1	Upstream Rt Ditch	Bare soil	0	Upstream Lt Ditch	Bare soil	0	Downstream Rt Outlet	Vegetated	1	Downstream Lt Outlet	Vegetated	1	Downstream Rt Ditch	Bare soil	0	Downstream Lt Ditch	Bare soil	0	Outlet Total	Improved Outlet System	5	Ditches Total	Unimproved Drainage System	1	SRI Total	Low Risk	50

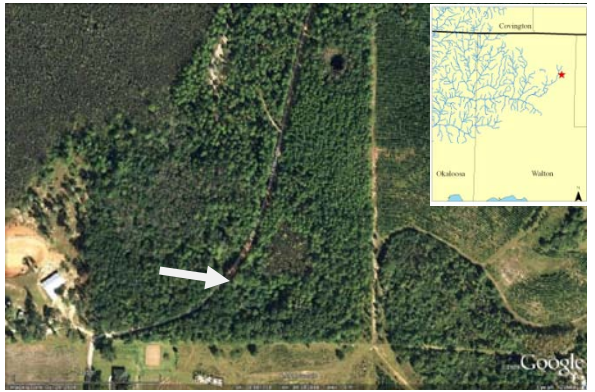
Risk Factor	Ranking	Score																																																																			
US Channel Morph	C	5																																																																			
DS Channel Morph	C	5																																																																			
DS Bank Alteration	HIGH	1																																																																			
Upstream Skew Angle	<5°	5																																																																			
Crossing fill condition	Good/Vegetated	5																																																																			
Inlet/Outlet Condition	No Impairment	5																																																																			
Road Approach Material	All Sand/Clay	3																																																																			
Potential Eroded Volume Mean	<21 y ³	5																																																																			
Approach Slope Mean	<2%	5

Soil K Factor	<0.20	5																																																																			
Upstream Rt Outlet	Vegetated	1																																																																			
Upstream Lt Outlet	Vegetated	1																																																																			
Upstream Rt Ditch	Bare soil	0																																																																			
Upstream Lt Ditch	Bare soil	0																																																																			
Downstream Rt Outlet	Vegetated	1																																																																			
Downstream Lt Outlet	Vegetated	1																																																																			
Downstream Rt Ditch	Bare soil	0																																																																			
Downstream Lt Ditch	Bare soil	0																																																																			
Outlet Total	Improved Outlet System	5

Ditches Total	Unimproved Drainage System	1																																																																			
SRI Total	Low Risk	50																																																																			
Additional Site Features <u>Crossing Type and Quantity:</u> Culvert, 1 <u>Crossing Materials:</u> Metal <u>Soil Types:</u> 10,11,13,22,23,35,39,69 <u>Rt Approach Prism Fill:</u> 0.15in <u>Lt Approach Prism Fill:</u> 0.1in		<table border="1"> <thead> <tr> <th>Feature</th> <th>Within Range</th> <th>Descriptive Field</th> </tr> </thead> <tbody> <tr> <td>303(d)</td> <td>No</td> <td>N/A</td> </tr> <tr> <td>Wetland Species</td> <td>No</td> <td>N/A</td> </tr> <tr> <td>Rare and Imperiled</td> <td>No</td> <td>N/A</td> </tr> <tr> <td>Land Use/Cover</td> <td>Yes</td> <td>AGRICULTURAL/HYDRIC PINE FLATWOODS</td> </tr> <tr> <td>Candidate Mussels</td> <td>No</td> <td>N/A</td> </tr> <tr> <td>Sturgeon C.H.</td> <td>No</td> <td>N/A</td> </tr> </tbody> </table>		Feature	Within Range	Descriptive Field	303(d)	No	N/A	Wetland Species	No	N/A	Rare and Imperiled	No	N/A	Land Use/Cover	Yes	AGRICULTURAL/HYDRIC PINE FLATWOODS	Candidate Mussels	No	N/A	Sturgeon C.H.	No	N/A
