Unnamed tributary		wa-0727-r-004b	Sedimentation Risk Index 34																																																																		
<u>Common:</u> 4.5mi E of Mossy Head <u>Drainage:</u> Gum Creek <i>GPS:</i> 30.755019, -86.240897 <u>Land owner:</u> Vicki and Michael Dekoninck-US, Thelma Adams-DS		<u>County:</u> Walton <u>State:</u> Florida <u>PLSS (T-R-S):</u> 3N-20-16-28060 <u>Parcel No.:</u> 7.10050;6.80010 <u>Road Name:</u> Blue Ridge Blvd

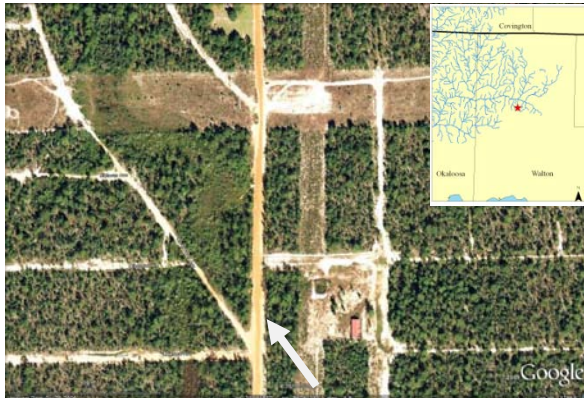
Crossing Structure: DS		DS																																																																			
<table border="1"> <thead> <tr> <th>Risk Factor</th> <th>Ranking</th> <th>Score</th> </tr> </thead> <tbody> <tr><td>US Channel Morph</td><td>DA</td><td>3</td></tr> <tr><td>DS Channel Morph</td><td>DA</td><td>3</td></tr> <tr><td>DS Bank Alteration</td><td>HIGH</td><td>1</td></tr> <tr><td>Upstream Skew Angle</td><td><5°</td><td>5</td></tr> <tr><td>Crossing fill condition</td><td>Poor/Bare soil</td><td>1</td></tr> <tr><td>Inlet/Outlet Condition</td><td>Sed Islands/Scouring</td><td>3</td></tr> <tr><td>Road Approach Material</td><td>All Sand/Clay</td><td>3</td></tr> <tr><td>Potential Eroded Volume Mean</td><td><21 y³</td><td>5</td></tr> <tr><td>Approach Slope Mean</td><td>2.1-4%</td><td>3</td></tr> <tr><td>Soil K Factor</td><td><0.20</td><td>5</td></tr> <tr><td>Upstream Rt Outlet</td><td>Bare soil</td><td>0</td></tr> <tr><td>Upstream Lt Outlet</td><td>Bare soil</td><td>0</td></tr> <tr><td>Upstream Rt Ditch</td><td>Bare soil</td><td>0</td></tr> <tr><td>Upstream Lt Ditch</td><td>Bare soil</td><td>0</td></tr> <tr><td>Downstream Rt Outlet</td><td>Other</td><td>0</td></tr> <tr><td>Downstream Lt Outlet</td><td>Other</td><td>0</td></tr> <tr><td>Downstream Rt Ditch</td><td>Bare soil</td><td>0</td></tr> <tr><td>Downstream Lt Ditch</td><td>Bare soil</td><td>0</td></tr> <tr><td>Outlet Total</td><td>Unimproved Outlet System</td><td>1</td></tr> <tr><td>Ditches Total</td><td>Unimproved Drainage System</td><td>1</td></tr> <tr><td>SRI Total</td><td>High Risk</td><td>34</td></tr> </tbody> </table>		Risk Factor	Ranking	Score	US Channel Morph	DA	3	DS Channel Morph	DA	3	DS Bank Alteration	HIGH	1	Upstream Skew Angle	<5°	5	Crossing fill condition	Poor/Bare soil	1	Inlet/Outlet Condition	Sed Islands/Scouring	3	Road Approach Material	All Sand/Clay	3	Potential Eroded Volume Mean	<21 y ³	5	Approach Slope Mean	2.1-4%	3	Soil K Factor	<0.20	5	Upstream Rt Outlet	Bare soil	0	Upstream Lt Outlet	Bare soil	0	Upstream Rt Ditch	Bare soil	0	Upstream Lt Ditch	Bare soil	0	Downstream Rt Outlet	Other	0	Downstream Lt Outlet	Other	0	Downstream Rt Ditch	Bare soil	0	Downstream Lt Ditch	Bare soil	0	Outlet Total	Unimproved Outlet System	1	Ditches Total	Unimproved Drainage System	1	SRI Total	High Risk	34

Notes: DS BMP fill.
