Metts Creek		ok-0407-r-005		Sedimentation Risk Index <b>50</b>																																																																			
<u>Common:</u> 4.2 mi S of Holt <u>Drainage:</u> Yellow River <u>GPS:</u> 30.655936, -86.729417 <u>Land owner:</u> US Government- Eglin AFB		<u>County:</u> Okaloosa <u>PLSS(T-R-S):</u> 2N-25-22 <u>Parcel No.:</u> 1 <u>Road Name:</u> Rattlesnake Bluff Rd		<u>State:</u> Florida

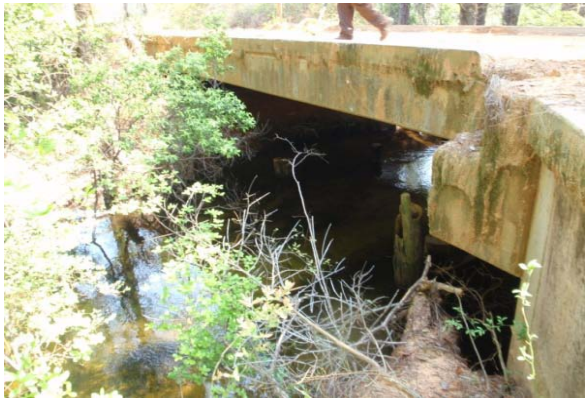
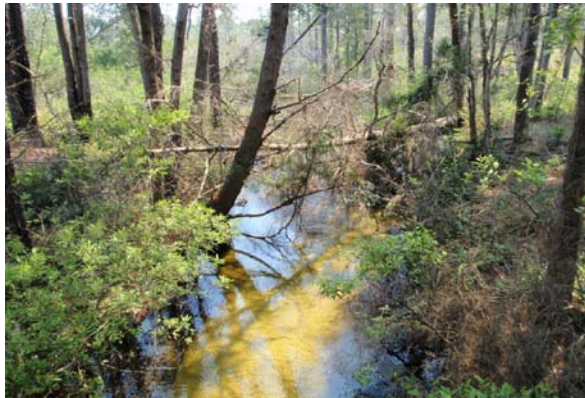
Crossing Structure: DS		US																																																																					
<table border="1"> <thead> <tr> <th>Risk Factor</th> <th>Ranking</th> <th>Score</th> </tr> </thead> <tbody> <tr><td>US Channel Morph</td><td>E</td><td>5</td></tr> <tr><td>DS Channel Morph</td><td>C</td><td>5</td></tr> <tr><td>DS Bank Alteration</td><td>NATURAL</td><td>5</td></tr> <tr><td>Upstream Skew Angle</td><td>&lt;5°</td><td>5</td></tr> <tr><td>Crossing fill condition</td><td>Good/Vegetated</td><td>5</td></tr> <tr><td>Inlet/Outlet Condition</td><td>No Impairment</td><td>5</td></tr> <tr><td>Road Approach Material</td><td>All Sand/Clay</td><td>3</td></tr> <tr><td>Potential Eroded Volume Mean</td><td>&gt;40 y<sup>3</sup></td><td>1</td></tr> <tr><td>Approach Slope Mean</td><td>&lt;2%</td><td>5</td></tr> <tr><td>Soil K Factor</td><td>&lt;0.20</td><td>5</td></tr> <tr><td>Upstream Rt Outlet</td><td>Vegetated</td><td>1</td></tr> <tr><td>Upstream Lt Outlet</td><td>Vegetated</td><td>1</td></tr> <tr><td>Upstream Rt Ditch</td><td>Bare soil</td><td>0</td></tr> <tr><td>Upstream Lt Ditch</td><td>Bare soil</td><td>0</td></tr> <tr><td>Downstream Rt Outlet</td><td>Vegetated</td><td>1</td></tr> <tr><td>Downstream Lt Outlet</td><td>Vegetated</td><td>1</td></tr> <tr><td>Downstream Rt Ditch</td><td>Bare soil</td><td>0</td></tr> <tr><td>Downstream Lt Ditch</td><td>Bare soil</td><td>0</td></tr> <tr><td>Outlet Total</td><td>Improved Outlet System</td><td>5</td></tr> <tr><td>Ditches Total</td><td>Unimproved Drainage System</td><td>1</td></tr> <tr><td><b>SRI Total</b></td><td><b>Low Risk</b></td><td><b>50</b></td></tr> </tbody> </table>		Risk Factor	Ranking	Score	US Channel Morph	E	5	DS Channel Morph	C	5	DS Bank Alteration	NATURAL	5	Upstream Skew Angle	<5°	5	Crossing fill condition	Good/Vegetated	5	Inlet/Outlet Condition	No Impairment	5	Road Approach Material	All Sand/Clay	3	Potential Eroded Volume Mean	>40 y <sup>3</sup>	1	Approach Slope Mean	<2%	5	Soil K Factor	<0.20	5	Upstream Rt Outlet	Vegetated	1	Upstream Lt Outlet	Vegetated	1	Upstream Rt Ditch	Bare soil	0	Upstream Lt Ditch	Bare soil	0	Downstream Rt Outlet	Vegetated	1	Downstream Lt Outlet	Vegetated	1	Downstream Rt Ditch	Bare soil	0	Downstream Lt Ditch	Bare soil	0	Outlet Total	Improved Outlet System	5	Ditches Total	Unimproved Drainage System	1	<b>SRI Total</b>	<b>Low Risk</b>	<b>50</b>

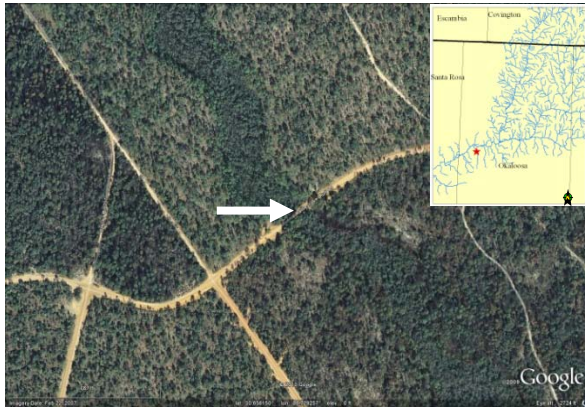
Risk Factor	Ranking	Score																																																																					
US Channel Morph	E	5																																																																					
DS Channel Morph	C	5																																																																					
DS Bank Alteration	NATURAL	5																																																																					
Upstream Skew Angle	<5°	5																																																																					
Crossing fill condition	Good/Vegetated	5																																																																					
Inlet/Outlet Condition	No Impairment	5																																																																					
Road Approach Material	All Sand/Clay	3																																																																					
Potential Eroded Volume Mean	>40 y <sup>3</sup>	1

Approach Slope Mean	<2%	5																																																																					
Soil K Factor	<0.20	5																																																																					
Upstream Rt Outlet	Vegetated	1																																																																					
Upstream Lt Outlet	Vegetated	1																																																																					
Upstream Rt Ditch	Bare soil	0																																																																					
Upstream Lt Ditch	Bare soil	0																																																																					
Downstream Rt Outlet	Vegetated	1																																																																					
Downstream Lt Outlet	Vegetated	1																																																																					
Downstream Rt Ditch	Bare soil	0																																																																					
Downstream Lt Ditch	Bare soil	0

Outlet Total	Improved Outlet System	5																																																																					
Ditches Total	Unimproved Drainage System	1																																																																					
<b>SRI Total</b>	<b>Low Risk</b>	<b>50</b>																																																																					
<b>Additional Site Features</b> <u>Crossing Type and Quantity:</u> Bridge, 1 <u>Crossing Materials:</u> Reinforced Concrete <u>Soil Types:</u> 12,13,15 <u>Rt Approach Prism Fill:</u> 0.75in <u>Lt Approach Prism Fill:</u> 2.0in		<table border="1"> <thead> <tr> <th>Feature</th> <th>Within Range</th> <th>Descriptive Field</th> </tr> </thead> <tbody> <tr> <td>303(d)</td> <td>No</td> <td>N/A</td> </tr> <tr> <td>Wetland Species</td> <td>Yes</td> <td>4-6 FOCAL SPECIES IN UPLAND AREAS</td> </tr> <tr> <td>Rare and Imperiled</td> <td>No</td> <td>N/A</td> </tr> <tr> <td>Land Use/Cover</td> <td>Yes</td> <td>INSTITUTIONAL/ N/A</td> </tr> <tr> <td>Candidate Mussels</td> <td>No</td> <td>N/A</td> </tr> <tr> <td>Sturgeon C.H.</td> <td>No</td> <td>N/A</td> </tr> </tbody> </table>				Feature	Within Range	Descriptive Field	303(d)	No	N/A	Wetland Species	Yes	4-6 FOCAL SPECIES IN UPLAND AREAS	Rare and Imperiled	No	N/A	Land Use/Cover	Yes	INSTITUTIONAL/ N/A	Candidate Mussels	No	N/A	Sturgeon C.H.	No	N/A
