Poley Creek		co-1102-r-007	Sedimentation Risk Index 50																																																																		
<u>Common:</u> 2.9mi SE of Five Points <u>Drainage:</u> Lightwood Knot <i>GPS:</i> 31.407671902,-86.273104606 <u>Land owner:</u> Paul Langford Tr. 3- North, Faye Rowls & Jordan Langford -SE, B &K Graham - SW		<u>County:</u> Covington <u>PLSS (T-R-S):</u> 5N-18E-17 <u>Parcel No.:</u> 3.04,3, 3.01 <u>Road Name:</u> Chalker Rd

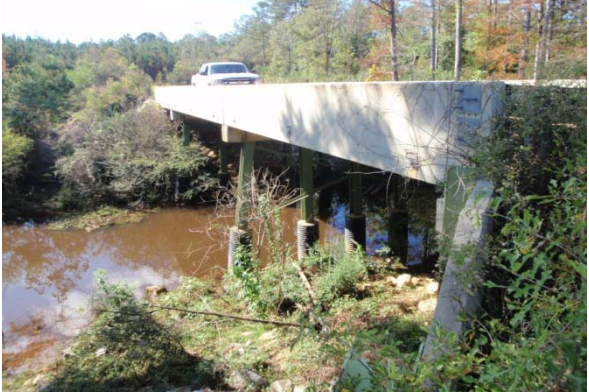
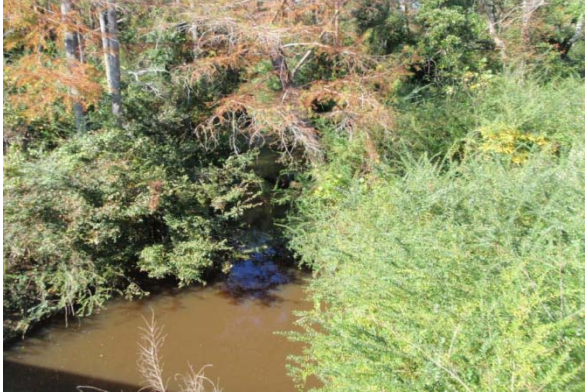
Crossing Structure: DS		US																																																																			
<table border="1"> <thead> <tr> <th>Risk Factor</th> <th>Ranking</th> <th>Score</th> </tr> </thead> <tbody> <tr><td>US Channel Morph</td><td>C</td><td>5</td></tr> <tr><td>DS Channel Morph</td><td>C</td><td>5</td></tr> <tr><td>DS Bank Alteration</td><td>MINOR/PARTIAL</td><td>3</td></tr> <tr><td>Upstream Skew Angle</td><td><5°</td><td>5</td></tr> <tr><td>Crossing fill condition</td><td>Fair/Rip Rap</td><td>3</td></tr> <tr><td>Inlet/Outlet Condition</td><td>No Impairment</td><td>5</td></tr> <tr><td>Road Approach Material</td><td>All Sand/Clay</td><td>3</td></tr> <tr><td>Potential Eroded Volume Mean</td><td>>40 y³</td><td>1</td></tr> <tr><td>Approach Slope Mean</td><td><2%</td><td>5</td></tr> <tr><td>Soil K Factor</td><td><0.20</td><td>5</td></tr> <tr><td>Upstream Rt Outlet</td><td>Rip Rap</td><td>1</td></tr> <tr><td>Upstream Lt Outlet</td><td>Rip Rap</td><td>1</td></tr> <tr><td>Upstream Rt Ditch</td><td>Vegetated</td><td>1</td></tr> <tr><td>Upstream Lt Ditch</td><td>Vegetated</td><td>1</td></tr> <tr><td>Downstream Rt Outlet</td><td>Rip Rap</td><td>1</td></tr> <tr><td>Downstream Lt Outlet</td><td>Rip Rap</td><td>1</td></tr> <tr><td>Downstream Rt Ditch</td><td>Vegetated</td><td>1</td></tr> <tr><td>Downstream Lt Ditch</td><td>Vegetated</td><td>1</td></tr> <tr><td>Outlet Total</td><td>Improved Outlet System</td><td>5</td></tr> <tr><td>Ditches Total</td><td>Improved Drainage System</td><td>5</td></tr> <tr><td>SRI Total</td><td>Low Risk</td><td>50</td></tr> </tbody> </table>				Risk Factor	Ranking	Score	US Channel Morph	C	5	DS Channel Morph	C	5	DS Bank Alteration	MINOR/PARTIAL	3	Upstream Skew Angle	<5°	5	Crossing fill condition	Fair/Rip Rap	3	Inlet/Outlet Condition	No Impairment	5	Road Approach Material	All Sand/Clay	3	Potential Eroded Volume Mean	>40 y ³	1	Approach Slope Mean	<2%	5	Soil K Factor	<0.20	5	Upstream Rt Outlet	Rip Rap	1	Upstream Lt Outlet	Rip Rap	1	Upstream Rt Ditch	Vegetated	1	Upstream Lt Ditch	Vegetated	1	Downstream Rt Outlet	Rip Rap	1	Downstream Lt Outlet	Rip Rap	1	Downstream Rt Ditch	Vegetated	1	Downstream Lt Ditch	Vegetated	1	Outlet Total	Improved Outlet System	5	Ditches Total	Improved Drainage System	5	SRI Total	Low Risk	50
