Mulberry Creek		co-1027-r-010	Sedimentation Risk Index <b>44</b>																																																																		
<u>Common:</u> 4.9mi NW of Opp <u>Drainage:</u> Poley Creek <u>GPS:</u> 31.334838128, -86.309673279 <u>Land owner:</u> Jack and Mary Odom		<u>County:</u> Covington <u>State:</u> Alabama <u>PLSS (T-R-S):</u> 4N-17E-1 <u>Parcel No.:</u> 3 <u>Road Name:</u> Carlisle Rd

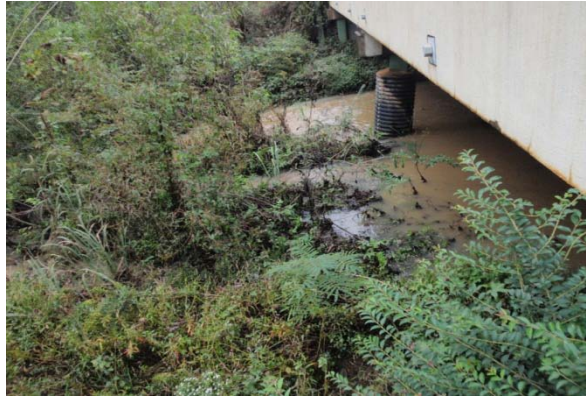
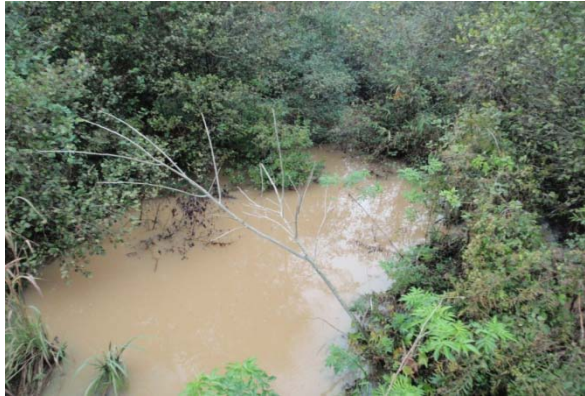
Crossing Structure: DS		US																																																																			
<table border="1"> <thead> <tr> <th>Risk Factor</th> <th>Ranking</th> <th>Score</th> </tr> </thead> <tbody> <tr><td>US Channel Morph</td><td>C</td><td>5</td></tr> <tr><td>DS Channel Morph</td><td>C</td><td>5</td></tr> <tr><td>DS Bank Alteration</td><td>MINOR/PARTIAL</td><td>3</td></tr> <tr><td>Upstream Skew Angle</td><td>&lt;5°</td><td>5</td></tr> <tr><td>Crossing fill condition</td><td>Good/Vegetated</td><td>5</td></tr> <tr><td>Inlet/Outlet Condition</td><td>No Impairment</td><td>5</td></tr> <tr><td>Road Approach Material</td><td>All Sand/Clay</td><td>3</td></tr> <tr><td>Potential Eroded Volume Mean</td><td>&gt;40 y<sup>3</sup></td><td>1</td></tr> <tr><td>Approach Slope Mean</td><td>&gt;4%</td><td>1</td></tr> <tr><td>Soil K Factor</td><td>&lt;0.20</td><td>5</td></tr> <tr><td>Upstream Rt Outlet</td><td>Vegetated</td><td>1</td></tr> <tr><td>Upstream Lt Outlet</td><td>Vegetated</td><td>1</td></tr> <tr><td>Upstream Rt Ditch</td><td>Bare soil</td><td>0</td></tr> <tr><td>Upstream Lt Ditch</td><td>Bare soil</td><td>0</td></tr> <tr><td>Downstream Rt Outlet</td><td>Vegetated</td><td>1</td></tr> <tr><td>Downstream Lt Outlet</td><td>Vegetated</td><td>1</td></tr> <tr><td>Downstream Rt Ditch</td><td>Bare soil</td><td>0</td></tr> <tr><td>Downstream Lt Ditch</td><td>Bare soil</td><td>0</td></tr> <tr><td>Outlet Total</td><td>Improved Outlet System</td><td>5</td></tr> <tr><td>Ditches Total</td><td>Unimproved Drainage System</td><td>1</td></tr> <tr><td><b>SRI Total</b></td><td><b>Medium Risk</b></td><td><b>44</b></td></tr> </tbody> </table>		Risk Factor	Ranking	Score	US Channel Morph	C	5	DS Channel Morph	C	5	DS Bank Alteration	MINOR/PARTIAL	3	Upstream Skew Angle	<5°	5	Crossing fill condition	Good/Vegetated	5	Inlet/Outlet Condition	No Impairment	5	Road Approach Material	All Sand/Clay	3	Potential Eroded Volume Mean	>40 y <sup>3</sup>	1	Approach Slope Mean	>4%	1	Soil K Factor	<0.20	5	Upstream Rt Outlet	Vegetated	1	Upstream Lt Outlet	Vegetated	1	Upstream Rt Ditch	Bare soil	0	Upstream Lt Ditch	Bare soil	0	Downstream Rt Outlet	Vegetated	1	Downstream Lt Outlet	Vegetated	1	Downstream Rt Ditch	Bare soil	0	Downstream Lt Ditch	Bare soil	0	Outlet Total	Improved Outlet System	5	Ditches Total	Unimproved Drainage System	1	<b>SRI Total</b>	<b>Medium Risk</b>	<b>44</b>
