Unnamed tributary		co-1103-r-015	Sedimentation Risk Index 48																																																																		
<u>Common:</u> 3.3mi NW of Brooklyn <u>Drainage:</u> Poley Creek <u>GPS:</u> 31.333270156,-86.221932759 <u>Land owner:</u> Robert M Williams West, Jody J Jones East		<u>County:</u> Covington <u>State:</u> Alabama <u>PLSS (T-R-S):</u> 4N-18E-11 <u>Parcel No.:</u> 6.01, 6 <u>Road Name:</u> Piney Grove Rd

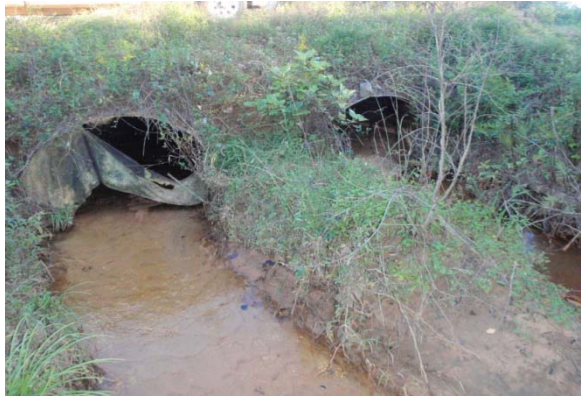
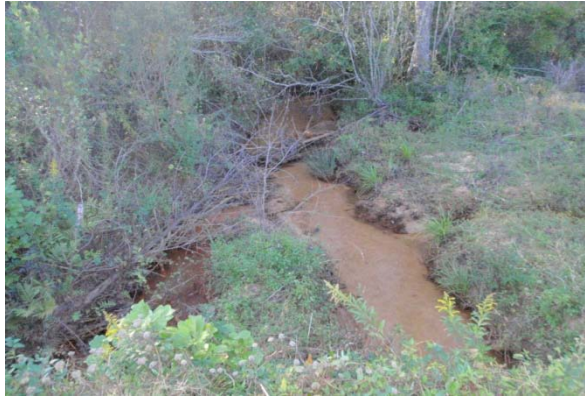
Crossing Structure: DS		DS																																																																			
<table border="1"> <thead> <tr> <th>Risk Factor</th> <th>Ranking</th> <th>Score</th> </tr> </thead> <tbody> <tr><td>US Channel Morph</td><td>E</td><td>5</td></tr> <tr><td>DS Channel Morph</td><td>E</td><td>5</td></tr> <tr><td>DS Bank Alteration</td><td>MINOR/PARTIAL</td><td>3</td></tr> <tr><td>Upstream Skew Angle</td><td><5°</td><td>5</td></tr> <tr><td>Crossing fill condition</td><td>Good/Vegetated</td><td>5</td></tr> <tr><td>Inlet/Outlet Condition</td><td>Sed Islands/Scouring</td><td>3</td></tr> <tr><td>Road Approach Material</td><td>All Sand/Clay</td><td>3</td></tr> <tr><td>Potential Eroded Volume Mean</td><td><21 y³</td><td>5</td></tr> <tr><td>Approach Slope Mean</td><td>2.1-4%</td><td>3</td></tr> <tr><td>Soil K Factor</td><td><0.20</td><td>5</td></tr> <tr><td>Upstream Rt Outlet</td><td>Vegetated</td><td>1</td></tr> <tr><td>Upstream Lt Outlet</td><td>Vegetated</td><td>1</td></tr> <tr><td>Upstream Rt Ditch</td><td>Bare soil</td><td>0</td></tr> <tr><td>Upstream Lt Ditch</td><td>Bare soil</td><td>0</td></tr> <tr><td>Downstream Rt Outlet</td><td>Bare soil</td><td>0</td></tr> <tr><td>Downstream Lt Outlet</td><td>Vegetated</td><td>1</td></tr> <tr><td>Downstream Rt Ditch</td><td>Bare soil</td><td>0</td></tr> <tr><td>Downstream Lt Ditch</td><td>Vegetated</td><td>1</td></tr> <tr><td>Outlet Total</td><td>Partially Improved Outlet System</td><td>3</td></tr> <tr><td>Ditches Total</td><td>Partially Improved Drainage System</td><td>3</td></tr> <tr><td>SRI Total</td><td>Low Risk</td><td>48</td></tr> </tbody> </table>				Risk Factor	Ranking	Score	US Channel Morph	E	5	DS Channel Morph	E	5	DS Bank Alteration	MINOR/PARTIAL	3	Upstream Skew Angle	<5°	5	Crossing fill condition	Good/Vegetated	5	Inlet/Outlet Condition	Sed Islands/Scouring	3	Road Approach Material	All Sand/Clay	3	Potential Eroded Volume Mean	<21 y ³	5	Approach Slope Mean	2.1-4%	3	Soil K Factor	<0.20	5	Upstream Rt Outlet	Vegetated	1	Upstream Lt Outlet	Vegetated	1	Upstream Rt Ditch	Bare soil	0	Upstream Lt Ditch	Bare soil	0	Downstream Rt Outlet	Bare soil	0	Downstream Lt Outlet	Vegetated	1	Downstream Rt Ditch	Bare soil	0	Downstream Lt Ditch	Vegetated	1	Outlet Total	Partially Improved Outlet System	3	Ditches Total	Partially Improved Drainage System	3	SRI Total	Low Risk	48

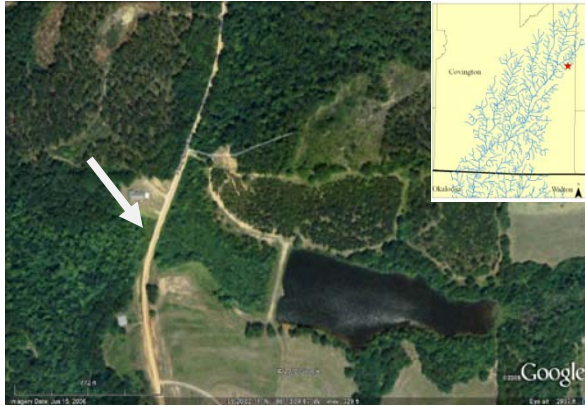
Risk Factor	Ranking	Score																																																																			
US Channel Morph	E	5																																																																			
DS Channel Morph	E	5																																																																			
DS Bank Alteration	MINOR/PARTIAL	3																																																																			
Upstream Skew Angle	<5°	5																																																																			
Crossing fill condition	Good/Vegetated	5																																																																			
Inlet/Outlet Condition	Sed Islands/Scouring	3																																																																			
Road Approach Material	All Sand/Clay	3																																																																			
Potential Eroded Volume Mean	<21 y ³	5																																																																			
Approach Slope Mean	2.1-4%	3

Soil K Factor	<0.20	5																																																																			
Upstream Rt Outlet	Vegetated	1																																																																			
Upstream Lt Outlet	Vegetated	1																																																																			
Upstream Rt Ditch	Bare soil	0																																																																			
Upstream Lt Ditch	Bare soil	0																																																																			
Downstream Rt Outlet	Bare soil	0																																																																			
Downstream Lt Outlet	Vegetated	1																																																																			
Downstream Rt Ditch	Bare soil	0																																																																			
Downstream Lt Ditch	Vegetated	1																																																																			
Outlet Total	Partially Improved Outlet System	3

Ditches Total	Partially Improved Drainage System	3																																																																			
SRI Total	Low Risk	48
