| Burnt Grocery Creek | | sr-0223-r-001 | Sedimentation Risk Index 48 | | | | | | | | | | | | | | | | | | | | | | | | | | | | | | | | | | | | | | | | | | | | | | | | | | | | | | | | | | | | | | | | | | |
| <u>Common:</u> 3mi SE of Harold <u>Drainage:</u> Yellow River <u>GPS:</u> 30.626983, -86.846339 <u>Land owner:</u> The Nature Conservancy | | <u>County:</u> Santa Rosa <u>State:</u> Florida <u>PLSS(T-R-S):</u> 2N-26-33 <u>Parcel No.:</u> 1 <u>Road Name:</u> Fisher Old Mill Rd | | | | | | | | | | | | | | | | | | | | | | | | | | | | | | | | | | | | | | | | | | | | | | | | | | | | | | | | | | | | | | | | | | | |

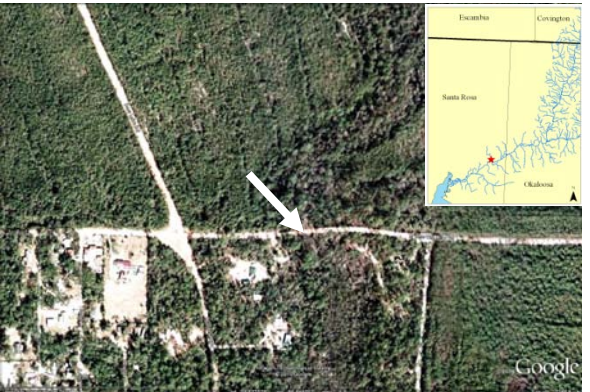
| Burnt Grocery Creek | | sr-0223-r-001 | Sedimentation Risk Index 48 | | | | | | | | | | | | | | | | | | | | | | | | | | | | | | | | | | | | | | | | | | | | | | | | | | | | | | | | | | | | | | | | | | |
|--|---|--|---|---|---|---|---|---|---|---|---|---|---|---|---|---|---|---|---|---|---|---|---|---|---|---|---|---|---|---|---|---|---|---|---|---|---|---|---|---|---|---|---|---|---|---|---|---|---|---|---|---|---|---|---|---|---|---|---|---|---|---|---|---|---|---|---|---|--|
| Crossing Structure: US | | DS | | | | | | | | | | | | | | | | | | | | | | | | | | | | | | | | | | | | | | | | | | | | | | | | | | | | | | | | | | | | | | | | | | | |

| Burnt Grocery Creek | | sr-0223-r-001 | Sedimentation Risk Index 48 | | | | | | | | | | | | | | | | | | | | | | | | | | | | | | | | | | | | | | | | | | | | | | | | | | | | | | | | | | | | | | | | | | |
|--|---|--|---|---|---|---|---|---|---|---|---|---|---|---|---|---|---|---|---|---|---|---|---|---|---|---|---|---|---|---|---|---|---|---|---|---|---|---|---|---|---|---|---|---|---|---|---|---|---|---|---|---|---|---|---|---|---|---|---|---|---|---|---|---|---|---|---|---|--|
| <table border="1"> <thead> <tr> <th>Risk Factor</th> <th>Ranking</th> <th>Score</th> </tr> </thead> <tbody> <tr><td>US Channel Morph</td><td>B</td><td>5</td></tr> <tr><td>DS Channel Morph</td><td>B</td><td>5</td></tr> <tr><td>DS Bank Alteration</td><td>NATURAL</td><td>5</td></tr> <tr><td>Upstream Skew Angle</td><td><5°</td><td>5</td></tr> <tr><td>Crossing fill condition</td><td>Good/Vegetated</td><td>5</td></tr> <tr><td>Inlet/Outlet Condition</td><td>No Impairment</td><td>5</td></tr> <tr><td>Road Approach Material</td><td>All Sand/Clay</td><td>3</td></tr> <tr><td>Potential Eroded Volume Mean</td><td>>40 y³</td><td>1</td></tr> <tr><td>Approach Slope Mean</td><td>2.1-4%</td><td>3</td></tr> <tr><td>Soil K Factor</td><td><0.20</td><td>5</td></tr> <tr><td>Upstream Rt Outlet</td><td>Bare soil</td><td>0</td></tr> <tr><td>Upstream Lt Outlet</td><td>Vegetated</td><td>1</td></tr> <tr><td>Upstream Rt Ditch</td><td>Bare soil</td><td>0</td></tr> <tr><td>Upstream Lt Ditch</td><td>Vegetated</td><td>1</td></tr> <tr><td>Downstream Rt Outlet</td><td>Bare soil</td><td>0</td></tr> <tr><td>Downstream Lt Outlet</td><td>Bare soil</td><td>0</td></tr> <tr><td>Downstream Rt Ditch</td><td>Bare soil</td><td>0</td></tr> <tr><td>Downstream Lt Ditch</td><td>Bare soil</td><td>0</td></tr> <tr><td>Outlet Total</td><td>Partially Improved Outlet System</td><td>3</td></tr> <tr><td>Ditches Total</td><td>Partially Improved Drainage System</td><td>3</td></tr> <tr><td>SRI Total</td><td>Low Risk</td><td>48</td></tr> </tbody> </table> | | Risk Factor | Ranking | Score | US Channel Morph | B | 5 | DS Channel Morph | B | 5 | DS Bank Alteration | NATURAL | 5 | Upstream Skew Angle | <5° | 5 | Crossing fill condition | Good/Vegetated | 5 | Inlet/Outlet Condition | No Impairment | 5 | Road Approach Material | All Sand/Clay | 3 | Potential Eroded Volume Mean | >40 y ³ | 1 | Approach Slope Mean | 2.1-4% | 3 | Soil K Factor | <0.20 | 5 | Upstream Rt Outlet | Bare soil | 0 | Upstream Lt Outlet | Vegetated | 1 | Upstream Rt Ditch | Bare soil | 0 | Upstream Lt Ditch | Vegetated | 1 | Downstream Rt Outlet | Bare soil | 0 | Downstream Lt Outlet | Bare soil | 0 | Downstream Rt Ditch | Bare soil | 0 | Downstream Lt Ditch | Bare soil | 0 | Outlet Total | Partially Improved Outlet System | 3 | Ditches Total | Partially Improved Drainage System | 3 | SRI Total | Low Risk | 48 | | |
