Shoal River			ok-0423-004		Severity Score 6.5
<u>Common:</u> 3.5mi SE of Crestview, 0.7mi DS of HWY 90 Bridge <u>Drainage:</u> Yellow River <u>GPS:</u> 30.744442, -86.514964 <u>Land owner:</u> RB: Purl G Adams Jr./ George & Essie Mack			<u>County:</u> Okaloosa <u>PLSS(T-R-S):</u> 3N-23W-23 <u>Parcel No.:</u> 1/ 1.0140		<u>State:</u> Florida

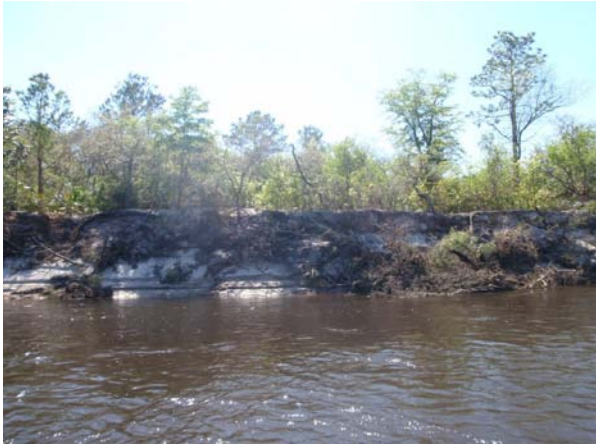
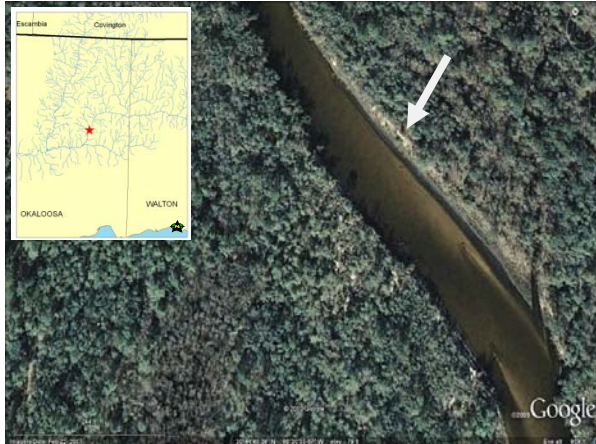
LB					
<b>Risk Factor</b>	<b>Ranking</b>	<b>Score</b>	<b>Feature</b>	<b>Within Range</b>	<b>Descriptive Field</b>
Channel Stability	Fair	1	303(d)	Yes	N/A
Channel Alteration	None	0	Wetland Species	Yes	1-3 FOCAL SPECIES IN UPLAND AREAS
Bank Erosion	Mass Wasting	1.5	Rare and Imperiled	Yes	GOLDSTRIPE DARTER, SPECKLED CHUB IRONCOLOR SHINER
BEHI	High	1	Land Use/ Cover	Yes	NA/ STREAMS AND WATERWAYS
Local NPSP	No Evidence	0	Candidate Mussels	No	N/A
Shoring Structures	Not Present	0	Sturgeon C.H.	No	N/A
Pipe Discharge	Not Present	0			
Water Odors	Not Present	0

Fish Passage Barrier	Not Present	0			
RB: Riparian Buffer	0-29 ft	0.75			
LB: Riparian Buffer	0-29 ft	0.75			
RB: Floodplain Access	None	0.75			
LB: Floodplain Access	None	0.75			
<b>River Threat Index:</b>		<b>6.5</b>	<b>Additional Site Features</b> <u>Stream Channel Woody Material:</u> Moderate <u>Impoundments:</u> None <u>Substrate Composition:</u> Medium Sand <u>Bank Material:</u> Sand and Roots

Notes: Located along an area of the Shoal that lacks sinuosity
