Unnamed tributary		wa-0714-r-001	Sedimentation Risk Index <b>42</b>																																																																		
<u>Common:</u> 4.9mi NW of Mossy Head <u>Drainage:</u> Wolf Branch <i>GPS:</i> 30.798529, -86.366837 <u>Land owner:</u> Theodore Lehmann Jr-US, John Mills-DS		<u>County:</u> Walton <i>State:</i> Florida <u>PLSS(T-R-S):</u> 4N-21-32 <u>Parcel No.:</u> 2.0011; 4 <u>Road Name:</u> Hinote Rd

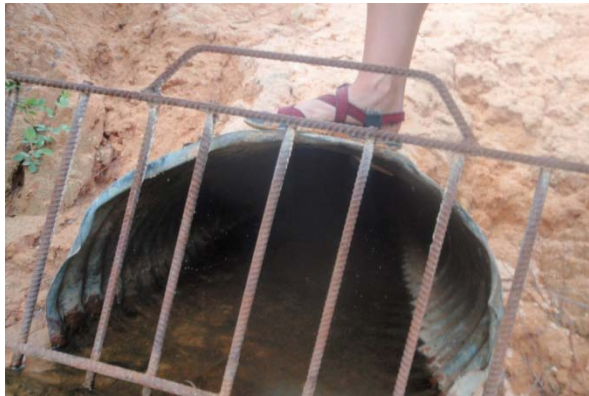
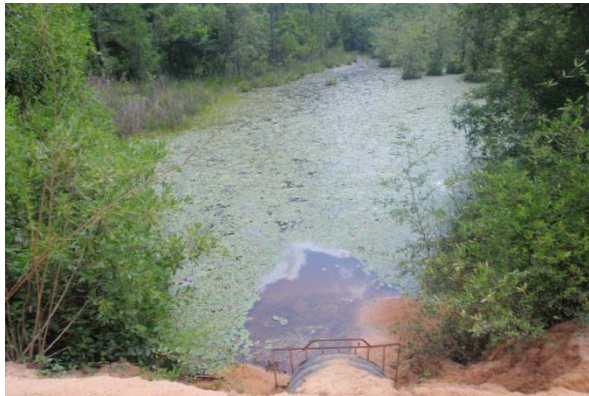
Crossing Structure: US		US																																																																			
<table border="1"> <thead> <tr> <th>Risk Factor</th> <th>Ranking</th> <th>Score</th> </tr> </thead> <tbody> <tr><td>US Channel Morph</td><td>WETLAND</td><td>5</td></tr> <tr><td>DS Channel Morph</td><td>E</td><td>5</td></tr> <tr><td>DS Bank Alteration</td><td>MINOR/PARTIAL</td><td>3</td></tr> <tr><td>Upstream Skew Angle</td><td>&lt;5°</td><td>5</td></tr> <tr><td>Crossing fill condition</td><td>Poor/Bare soil</td><td>1</td></tr> <tr><td>Inlet/Outlet Condition</td><td>No Impairment</td><td>5</td></tr> <tr><td>Road Approach Material</td><td>All Sand/Clay</td><td>3</td></tr> <tr><td>Potential Eroded Volume Mean</td><td>&lt;21 y<sup>3</sup></td><td>5</td></tr> <tr><td>Approach Slope Mean</td><td>2.1-4%</td><td>3</td></tr> <tr><td>Soil K Factor</td><td>0.21-0.40</td><td>3</td></tr> <tr><td>Upstream Rt Outlet</td><td>Vegetated</td><td>1</td></tr> <tr><td>Upstream Lt Outlet</td><td>Vegetated</td><td>1</td></tr> <tr><td>Upstream Rt Ditch</td><td>Bare soil</td><td>0</td></tr> <tr><td>Upstream Lt Ditch</td><td>Bare soil</td><td>0</td></tr> <tr><td>Downstream Rt Outlet</td><td>Vegetated</td><td>1</td></tr> <tr><td>Downstream Lt Outlet</td><td>Bare soil</td><td>0</td></tr> <tr><td>Downstream Rt Ditch</td><td>Bare soil</td><td>0</td></tr> <tr><td>Downstream Lt Ditch</td><td>Bare soil</td><td>0</td></tr> <tr><td>Outlet Total</td><td>Partially Improved Outlet System</td><td>3</td></tr> <tr><td>Ditches Total</td><td>Unimproved Drainage System</td><td>1</td></tr> <tr><td><b>SRI Total</b></td><td><b>Medium Risk</b></td><td><b>42</b></td></tr> </tbody> </table>		Risk Factor	Ranking	Score	US Channel Morph	WETLAND	5	DS Channel Morph	E	5	DS Bank Alteration	MINOR/PARTIAL	3	Upstream Skew Angle	<5°	5	Crossing fill condition	Poor/Bare soil	1	Inlet/Outlet Condition	No Impairment	5	Road Approach Material	All Sand/Clay	3	Potential Eroded Volume Mean	<21 y <sup>3</sup>	5	Approach Slope Mean	2.1-4%	3	Soil K Factor	0.21-0.40	3	Upstream Rt Outlet	Vegetated	1	Upstream Lt Outlet	Vegetated	1	Upstream Rt Ditch	Bare soil	0	Upstream Lt Ditch	Bare soil	0	Downstream Rt Outlet	Vegetated	1	Downstream Lt Outlet	Bare soil	0	Downstream Rt Ditch	Bare soil	0	Downstream Lt Ditch	Bare soil	0	Outlet Total	Partially Improved Outlet System	3	Ditches Total	Unimproved Drainage System	1	<b>SRI Total</b>	<b>Medium Risk</b>	<b>42</b>

Notes: Grate over inlet.
