Unnamed tributary		wa-1005-r-005	Sedimentation Risk Index 36																																																																		
<u>Common:</u> 6.9mi N of Mossy Head <u>Drainage:</u> Long Creek <u>GPS:</u> 30.836530868, -86.351276376 <u>Land owner:</u> Dreamland Investments & LLC-US, Parke Lexington II of Gainesville LTD- DS		<u>County:</u> Walton <u>State:</u> Florida <u>PLSS (T-R-S):</u> 4N-21-16-38000 <u>Parcel No.:</u> 2.0010; 1 <u>Road Name:</u> Long Rd

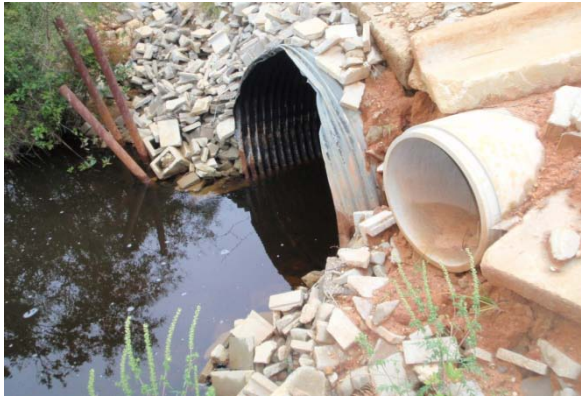
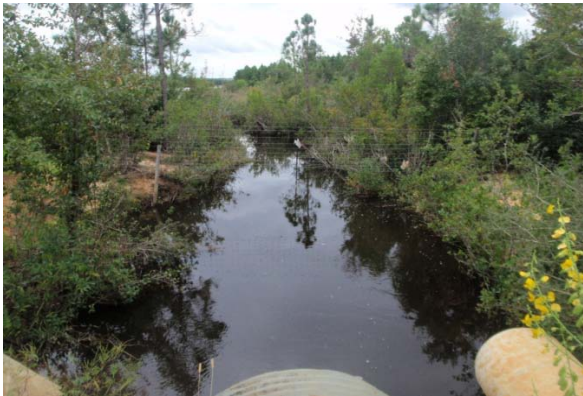
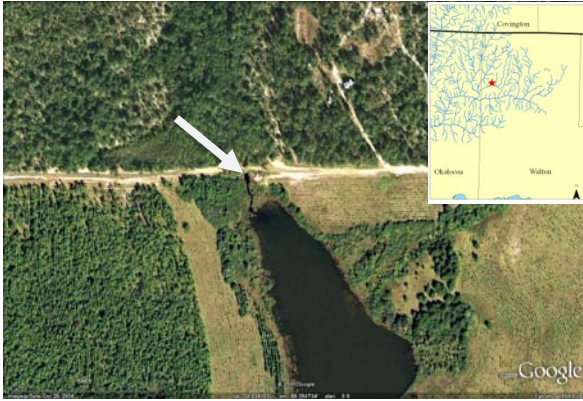
Crossing Structure: US		US																																																																			
<table border="1"> <thead> <tr> <th>Risk Factor</th> <th>Ranking</th> <th>Score</th> </tr> </thead> <tbody> <tr><td>US Channel Morph</td><td>WETLAND</td><td>5</td></tr> <tr><td>DS Channel Morph</td><td>PONDED</td><td>1</td></tr> <tr><td>DS Bank Alteration</td><td>MINOR/PARTIAL</td><td>3</td></tr> <tr><td>Upstream Skew Angle</td><td><5°</td><td>5</td></tr> <tr><td>Crossing fill condition</td><td>Fair/Rip Rap</td><td>3</td></tr> <tr><td>Inlet/Outlet Condition</td><td>No Impairment</td><td>5</td></tr> <tr><td>Road Approach Material</td><td>All Sand/Clay</td><td>3</td></tr> <tr><td>Potential Eroded Volume Mean</td><td>21-40 y³</td><td>3</td></tr> <tr><td>Approach Slope Mean</td><td>>4%</td><td>1</td></tr> <tr><td>Soil K Factor</td><td>0.21-0.40</td><td>3</td></tr> <tr><td>Upstream Rt Outlet</td><td>Vegetated</td><td>1</td></tr> <tr><td>Upstream Lt Outlet</td><td>Vegetated</td><td>1</td></tr> <tr><td>Upstream Rt Ditch</td><td>Bare soil</td><td>0</td></tr> <tr><td>Upstream Lt Ditch</td><td>Bare soil</td><td>0</td></tr> <tr><td>Downstream Rt Outlet</td><td>Vegetated</td><td>1</td></tr> <tr><td>Downstream Lt Outlet</td><td>Bare soil</td><td>0</td></tr> <tr><td>Downstream Rt Ditch</td><td>Bare soil</td><td>0</td></tr> <tr><td>Downstream Lt Ditch</td><td>Bare soil</td><td>0</td></tr> <tr><td>Outlet Total</td><td>Partially Improved Outlet System</td><td>3</td></tr> <tr><td>Ditches Total</td><td>Unimproved Drainage System</td><td>1</td></tr> <tr><td>SRI Total</td><td>High Risk</td><td>36</td></tr> </tbody> </table>		Risk Factor	Ranking	Score	US Channel Morph	WETLAND	5	DS Channel Morph	PONDED	1	DS Bank Alteration	MINOR/PARTIAL	3	Upstream Skew Angle	<5°	5	Crossing fill condition	Fair/Rip Rap	3	Inlet/Outlet Condition	No Impairment	5	Road Approach Material	All Sand/Clay	3	Potential Eroded Volume Mean	21-40 y ³	3	Approach Slope Mean	>4%	1	Soil K Factor	0.21-0.40	3	Upstream Rt Outlet	Vegetated	1	Upstream Lt Outlet	Vegetated	1	Upstream Rt Ditch	Bare soil	0	Upstream Lt Ditch	Bare soil	0	Downstream Rt Outlet	Vegetated	1	Downstream Lt Outlet	Bare soil	0	Downstream Rt Ditch	Bare soil	0	Downstream Lt Ditch	Bare soil	0	Outlet Total	Partially Improved Outlet System	3	Ditches Total	Unimproved Drainage System	1	SRI Total	High Risk	36

Notes: 2nd culvert is concrete and placed well above the water level.
