| Pitts River | | | sr-0305-001 | | Severity Score<br>6.25 | |
| <u>Common:</u> 14mi E of Milton<br><u>Drainage:</u> Yellow River <u>GPS:</u> 30.6435, -86.800483<br><u>Land owner:</u> H. A. Morris | | | <u>County:</u> Santa Rosa<br><u>PLSS(T-R-S):</u> 2N-26W-25<br><u>Parcel No.:</u> 2 | | <u>State:</u> Florida | |

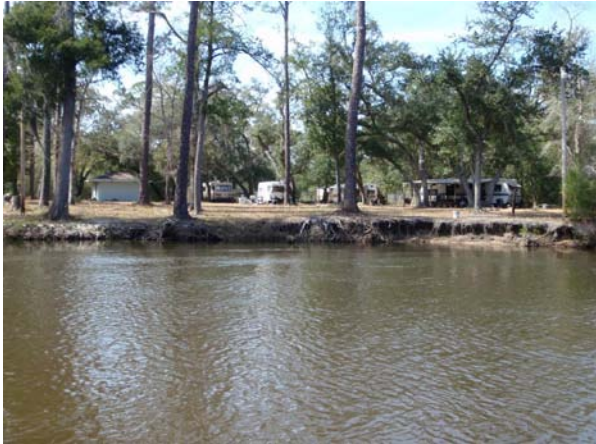
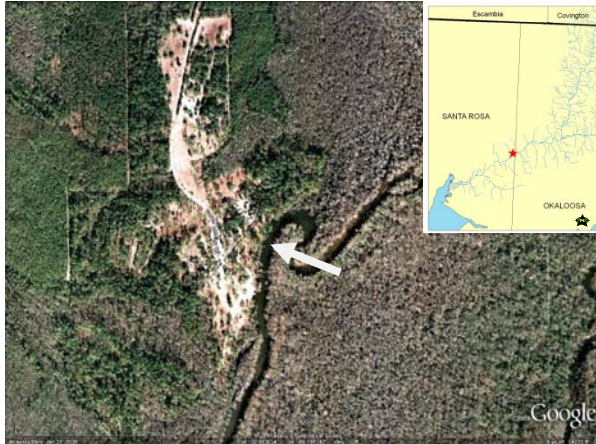
| Pitts River | | | sr-0305-001 | | Severity Score<br>6.25 | |
|---|---|---|--|---|---|--|
| RB | | | | | | |

| Pitts River | | | sr-0305-001 | | Severity Score<br>6.25 | |
|---|---|---|--|---|---|--|
| Bank Erosion | Active | 1 | Rare and Imperiled | Yes | GOLDSTRIPE DARTER, SPECKLED CHUB, IRONCOLOR SHINER, GULF STURGEON, ALABAMA SHAD, ALLIGATOR GAR, SPECKLED DARTER, SPOTTED BULLHEAD | |
| Shoring Structures | Present | 1.5 | Sturgeon C.H. | No | N/A | |

Notes: Concrete shoring structure and two boat launches present. Road leading down is Garner Landing Rd
