Unnamed tributary		co-0810-r-14a		Sedimentation Risk Index 38																																																																			
<u>Common:</u> 7.4mi S of Andalusia <u>Drainage:</u> Five Runs Creek <u>GPS:</u> 31.200686, -86.478814 <u>Land owner:</u> C&G LLC		<u>County:</u> Covington <u>PLSS (T-R-S):</u> 3N-16E-29 <u>Parcel No.:</u> 1 <u>Road Name:</u> Bass Bridge Rd		<u>State:</u> Alabama

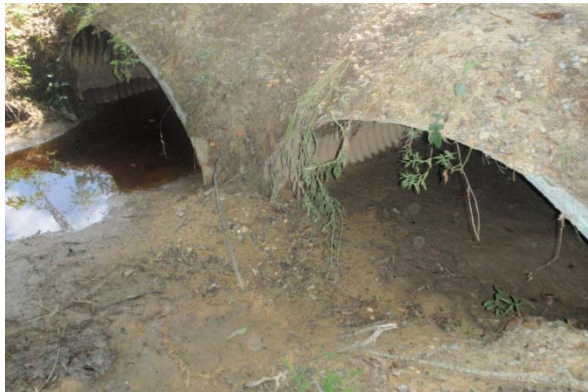
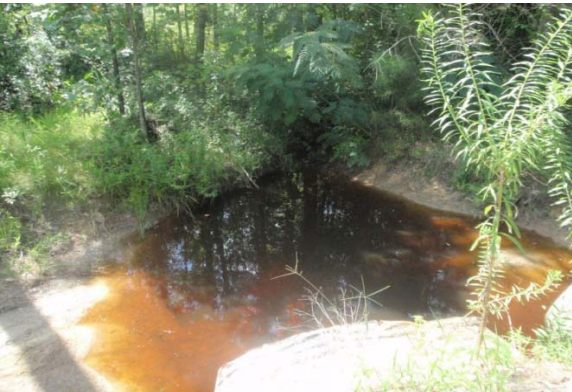
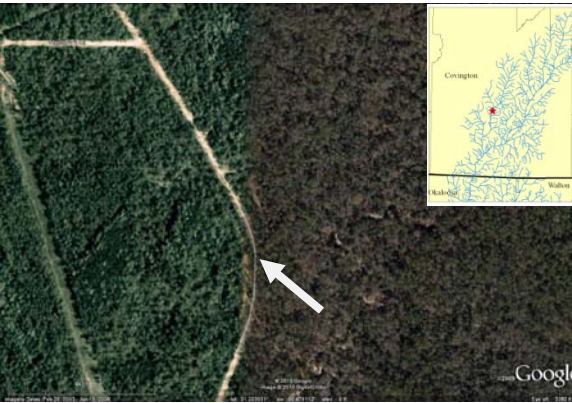
Crossing Structure: DS		US																																																																					
<table border="1"> <thead> <tr> <th>Risk Factor</th> <th>Ranking</th> <th>Score</th> </tr> </thead> <tbody> <tr><td>US Channel Morph</td><td>DA</td><td>3</td></tr> <tr><td>DS Channel Morph</td><td>DA</td><td>3</td></tr> <tr><td>DS Bank Alteration</td><td>HIGH</td><td>1</td></tr> <tr><td>Upstream Skew Angle</td><td><5°</td><td>5</td></tr> <tr><td>Crossing fill condition</td><td>Poor/Bare soil</td><td>1</td></tr> <tr><td>Inlet/Outlet Condition</td><td>No Impairment</td><td>5</td></tr> <tr><td>Road Approach Material</td><td>All Sand/Clay</td><td>3</td></tr> <tr><td>Potential Eroded Volume Mean</td><td>>40 y³</td><td>1</td></tr> <tr><td>Approach Slope Mean</td><td><2%</td><td>5</td></tr> <tr><td>Soil K Factor</td><td><0.20</td><td>5</td></tr> <tr><td>Upstream Rt Outlet</td><td>Vegetated</td><td>1</td></tr> <tr><td>Upstream Lt Outlet</td><td>Vegetated</td><td>1</td></tr> <tr><td>Upstream Rt Ditch</td><td>Bare soil</td><td>0</td></tr> <tr><td>Upstream Lt Ditch</td><td>Bare soil</td><td>0</td></tr> <tr><td>Downstream Rt Outlet</td><td>Vegetated</td><td>1</td></tr> <tr><td>Downstream Lt Outlet</td><td>Vegetated</td><td>1</td></tr> <tr><td>Downstream Rt Ditch</td><td>Bare soil</td><td>0</td></tr> <tr><td>Downstream Lt Ditch</td><td>Bare soil</td><td>0</td></tr> <tr><td>Outlet Total</td><td>Improved Outlet System</td><td>5</td></tr> <tr><td>Ditches Total</td><td>Unimproved Drainage System</td><td>1</td></tr> <tr><td>SRI Total</td><td>Medium Risk</td><td>38</td></tr> </tbody> </table>		Risk Factor	Ranking	Score	US Channel Morph	DA	3	DS Channel Morph	DA	3	DS Bank Alteration	HIGH	1	Upstream Skew Angle	<5°	5	Crossing fill condition	Poor/Bare soil	1	Inlet/Outlet Condition	No Impairment	5	Road Approach Material	All Sand/Clay	3	Potential Eroded Volume Mean	>40 y ³	1	Approach Slope Mean	<2%	5	Soil K Factor	<0.20	5	Upstream Rt Outlet	Vegetated	1	Upstream Lt Outlet	Vegetated	1	Upstream Rt Ditch	Bare soil	0	Upstream Lt Ditch	Bare soil	0	Downstream Rt Outlet	Vegetated	1	Downstream Lt Outlet	Vegetated	1	Downstream Rt Ditch	Bare soil	0	Downstream Lt Ditch	Bare soil	0	Outlet Total	Improved Outlet System	5	Ditches Total	Unimproved Drainage System	1	SRI Total	Medium Risk	38

Notes: Significant difference between US and DS channel conditions. No flow through Lt Culvert.
