Unnamed tributary		ok-0526-r-009	Sedimentation Risk Index <b>44</b>																																																																		
<u>Common:</u> 3mi NE of Blackman <u>Drainage:</u> Big Horse Creek <u>GPS:</u> 30.967639, -86.625359 <u>Land owner:</u> Lonnie Hughes Jr- US, Rhonda Nelson- DS		<u>County:</u> Okaloosa <u>State:</u> Florida <u>PLSS(T-R-S):</u> 5N-24-03 <u>Parcel No.:</u> 1.0040, 1.002A <u>Road Name:</u> Owen Cotton Cemetery Rd

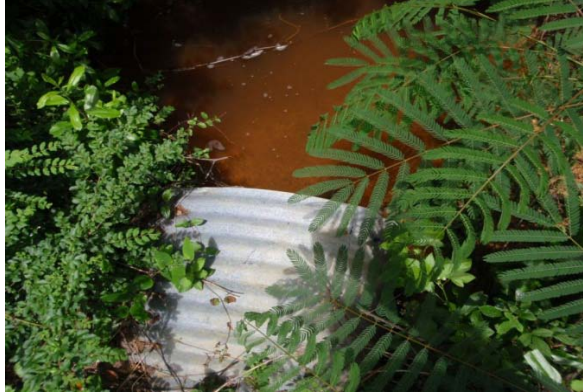
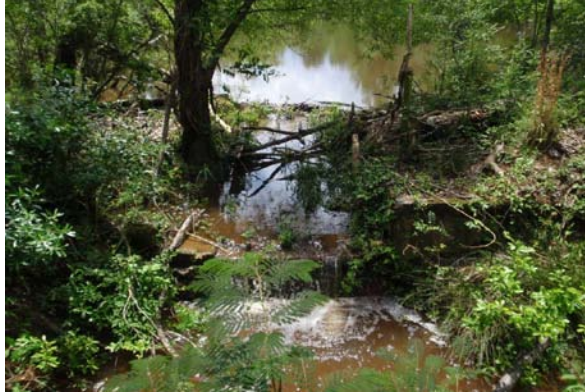
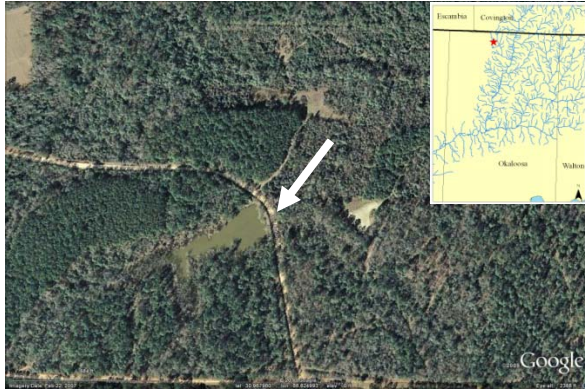
Crossing Structure: DS		US																																																																			
<table border="1"> <thead> <tr> <th>Risk Factor</th> <th>Ranking</th> <th>Score</th> </tr> </thead> <tbody> <tr><td>US Channel Morph</td><td>PONDED</td><td>1</td></tr> <tr><td>DS Channel Morph</td><td>B</td><td>5</td></tr> <tr><td>DS Bank Alteration</td><td>HIGH</td><td>1</td></tr> <tr><td>Upstream Skew Angle</td><td>&lt;5°</td><td>5</td></tr> <tr><td>Crossing fill condition</td><td>Good/Vegetated</td><td>5</td></tr> <tr><td>Inlet/Outlet Condition</td><td>No Impairment</td><td>5</td></tr> <tr><td>Road Approach Material</td><td>All Native Soil</td><td>1</td></tr> <tr><td>Potential Eroded Volume Mean</td><td>&lt;21 y<sup>3</sup></td><td>5</td></tr> <tr><td>Approach Slope Mean</td><td>2.1-4%</td><td>3</td></tr> <tr><td>Soil K Factor</td><td>&lt;0.20</td><td>5</td></tr> <tr><td>Upstream Rt Outlet</td><td>Vegetated</td><td>1</td></tr> <tr><td>Upstream Lt Outlet</td><td>Vegetated</td><td>1</td></tr> <tr><td>Upstream Rt Ditch</td><td>Vegetated</td><td>1</td></tr> <tr><td>Upstream Lt Ditch</td><td>Bare soil</td><td>0</td></tr> <tr><td>Downstream Rt Outlet</td><td>Vegetated</td><td>1</td></tr> <tr><td>Downstream Lt Outlet</td><td>Vegetated</td><td>1</td></tr> <tr><td>Downstream Rt Ditch</td><td>Bare soil</td><td>0</td></tr> <tr><td>Downstream Lt Ditch</td><td>Bare soil</td><td>0</td></tr> <tr><td>Outlet Total</td><td>Improved Outlet System</td><td>5</td></tr> <tr><td>Ditches Total</td><td>Partially Improved Drainage System</td><td>3</td></tr> <tr><td><b>SRI Total</b></td><td><b>Medium Risk</b></td><td><b>44</b></td></tr> </tbody> </table>		Risk Factor	Ranking	Score	US Channel Morph	PONDED	1	DS Channel Morph	B	5	DS Bank Alteration	HIGH	1	Upstream Skew Angle	<5°	5	Crossing fill condition	Good/Vegetated	5	Inlet/Outlet Condition	No Impairment	5	Road Approach Material	All Native Soil	1	Potential Eroded Volume Mean	<21 y <sup>3</sup>	5	Approach Slope Mean	2.1-4%	3	Soil K Factor	<0.20	5	Upstream Rt Outlet	Vegetated	1	Upstream Lt Outlet	Vegetated	1	Upstream Rt Ditch	Vegetated	1	Upstream Lt Ditch	Bare soil	0	Downstream Rt Outlet	Vegetated	1	Downstream Lt Outlet	Vegetated	1	Downstream Rt Ditch	Bare soil	0	Downstream Lt Ditch	Bare soil	0	Outlet Total	Improved Outlet System	5	Ditches Total	Partially Improved Drainage System	3	<b>SRI Total</b>	<b>Medium Risk</b>	<b>44</b>
