Yellow River		ok-0319-001		Severity Score 5.25	
<u>Common:</u> 7mi SW of Crestview, Little Gin Hole Landing on EAFB <u>Drainage:</u> Blackwater Bay <u>GPS:</u> 30.680277, -86.650922 <u>Land owner:</u> USA- Eglin AFB		<u>County:</u> Okaloosa <u>PLSS(T-R-S):</u> 2N-16W-16 <u>Parcel No.:</u> 1		<u>State:</u> Florida

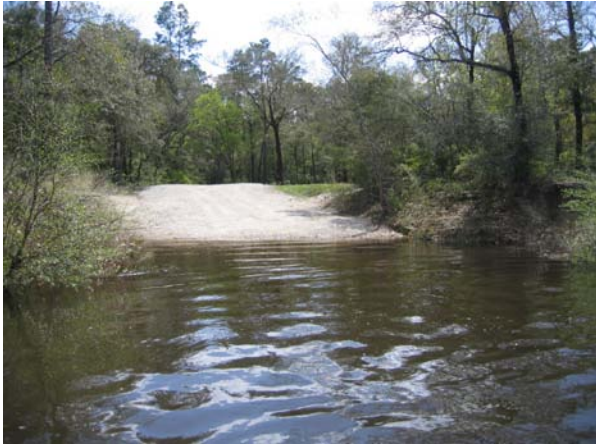
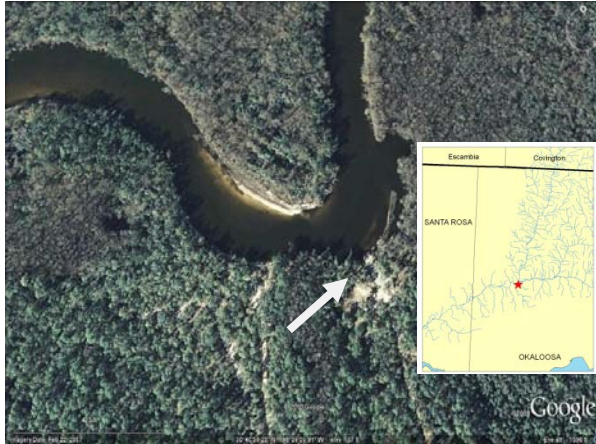
LB					
Risk Factor	Ranking	Score	Feature	Within Range	Descriptive Field
Channel Stability	Good	0.5	303(d)	No	N/A
Channel Alteration	None	0	Wetland Species	Yes	1-3 FOCAL SPECIES IN WETLAND AREAS
Bank Erosion	Active	1	Rare and Imperiled	Yes	ALABAMA SHAD, ALLIGATOR GAR, BLUENOSE SHINER, GULF STURGEON, SPECKLED CHUB, IRONCOLOR SHINER, SPOTTED BULLHEAD, SPECKLED DARTER
BEHI	Moderate	0.5	Land Use/ Cover	Yes	N/A/ STREAMS AND WATERWAYS & UPLAND AND CONIFEROUS FORESTS
Local NPSP	Moderate Potential	1	Candidate Mussels	Yes	NARROW PIGTOE
Shoring Structures	Present	1.5	Sturgeon C.H.	Yes	N/A

Pipe Discharge	Not Present	0			
Water Odors	Not Present	0			
Fish Passage Barrier	Not Present	0			
RB: Riparian Buffer	100+ ft	0			
LB: Riparian Buffer	0-29 ft	0.75			
RB: Floodplain Access	Full	0			
LB: Floodplain Access	Full	0			
River Threat Index:		5.25	Additional Site Features <u>Stream Channel Woody Material:</u> Infrequent <u>Impoundments:</u> None <u>Substrate Composition:</u> Medium Sand and Gravel <u>Bank Material:</u> Sand

Notes: A gravel road leads to this recreational site. Little Gin Hole Landing.
