Big Horse Creek		ok-0526-r-004		Sedimentation Risk Index 54																																																																			
<u>Common:</u> 2.7mi NE of Blackman <u>Drainage:</u> Yellow River <u>GPS:</u> 30.955489, -86.608581 <u>Land owner:</u> Blackwater River State Forest		<u>County:</u> Okaloosa <u>PLSS(T-R-S):</u> 5N-24-02 <u>Parcel No.:</u> 8 <u>Road Name:</u> Creston Barrow Rd		<u>State:</u> Florida

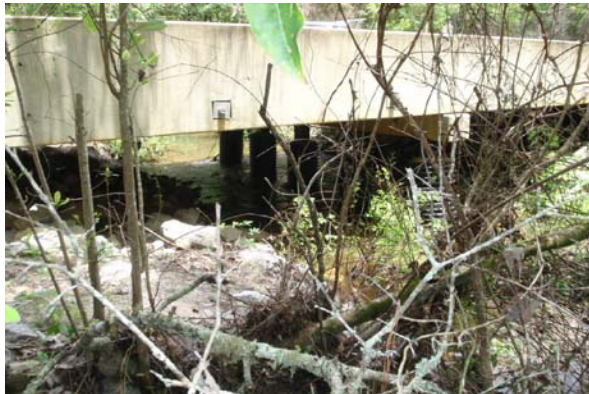
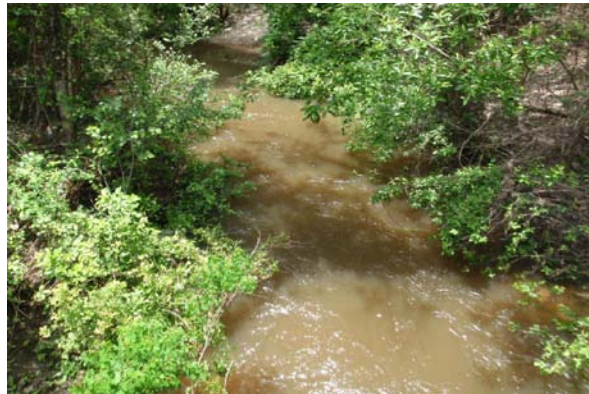
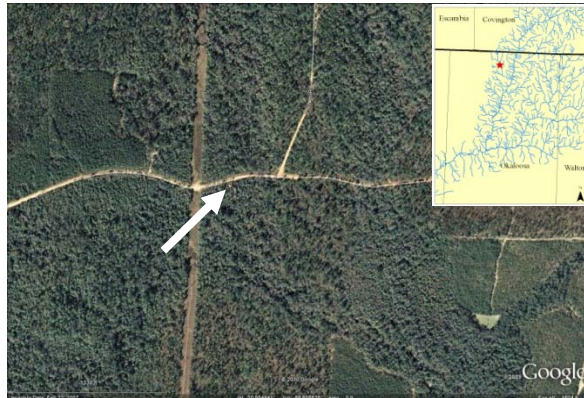
Crossing Structure: DS		DS																																																																					
<table border="1"> <thead> <tr> <th>Risk Factor</th> <th>Ranking</th> <th>Score</th> </tr> </thead> <tbody> <tr><td>US Channel Morph</td><td>B</td><td>5</td></tr> <tr><td>DS Channel Morph</td><td>B</td><td>5</td></tr> <tr><td>DS Bank Alteration</td><td>NATURAL</td><td>5</td></tr> <tr><td>Upstream Skew Angle</td><td><5°</td><td>5</td></tr> <tr><td>Crossing fill condition</td><td>Fair/Rip Rap</td><td>3</td></tr> <tr><td>Inlet/Outlet Condition</td><td>No Impairment</td><td>5</td></tr> <tr><td>Road Approach Material</td><td>All Sand/Clay</td><td>3</td></tr> <tr><td>Potential Eroded Volume Mean</td><td><21 y³</td><td>5</td></tr> <tr><td>Approach Slope Mean</td><td><2%</td><td>5</td></tr> <tr><td>Soil K Factor</td><td>0.21-0.40</td><td>3</td></tr> <tr><td>Upstream Rt Outlet</td><td>Vegetated</td><td>1</td></tr> <tr><td>Upstream Lt Outlet</td><td>Vegetated</td><td>1</td></tr> <tr><td>Upstream Rt Ditch</td><td>Rip Rap</td><td>1</td></tr> <tr><td>Upstream Lt Ditch</td><td>Rip Rap</td><td>1</td></tr> <tr><td>Downstream Rt Outlet</td><td>Rip Rap</td><td>1</td></tr> <tr><td>Downstream Lt Outlet</td><td>Vegetated</td><td>1</td></tr> <tr><td>Downstream Rt Ditch</td><td>Rip Rap</td><td>1</td></tr> <tr><td>Downstream Lt Ditch</td><td>Rip Rap</td><td>1</td></tr> <tr><td>Outlet Total</td><td>Improved Outlet System</td><td>5</td></tr> <tr><td>Ditches Total</td><td>Improved Drainage System</td><td>5</td></tr> <tr><td>SRI Total</td><td>Low Risk</td><td>54</td></tr> </tbody> </table>		Risk Factor	Ranking	Score	US Channel Morph	B	5	DS Channel Morph	B	5	DS Bank Alteration	NATURAL	5	Upstream Skew Angle	<5°	5	Crossing fill condition	Fair/Rip Rap	3	Inlet/Outlet Condition	No Impairment	5	Road Approach Material	All Sand/Clay	3	Potential Eroded Volume Mean	<21 y ³	5	Approach Slope Mean	<2%	5	Soil K Factor	0.21-0.40	3	Upstream Rt Outlet	Vegetated	1	Upstream Lt Outlet	Vegetated	1	Upstream Rt Ditch	Rip Rap	1	Upstream Lt Ditch	Rip Rap	1	Downstream Rt Outlet	Rip Rap	1	Downstream Lt Outlet	Vegetated	1	Downstream Rt Ditch	Rip Rap	1	Downstream Lt Ditch	Rip Rap	1	Outlet Total	Improved Outlet System	5	Ditches Total	Improved Drainage System	5	SRI Total	Low Risk	54

Ditches Total	Improved Drainage System	5																																																																					
SRI Total	Low Risk	54																																																																					
Additional Site Features <u>Crossing Type and Quantity:</u> Bridge, 1 <u>Crossing Materials:</u> Reinforced Concrete <u>Soil Types:</u> 12,13,16,20,23,24,36,39,43,52 <u>Rt Approach Prism Fill:</u> 0.5in <u>Lt Approach Prism Fill:</u> 0.75in		<table border="1"> <thead> <tr> <th>Feature</th> <th>Within Range</th> <th>Descriptive Field</th> </tr> </thead> <tbody> <tr> <td>303(d)</td> <td>No</td> <td>N/A</td> </tr> <tr> <td>Wetland Species</td> <td>No</td> <td>N/A</td> </tr> <tr> <td>Rare and Imperiled</td> <td>Yes</td> <td>BLACKTIP SHINER, IRONCOLOR SHINER</td> </tr> <tr> <td>Land Use/ Cover</td> <td>Yes</td> <td>PUBLIC/SEMI-PUBLIC/ WETLAND FORESTED MIX</td> </tr> <tr> <td>Candidate Mussels</td> <td>No</td> <td>N/A</td> </tr> <tr> <td>Sturgeon C.H.</td> <td>No</td> <td>N/A</td> </tr> </tbody> </table>				Feature	Within Range	Descriptive Field	303(d)	No	N/A	Wetland Species	No	N/A	Rare and Imperiled	Yes	BLACKTIP SHINER, IRONCOLOR SHINER	Land Use/ Cover	Yes	PUBLIC/SEMI-PUBLIC/ WETLAND FORESTED MIX	Candidate Mussels	No	N/A	Sturgeon C.H.	No	N/A
