Unnamed tributary		co-0901-r-011	Sedimentation Risk Index 42																																																																		
<u>Common:</u> 12.3mi NW of Florala <u>Drainage:</u> Poplar Creek <u>GPS:</u> 31.168688885, -86.412788931 <u>Land owner:</u> T & TW -DS, T.Ivey Powell & Sons Inc. -US		<u>County:</u> Covington <u>State:</u> Alabama <u>PLSS (T-R-S):</u> 2N-16E-2/1 <u>Parcel No.:</u> 7.01; 3 <u>Road Name:</u> Tim Powell Rd

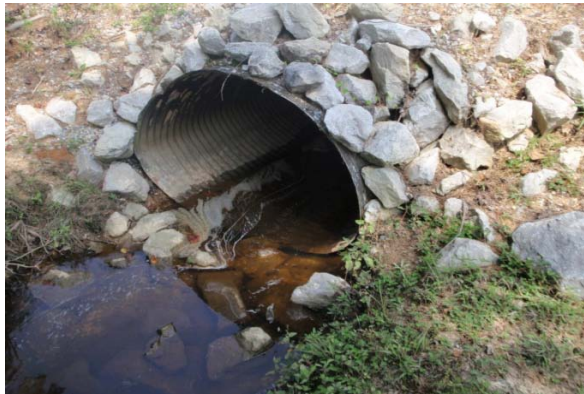
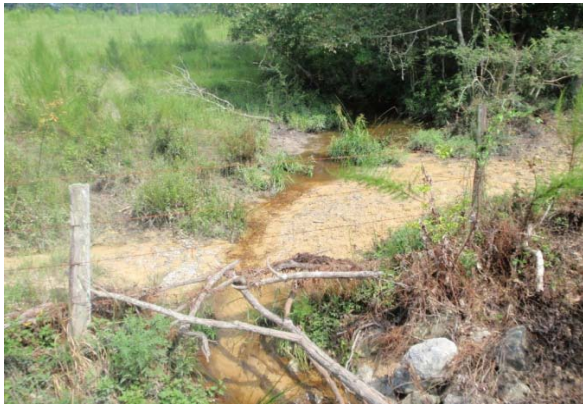
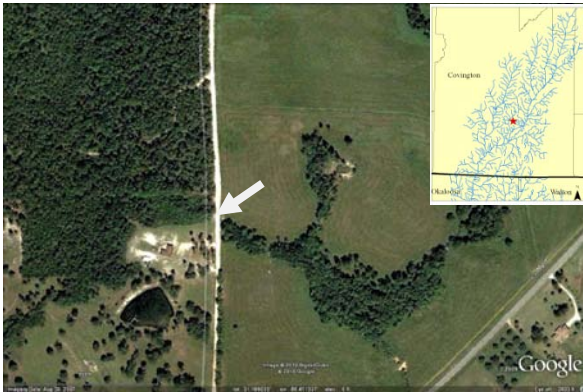
Crossing Structure: DS		US																																																																			
<table border="1"> <thead> <tr> <th>Risk Factor</th> <th>Ranking</th> <th>Score</th> </tr> </thead> <tbody> <tr><td>US Channel Morph</td><td>E</td><td>5</td></tr> <tr><td>DS Channel Morph</td><td>E</td><td>5</td></tr> <tr><td>DS Bank Alteration</td><td>MINOR/PARTIAL</td><td>3</td></tr> <tr><td>Upstream Skew Angle</td><td><5°</td><td>5</td></tr> <tr><td>Crossing fill condition</td><td>Fair/Rip Rap</td><td>3</td></tr> <tr><td>Inlet/Outlet Condition</td><td>Sed Islands/Scouring</td><td>3</td></tr> <tr><td>Road Approach Material</td><td>All Aggregate</td><td>5</td></tr> <tr><td>Potential Eroded Volume Mean</td><td><21 y³</td><td>5</td></tr> <tr><td>Approach Slope Mean</td><td>>4%</td><td>1</td></tr> <tr><td>Soil K Factor</td><td><0.20</td><td>5</td></tr> <tr><td>Upstream Rt Outlet</td><td>Bare soil</td><td>0</td></tr> <tr><td>Upstream Lt Outlet</td><td>Bare soil</td><td>0</td></tr> <tr><td>Upstream Rt Ditch</td><td>Vegetated</td><td>1</td></tr> <tr><td>Upstream Lt Ditch</td><td>Bare soil</td><td>0</td></tr> <tr><td>Downstream Rt Outlet</td><td>Bare soil</td><td>0</td></tr> <tr><td>Downstream Lt Outlet</td><td>Bare soil</td><td>0</td></tr> <tr><td>Downstream Rt Ditch</td><td>Vegetated</td><td>1</td></tr> <tr><td>Downstream Lt Ditch</td><td>Vegetated</td><td>1</td></tr> <tr><td>Outlet Total</td><td>Unimproved Outlet System</td><td>1</td></tr> <tr><td>Ditches Total</td><td>Partially Improved Drainage System</td><td>3</td></tr> <tr><td>SRI Total</td><td>Medium Risk</td><td>44</td></tr> </tbody> </table>		Risk Factor	Ranking	Score	US Channel Morph	E	5	DS Channel Morph	E	5	DS Bank Alteration	MINOR/PARTIAL	3	Upstream Skew Angle	<5°	5	Crossing fill condition	Fair/Rip Rap	3	Inlet/Outlet Condition	Sed Islands/Scouring	3	Road Approach Material	All Aggregate	5	Potential Eroded Volume Mean	<21 y ³	5	Approach Slope Mean	>4%	1	Soil K Factor	<0.20	5	Upstream Rt Outlet	Bare soil	0	Upstream Lt Outlet	Bare soil	0	Upstream Rt Ditch	Vegetated	1	Upstream Lt Ditch	Bare soil	0	Downstream Rt Outlet	Bare soil	0	Downstream Lt Outlet	Bare soil	0	Downstream Rt Ditch	Vegetated	1	Downstream Lt Ditch	Vegetated	1	Outlet Total	Unimproved Outlet System	1	Ditches Total	Partially Improved Drainage System	3	SRI Total	Medium Risk	44

Notes: Fence across US
