Long Creek		wa-0626-r-004	Sedimentation Risk Index 40																																																																		
<u>Common:</u> 6.8mi SE of Florala <u>Drainage:</u> Pond Creek GPS: 30.911463, -86.300719 <u>Land owner:</u> Wayne & Joanna Campbell- US, Sharron Adrian- DS		<u>County:</u> Walton <u>PLSS(T-R-S):</u> 5N-21-24/25 <u>Parcel No.:</u> 2; 2.001 <u>Road Name:</u> Campground Rd

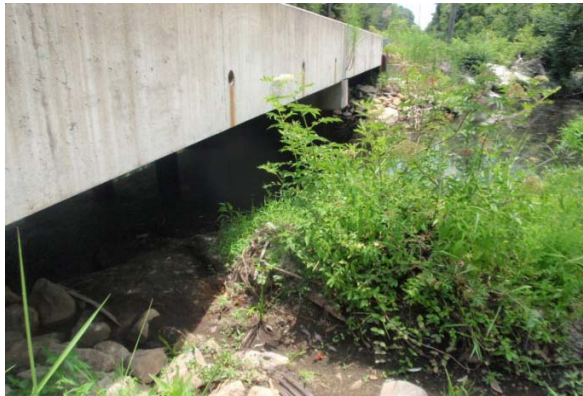
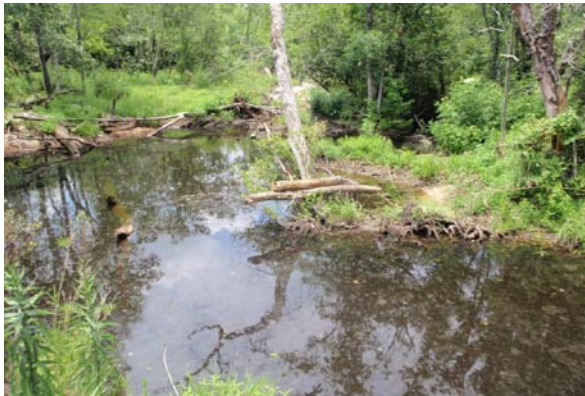
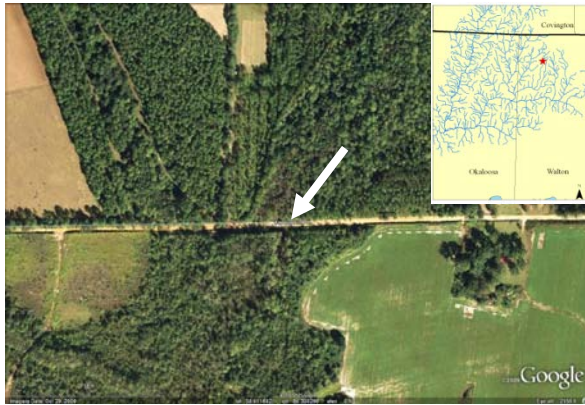
Crossing Structure: DS		DS																																																																			
<table border="1"> <thead> <tr> <th>Risk Factor</th> <th>Ranking</th> <th>Score</th> </tr> </thead> <tbody> <tr><td>US Channel Morph</td><td>DA</td><td>3</td></tr> <tr><td>DS Channel Morph</td><td>DA</td><td>3</td></tr> <tr><td>DS Bank Alteration</td><td>NATURAL</td><td>5</td></tr> <tr><td>Upstream Skew Angle</td><td><5°</td><td>5</td></tr> <tr><td>Crossing fill condition</td><td>Fair/Rip Rap</td><td>3</td></tr> <tr><td>Inlet/Outlet Condition</td><td>No Impairment</td><td>5</td></tr> <tr><td>Road Approach Material</td><td>All Sand/Clay</td><td>3</td></tr> <tr><td>Potential Eroded Volume Mean</td><td>21-40 y³</td><td>3</td></tr> <tr><td>Approach Slope Mean</td><td>2.1-4%</td><td>3</td></tr> <tr><td>Soil K Factor</td><td>0.21-0.40</td><td>3</td></tr> <tr><td>Upstream Rt Outlet</td><td>Vegetated</td><td>1</td></tr> <tr><td>Upstream Lt Outlet</td><td>Vegetated</td><td>1</td></tr> <tr><td>Upstream Rt Ditch</td><td>Bare soil</td><td>0</td></tr> <tr><td>Upstream Lt Ditch</td><td>Bare soil</td><td>0</td></tr> <tr><td>Downstream Rt Outlet</td><td>Bare soil</td><td>0</td></tr> <tr><td>Downstream Lt Outlet</td><td>Bare soil</td><td>0</td></tr> <tr><td>Downstream Rt Ditch</td><td>Bare soil</td><td>0</td></tr> <tr><td>Downstream Lt Ditch</td><td>Bare soil</td><td>0</td></tr> <tr><td>Outlet Total</td><td>Partially Improved Outlet System</td><td>3</td></tr> <tr><td>Ditches Total</td><td>Unimproved Drainage System</td><td>1</td></tr> <tr><td>SRI Total</td><td>Medium Risk</td><td>40</td></tr> </tbody> </table>		Risk Factor	Ranking	Score	US Channel Morph	DA	3	DS Channel Morph	DA	3	DS Bank Alteration	NATURAL	5	Upstream Skew Angle	<5°	5	Crossing fill condition	Fair/Rip Rap	3	Inlet/Outlet Condition	No Impairment	5	Road Approach Material	All Sand/Clay	3	Potential Eroded Volume Mean	21-40 y ³	3	Approach Slope Mean	2.1-4%	3	Soil K Factor	0.21-0.40	3	Upstream Rt Outlet	Vegetated	1	Upstream Lt Outlet	Vegetated	1	Upstream Rt Ditch	Bare soil	0	Upstream Lt Ditch	Bare soil	0	Downstream Rt Outlet	Bare soil	0	Downstream Lt Outlet	Bare soil	0	Downstream Rt Ditch	Bare soil	0	Downstream Lt Ditch	Bare soil	0	Outlet Total	Partially Improved Outlet System	3	Ditches Total	Unimproved Drainage System	1	SRI Total	Medium Risk	40

Notes: Water not flowing.
