Murder Creek		ok-0429-r-015	Sedimentation Risk Index 40																																																																		
<u>Common:</u> 5mi SW of Laurel Hill <u>Drainage:</u> Yellow River <u>GPS:</u> 30.910203, -86.514943 <u>Land owner:</u> Dean & Deborah Clary		<u>County:</u> Okaloosa <u>State:</u> Florida <u>PLSS(T-R-S):</u> 5N-23-23 <u>Parcel No.:</u> 5.001 <u>Road Name:</u> W Plympton Rd

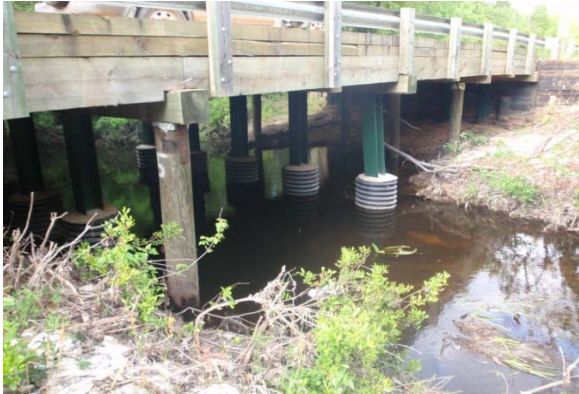
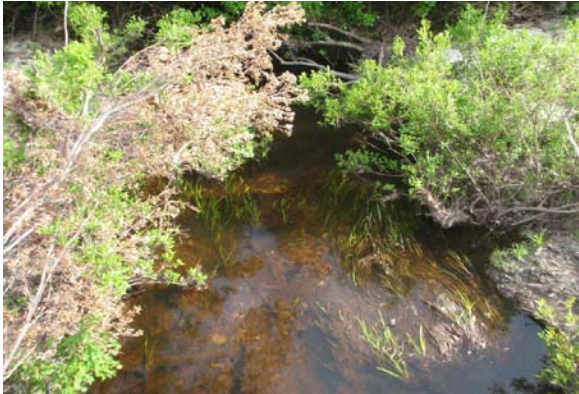
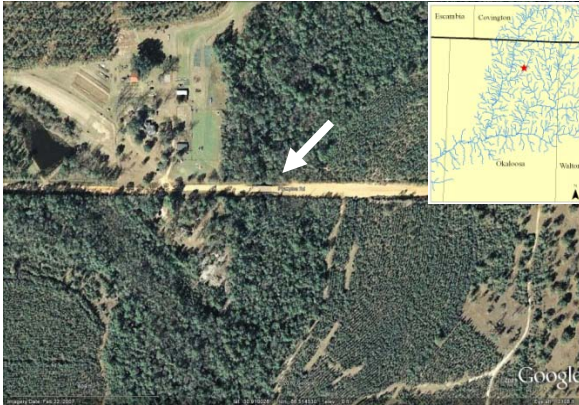
Risk Factor	Ranking	Score																																																																			
US Channel Morph	E	5																																																																			
DS Channel Morph	C	5																																																																			
DS Bank Alteration	MINOR/PARTIAL	3																																																																			
Upstream Skew Angle	<5°	5																																																																			
Crossing fill condition	Good/Vegetated	5																																																																			
Inlet/Outlet Condition	Sed Islands/Scouring	3																																																																			
Road Approach Material	All Sand/Clay	3																																																																			
Potential Eroded Volume Mean	>40 y ³	1																																																																			
Approach Slope Mean	>4%	1

Soil K Factor	<0.20	5																																																																			
Upstream Rt Outlet	Vegetated	1																																																																			
Upstream Lt Outlet	Vegetated	1																																																																			
Upstream Rt Ditch	Bare soil	0																																																																			
Upstream Lt Ditch	Bare soil	0																																																																			
Downstream Rt Outlet	Vegetated	1																																																																			
Downstream Lt Outlet	Bare soil	0																																																																			
Downstream Rt Ditch	Bare soil	0																																																																			
Downstream Lt Ditch	Bare soil	0																																																																			
Outlet Total	Partially Improved Outlet System	3

Ditches Total	Unimproved Drainage System	1																																																																			
SRI Total	Medium Risk	40																																																																			
Additional Site Features <u>Crossing Type and Quantity:</u> Bridge,1 <u>Crossing Materials:</u> Wood <u>Soil Types:</u> 13,23,25,34,36,37,39,40,43 <u>Rt Approach Prism Fill:</u> 1.5in <u>Lt Approach Prism Fill:</u> 1.0in		<table border="1"> <thead> <tr> <th>Feature</th> <th>Within Range</th> <th>Descriptive Field</th> </tr> </thead> <tbody> <tr> <td>303(d)</td> <td>Yes</td> <td>DISSOLVED OXYGEN, COLIFORMS</td> </tr> <tr> <td>Wetland Species</td> <td>No</td> <td>N/A</td> </tr> <tr> <td>Rare and Imperiled</td> <td>Yes</td> <td>BLACKTIP SHINER, IRONCOLOR SHINER</td> </tr> <tr> <td>Land Use/Cover</td> <td>Yes</td> <td>AGRICULTURAL/ WETLAND FORESTED MIX</td> </tr> <tr> <td>Candidate Mussels</td> <td>No</td> <td>N/A</td> </tr> <tr> <td>Sturgeon C.H.</td> <td>No</td> <td>N/A</td> </tr> </tbody> </table>		Feature	Within Range	Descriptive Field	303(d)	Yes	DISSOLVED OXYGEN, COLIFORMS	Wetland Species	No	N/A	Rare and Imperiled	Yes	BLACKTIP SHINER, IRONCOLOR SHINER	Land Use/Cover	Yes	AGRICULTURAL/ WETLAND FORESTED MIX	Candidate Mussels	No	N/A	Sturgeon C.H.	No	N/A
