Pigpen Creek		cr-1102-r-012	Sedimentation Risk Index <b>42</b>																																																																		
<u>Common:</u> 3.6mi SW of Pine Level <u>Drainage:</u> Yellow River <u>GPS:</u> 31.458812845,-86.244201161 <u>Land owner:</u> Doris Mitchell Halacker		<u>County:</u> Crenshaw <u>State:</u> Alabama <u>PLSS (T-R-S):</u> 6N-18E-28 <u>Parcel No.:</u> 9 <u>Road Name:</u> Settlement Rd

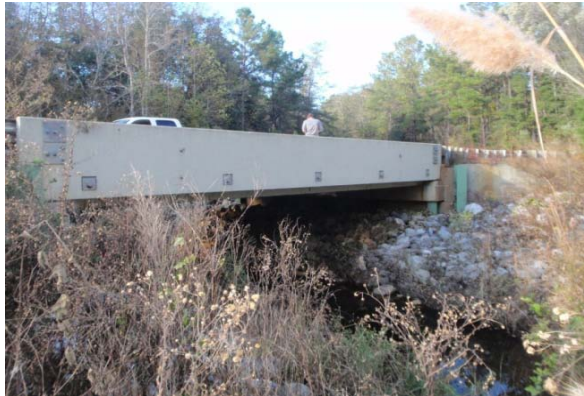
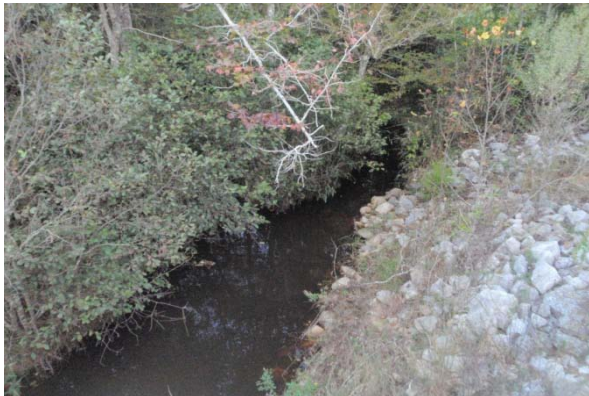
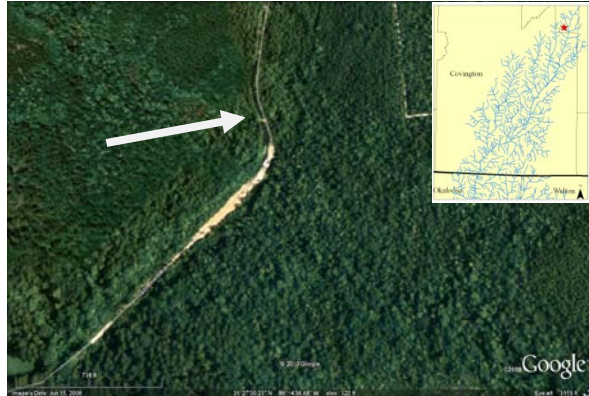
Crossing Structure: DS		US																																																																			
<table border="1"> <thead> <tr> <th>Risk Factor</th> <th>Ranking</th> <th>Score</th> </tr> </thead> <tbody> <tr><td>US Channel Morph</td><td>DA</td><td>3</td></tr> <tr><td>DS Channel Morph</td><td>C</td><td>5</td></tr> <tr><td>DS Bank Alteration</td><td>MINOR/PARTIAL</td><td>3</td></tr> <tr><td>Upstream Skew Angle</td><td>&lt;5°</td><td>5</td></tr> <tr><td>Crossing fill condition</td><td>Fair/Rip Rap</td><td>3</td></tr> <tr><td>Inlet/Outlet Condition</td><td>No Impairment</td><td>5</td></tr> <tr><td>Road Approach Material</td><td>All Sand/Clay</td><td>3</td></tr> <tr><td>Potential Eroded Volume Mean</td><td>21-40 y<sup>3</sup></td><td>3</td></tr> <tr><td>Approach Slope Mean</td><td>&gt;4%</td><td>1</td></tr> <tr><td>Soil K Factor</td><td>&lt;0.20</td><td>5</td></tr> <tr><td>Upstream Rt Outlet</td><td>Bare soil</td><td>0</td></tr> <tr><td>Upstream Lt Outlet</td><td>Rip Rap</td><td>1</td></tr> <tr><td>Upstream Rt Ditch</td><td>Rip Rap</td><td>1</td></tr> <tr><td>Upstream Lt Ditch</td><td>Rip Rap</td><td>1</td></tr> <tr><td>Downstream Rt Outlet</td><td>Vegetated</td><td>1</td></tr> <tr><td>Downstream Lt Outlet</td><td>Rip Rap</td><td>1</td></tr> <tr><td>Downstream Rt Ditch</td><td>Bare soil</td><td>0</td></tr> <tr><td>Downstream Lt Ditch</td><td>Rip Rap</td><td>1</td></tr> <tr><td>Outlet Total</td><td>Partially Improved Outlet System</td><td>3</td></tr> <tr><td>Ditches Total</td><td>Partially Improved Drainage System</td><td>3</td></tr> <tr><td><b>SRI Total</b></td><td><b>Medium Risk</b></td><td><b>42</b></td></tr> </tbody> </table>		Risk Factor	Ranking	Score	US Channel Morph	DA	3	DS Channel Morph	C	5	DS Bank Alteration	MINOR/PARTIAL	3	Upstream Skew Angle	<5°	5	Crossing fill condition	Fair/Rip Rap	3	Inlet/Outlet Condition	No Impairment	5	Road Approach Material	All Sand/Clay	3	Potential Eroded Volume Mean	21-40 y <sup>3</sup>	3	Approach Slope Mean	>4%	1	Soil K Factor	<0.20	5	Upstream Rt Outlet	Bare soil	0	Upstream Lt Outlet	Rip Rap	1	Upstream Rt Ditch	Rip Rap	1	Upstream Lt Ditch	Rip Rap	1	Downstream Rt Outlet	Vegetated	1	Downstream Lt Outlet	Rip Rap	1	Downstream Rt Ditch	Bare soil	0	Downstream Lt Ditch	Rip Rap	1	Outlet Total	Partially Improved Outlet System	3	Ditches Total	Partially Improved Drainage System	3	<b>SRI Total</b>	<b>Medium Risk</b>	<b>42</b>

Risk Factor	Ranking	Score																																																																			
US Channel Morph	DA	3																																																																			
DS Channel Morph	C	5																																																																			
DS Bank Alteration	MINOR/PARTIAL	3																																																																			
Upstream Skew Angle	<5°	5																																																																			
Crossing fill condition	Fair/Rip Rap	3																																																																			
Inlet/Outlet Condition	No Impairment	5																																																																			
Road Approach Material	All Sand/Clay	3																																																																			
Potential Eroded Volume Mean	21-40 y <sup>3</sup>	3																																																																			
Approach Slope Mean	>4%	1

Soil K Factor	<0.20	5																																																																			
Upstream Rt Outlet	Bare soil	0																																																																			
Upstream Lt Outlet	Rip Rap	1																																																																			
Upstream Rt Ditch	Rip Rap	1																																																																			
Upstream Lt Ditch	Rip Rap	1																																																																			
Downstream Rt Outlet	Vegetated	1																																																																			
Downstream Lt Outlet	Rip Rap	1																																																																			
Downstream Rt Ditch	Bare soil	0																																																																			
Downstream Lt Ditch	Rip Rap	1																																																																			
Outlet Total	Partially Improved Outlet System	3

Ditches Total	Partially Improved Drainage System	3																																																																			
<b>SRI Total</b>	<b>Medium Risk</b>	<b>42</b>																																																																			
<b>Additional Site Features</b> <u>Crossing Type and Quantity:</u> Bridge,1 <u>Crossing Materials:</u> Reinforced Concrete <u>Soil Types:</u> BbA,DoB,NsE,OrB,TaB <u>Rt Approach Prism Fill:</u> 0.25in <u>Lt Approach Prism Fill:</u> 0.5in		<table border="1"> <thead> <tr> <th>Feature</th> <th>Within Range</th> <th>Descriptive Field</th> </tr> </thead> <tbody> <tr><td>303(d)</td><td>No</td><td>N/A</td></tr> <tr><td>Wetland Species</td><td>No</td><td>N/A</td></tr> <tr><td>Rare and Imperiled</td><td>No</td><td>N/A</td></tr> <tr><td>Land Use/Cover</td><td>Yes</td><td>N/A/ SUCCESIONAL SHRUB/SCRUB (OTHER)</td></tr> <tr><td>Candidate Mussels</td><td>No</td><td>N/A</td></tr> <tr><td>Sturgeon C.H.</td><td>No</td><td>N/A</td></tr> </tbody> </table>		Feature	Within Range	Descriptive Field	303(d)	No	N/A	Wetland Species	No	N/A	Rare and Imperiled	No	N/A	Land Use/Cover	Yes	N/A/ SUCCESIONAL SHRUB/SCRUB (OTHER)	Candidate Mussels	No	N/A	Sturgeon C.H.	No	N/A
