Unnamed tributary		co-1102-r-010	Sedimentation Risk Index <b>48</b>																																																																		
<u>Common:</u> 1.0mi NE of Five Points <u>Drainage:</u> Poley Creek <u>GPS:</u> 31.443749815,-86.287363957 <u>Land owner:</u> Josephine Ray		<u>County:</u> Covington <u>State:</u> Alabama <u>PLSS (T-R-S):</u> 6N-18E-31 <u>Parcel No.:</u> 10 <u>Road Name:</u> Jack Kelly Rd

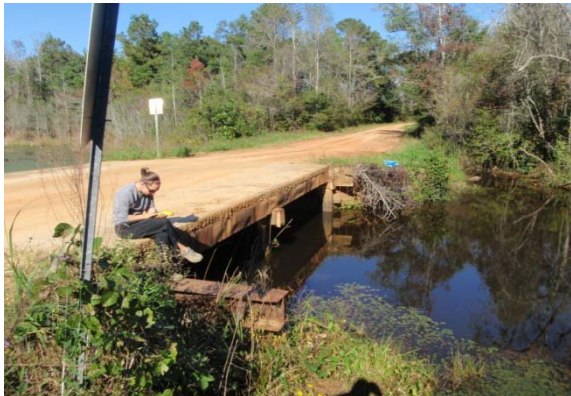
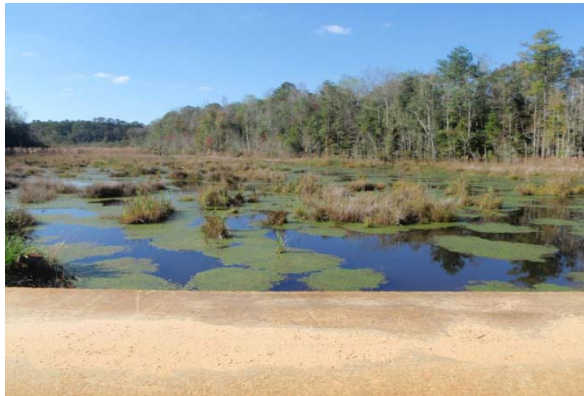
Crossing Structure: DS		US																																																																			
<table border="1"> <thead> <tr> <th>Risk Factor</th> <th>Ranking</th> <th>Score</th> </tr> </thead> <tbody> <tr><td>US Channel Morph</td><td>WETLAND</td><td>5</td></tr> <tr><td>DS Channel Morph</td><td>WETLAND</td><td>5</td></tr> <tr><td>DS Bank Alteration</td><td>MINOR/PARTIAL</td><td>3</td></tr> <tr><td>Upstream Skew Angle</td><td>&lt;5°</td><td>5</td></tr> <tr><td>Crossing fill condition</td><td>Good/Vegetated</td><td>5</td></tr> <tr><td>Inlet/Outlet Condition</td><td>No Impairment</td><td>5</td></tr> <tr><td>Road Approach Material</td><td>All Sand/Clay</td><td>3</td></tr> <tr><td>Potential Eroded Volume Mean</td><td>21-40 y<sup>3</sup></td><td>3</td></tr> <tr><td>Approach Slope Mean</td><td>&lt;2%</td><td>5</td></tr> <tr><td>Soil K Factor</td><td>&lt;0.20</td><td>5</td></tr> <tr><td>Upstream Rt Outlet</td><td>Vegetated</td><td>1</td></tr> <tr><td>Upstream Lt Outlet</td><td>Vegetated</td><td>1</td></tr> <tr><td>Upstream Rt Ditch</td><td>Bare soil</td><td>0</td></tr> <tr><td>Upstream Lt Ditch</td><td>Bare soil</td><td>0</td></tr> <tr><td>Downstream Rt Outlet</td><td>Bare soil</td><td>0</td></tr> <tr><td>Downstream Lt Outlet</td><td>Bare soil</td><td>0</td></tr> <tr><td>Downstream Rt Ditch</td><td>Bare soil</td><td>0</td></tr> <tr><td>Downstream Lt Ditch</td><td>Bare soil</td><td>0</td></tr> <tr><td>Outlet Total</td><td>Partially Improved Outlet System</td><td>3</td></tr> <tr><td>Ditches Total</td><td>Unimproved Drainage System</td><td>1</td></tr> <tr><td>SRI Total</td><td><b>Low Risk</b></td><td><b>48</b></td></tr> </tbody> </table>		Risk Factor	Ranking	Score	US Channel Morph	WETLAND	5	DS Channel Morph	WETLAND	5	DS Bank Alteration	MINOR/PARTIAL	3	Upstream Skew Angle	<5°	5	Crossing fill condition	Good/Vegetated	5	Inlet/Outlet Condition	No Impairment	5	Road Approach Material	All Sand/Clay	3	Potential Eroded Volume Mean	21-40 y <sup>3</sup>	3	Approach Slope Mean	<2%	5	Soil K Factor	<0.20	5	Upstream Rt Outlet	Vegetated	1	Upstream Lt Outlet	Vegetated	1	Upstream Rt Ditch	Bare soil	0	Upstream Lt Ditch	Bare soil	0	Downstream Rt Outlet	Bare soil	0	Downstream Lt Outlet	Bare soil	0	Downstream Rt Ditch	Bare soil	0	Downstream Lt Ditch	Bare soil	0	Outlet Total	Partially Improved Outlet System	3	Ditches Total	Unimproved Drainage System	1	SRI Total	<b>Low Risk</b>	<b>48</b>
