Unnamed tributary		wa-0707-r-003	Sedimentation Risk Index 34																																																																		
<u>Common:</u> 1.7mi NE of Mossy Head <u>Drainage:</u> Battle Creek <u>GPS:</u> 30.756542, -86.295839 <u>Land owner:</u> Barbara Hall		<u>County:</u> Walton <u>State:</u> Florida <u>PLSS:</u> 13-3N-21 <u>Parcel No.:</u> 0D <u>Road Name:</u> Donna Ln

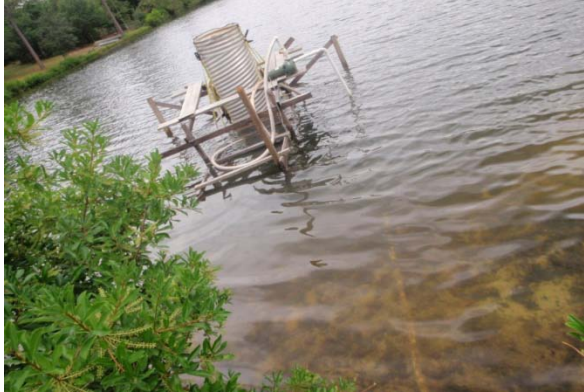
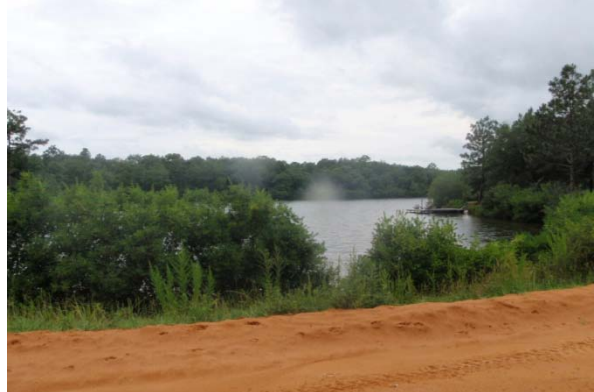
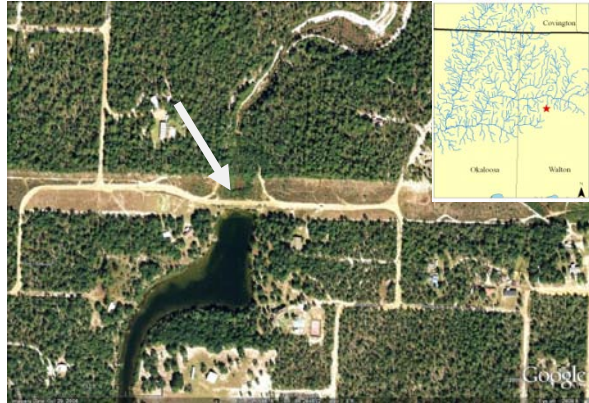
Risk Factor	Ranking	Score																																																																			
US Channel Morph	PONDED	1																																																																			
DS Channel Morph	DA	3																																																																			
DS Bank Alteration	NATURAL	5																																																																			
Upstream Skew Angle	5-30°	3																																																																			
Crossing fill condition	Poor/Bare soil	1																																																																			
Inlet/Outlet Condition	No Impairment	5																																																																			
Road Approach Material	All Native Soil	1																																																																			
Potential Eroded Volume Mean	>40 y ³	1																																																																			
Approach Slope Mean	>4%	1

Soil K Factor	<0.20	5																																																																			
Upstream Rt Outlet	Vegetated	1																																																																			
Upstream Lt Outlet	Vegetated	1																																																																			
Upstream Rt Ditch	Vegetated	1																																																																			
Upstream Lt Ditch	Bare soil	0																																																																			
Downstream Rt Outlet	Vegetated	1																																																																			
Downstream Lt Outlet	Vegetated	1																																																																			
Downstream Rt Ditch	Vegetated	1																																																																			
Downstream Lt Ditch	Bare soil	0																																																																			
Outlet Total	Improved Outlet System	5

Ditches Total	Partially Improved Drainage System	3																																																																			
SRI Total	High Risk	34																																																																			
Additional Site Features <u>Crossing Type and Quantity:</u> Reservoir Drain, 1 <u>Crossing Materials:</u> Metal <u>Soil Types:</u> 33,34 <u>Rt Approach Prism Fill:</u> 2.0in <u>Lt Approach Prism Fill:</u> 1.0in		<table border="1"> <thead> <tr> <th>Feature</th> <th>Within Range</th> <th>Descriptive Field</th> </tr> </thead> <tbody> <tr> <td>303(d)</td> <td>No</td> <td>N/A</td> </tr> <tr> <td>Wetland Species</td> <td>Yes</td> <td>1-3 FOCAL SPECIES IN UPLAND AREAS</td> </tr> <tr> <td>Rare and Imperiled</td> <td>No</td> <td>N/A</td> </tr> <tr> <td>Land Use/ Cover</td> <td>Yes</td> <td>RESIDENTIAL/ ELECTRICAL POWER TRANSMISSION LINES</td> </tr> <tr> <td>Candidate Mussels</td> <td>No</td> <td>N/A</td> </tr> <tr> <td>Sturgeon C.H.</td> <td>No</td> <td>N/A</td> </tr> </tbody> </table>		Feature	Within Range	Descriptive Field	303(d)	No	N/A	Wetland Species	Yes	1-3 FOCAL SPECIES IN UPLAND AREAS	Rare and Imperiled	No	N/A	Land Use/ Cover	Yes	RESIDENTIAL/ ELECTRICAL POWER TRANSMISSION LINES	Candidate Mussels	No	N/A	Sturgeon C.H.	No	N/A
