| Unnamed tributary | | co-0904-r-008 | Sedimentation Risk Index 42 | | | | | | | | | | | | | | | | | | | | | | | | | | | | | | | | | | | | | | | | | | | | | | | | | | | | | | | | | | | | | | | | | | |
| <u>Common:</u> 8.8mi SE of Andalusia <u>Drainage:</u> Yellow River <u>GPS:</u> 31.224030612, -86.370864491 <u>Land owner:</u> George Jr & Madge Powell-US, Jodie & Irene Wiggins-DS | | <u>County:</u> Covington <u>State:</u> Alabama <u>PLSS (T-R-S):</u> 3N-17E-17 <u>Parcel No.:</u> 4; 7 <u>Road Name:</u> Lost Forty Rd | | | | | | | | | | | | | | | | | | | | | | | | | | | | | | | | | | | | | | | | | | | | | | | | | | | | | | | | | | | | | | | | | | | |

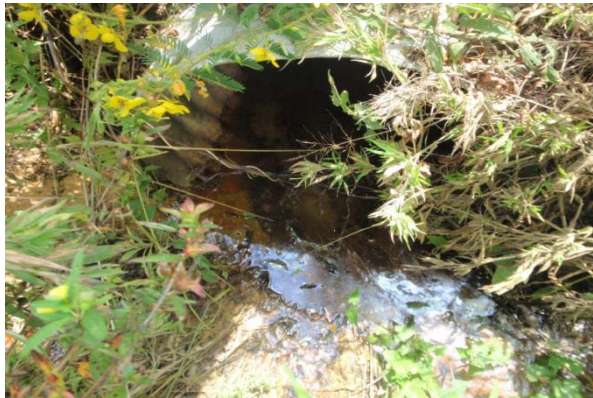
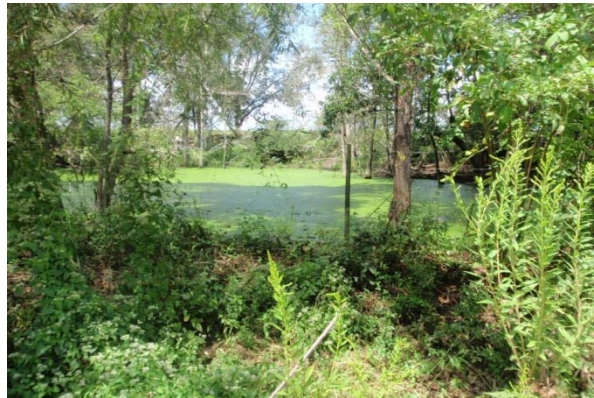
| Unnamed tributary | | co-0904-r-008 | Sedimentation Risk Index 42 | | | | | | | | | | | | | | | | | | | | | | | | | | | | | | | | | | | | | | | | | | | | | | | | | | | | | | | | | | | | | | | | | | |
|---|---|--|---|---|---|---|---|---|---|---|---|---|---|---|---|---|---|---|---|---|---|---|---|---|---|---|---|---|---|---|---|---|---|---|---|---|---|---|---|---|---|---|---|---|---|---|---|---|---|---|---|---|---|---|---|---|---|---|---|---|---|---|---|---|---|---|---|---|--|
| Crossing Structure: US | | US | | | | | | | | | | | | | | | | | | | | | | | | | | | | | | | | | | | | | | | | | | | | | | | | | | | | | | | | | | | | | | | | | | | |

Notes: Farm land US- pond seriously nutrient loaded.
