Unnamed tributary		co-0831-r-013	Sedimentation Risk Index 32																																																																		
<u>Common:</u> 7.9mi SW of Opp <u>Drainage:</u> Indian Creek <i>GPS:</i> 31.195797, -86.343972 <u>Land owner:</u> Unknown- Under 5AC not displayed		<u>County:</u> Covington <i>State:</i> Alabama <u>PLSS (T-R-S):</u> 3N-17E-27 <u>Parcel No.:</u> Unknown <u>Road Name:</u> Coon Rd

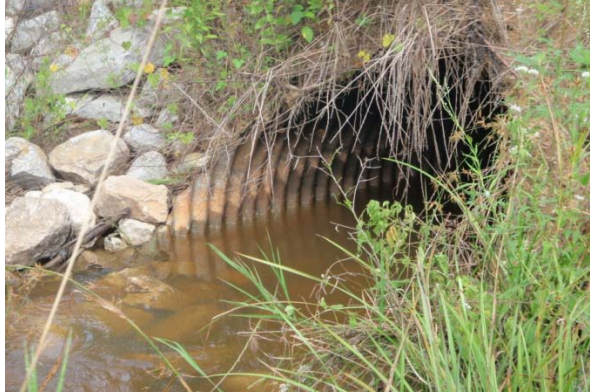
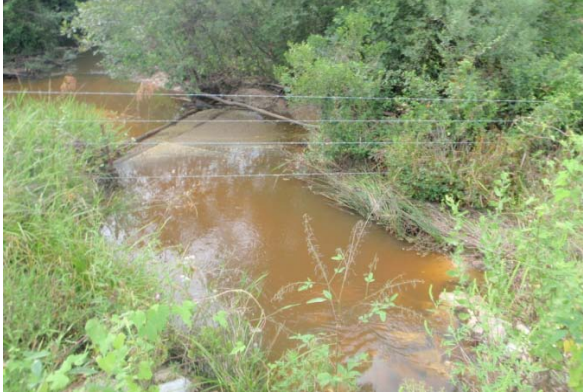
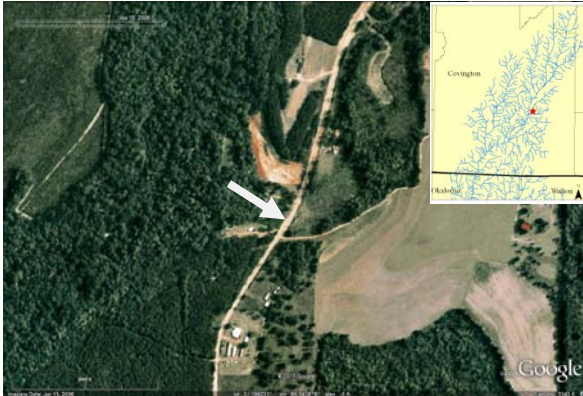
Crossing Structure: DS		DS																																																																			
<table border="1"> <thead> <tr> <th>Risk Factor</th> <th>Ranking</th> <th>Score</th> </tr> </thead> <tbody> <tr><td>US Channel Morph</td><td>BEAVER DAM</td><td>3</td></tr> <tr><td>DS Channel Morph</td><td>C</td><td>5</td></tr> <tr><td>DS Bank Alteration</td><td>HIGH</td><td>1</td></tr> <tr><td>Upstream Skew Angle</td><td>5-30°</td><td>3</td></tr> <tr><td>Crossing fill condition</td><td>Poor/Bare soil</td><td>1</td></tr> <tr><td>Inlet/Outlet Condition</td><td>Sed Islands/Scouring</td><td>3</td></tr> <tr><td>Road Approach Material</td><td>All Sand/Clay</td><td>3</td></tr> <tr><td>Potential Eroded Volume Mean</td><td>21-40 y³</td><td>3</td></tr> <tr><td>Approach Slope Mean</td><td>2.1-4%</td><td>3</td></tr> <tr><td>Soil K Factor</td><td>0.21-0.40</td><td>3</td></tr> <tr><td>Upstream Rt Outlet</td><td>Bare soil</td><td>0</td></tr> <tr><td>Upstream Lt Outlet</td><td>Bare soil</td><td>0</td></tr> <tr><td>Upstream Rt Ditch</td><td>Bare soil</td><td>0</td></tr> <tr><td>Upstream Lt Ditch</td><td>Bare soil</td><td>0</td></tr> <tr><td>Downstream Rt Outlet</td><td>Bare soil</td><td>0</td></tr> <tr><td>Downstream Lt Outlet</td><td>Rip Rap</td><td>1</td></tr> <tr><td>Downstream Rt Ditch</td><td>Bare soil</td><td>0</td></tr> <tr><td>Downstream Lt Ditch</td><td>Bare soil</td><td>0</td></tr> <tr><td>Outlet Total</td><td>Partially Improved Outlet System</td><td>3</td></tr> <tr><td>Ditches Total</td><td>Unimproved Drainage System</td><td>1</td></tr> <tr><td>SRI Total</td><td>High Risk</td><td>32</td></tr> </tbody> </table>				Risk Factor	Ranking	Score	US Channel Morph	BEAVER DAM	3	DS Channel Morph	C	5	DS Bank Alteration	HIGH	1	Upstream Skew Angle	5-30°	3	Crossing fill condition	Poor/Bare soil	1	Inlet/Outlet Condition	Sed Islands/Scouring	3	Road Approach Material	All Sand/Clay	3	Potential Eroded Volume Mean	21-40 y ³	3	Approach Slope Mean	2.1-4%	3	Soil K Factor	0.21-0.40	3	Upstream Rt Outlet	Bare soil	0	Upstream Lt Outlet	Bare soil	0	Upstream Rt Ditch	Bare soil	0	Upstream Lt Ditch	Bare soil	0	Downstream Rt Outlet	Bare soil	0	Downstream Lt Outlet	Rip Rap	1	Downstream Rt Ditch	Bare soil	0	Downstream Lt Ditch	Bare soil	0	Outlet Total	Partially Improved Outlet System	3	Ditches Total	Unimproved Drainage System	1	SRI Total	High Risk	32

Ditches Total	Unimproved Drainage System	1																																																																			
SRI Total	High Risk	32																																																																			
Additional Site Features <u>Crossing Type and Quantity:</u> Culvert, 1 <u>Crossing Materials:</u> Metal <u>Soil Types:</u> BoB, CdC, MBA, OrC, OrE, TrB <u>Rt Approach Prism Fill:</u> 0.25in <u>Lt Approach Prism Fill:</u> 0.25in

Notes: Fence across DS
