Shoal River		wa-0720-001	Severity Score 6.75	
<u>Common:</u> 3.5mi N of Mossy Head, HWY 285 Bridge Crossing <u>Drainage:</u> Yellow River <u>GPS:</u> 30.795099684, -86.307253847 <u>Land owner:</u> RB: Matthew Braley/ LB: Charlie Sierra Association Inc		<u>County:</u> Walton <u>State:</u> Florida <u>PLSS(T-R-S):</u> 4N-21W-35 <u>Parcel No.:</u> 1.004/ 1

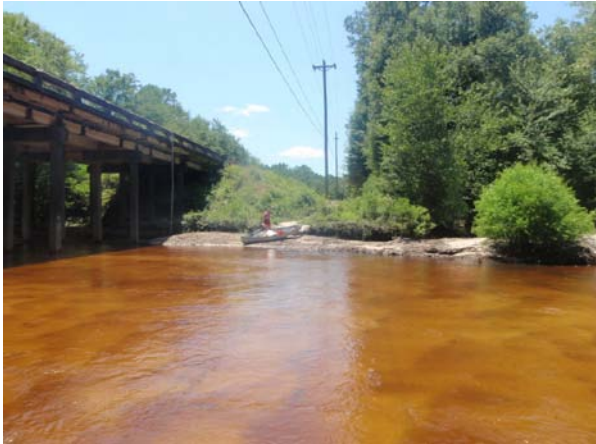
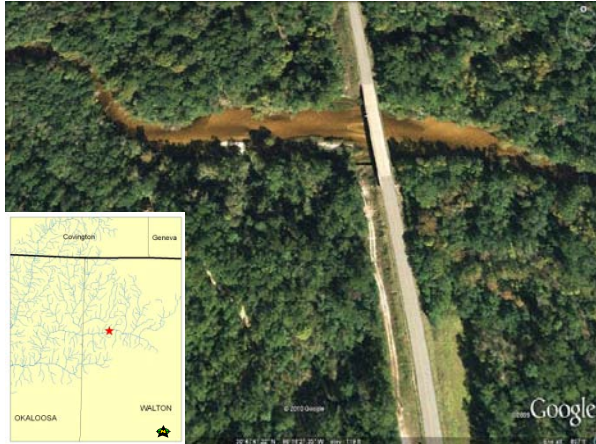
Notes: Bridge crossing at New Harmony Rd and power lines. OFW
 Unimproved boat launch/access area. Shallow all the way across.
