Blaze Branch		cr-1103-r-004		Sedimentation Risk Index 34																																																																			
<u>Common:</u> 1.0mi SW of Pine Level <u>Drainage:</u> Lightwood Knot <i>GPS:</i> 31.469813150,-86.202034694 <u>Land owner:</u> Heath Kilcrease -US, Robert Jr. Kilcrease -DS		<u>County:</u> Crenshaw <u>PLSS (T-R-S):</u> 6N-18E-24/25 <u>Parcel No.:</u> 8,1 <u>Road Name:</u> Kilcrease Rd		<u>State:</u> Alabama

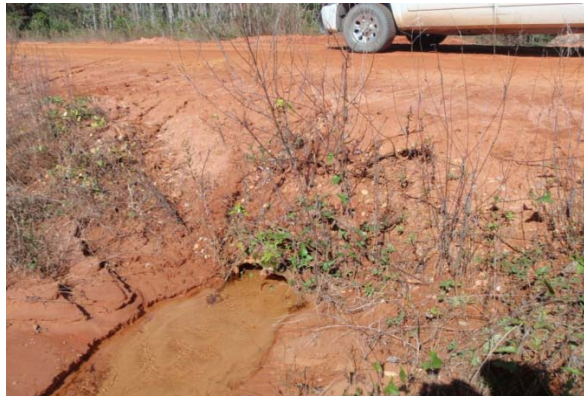
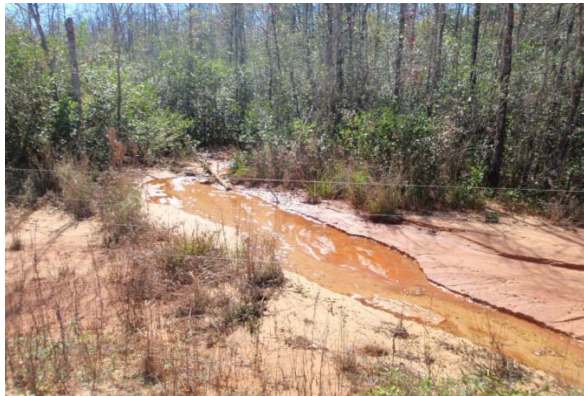
Crossing Structure: US		DS																																																																					
<table border="1"> <thead> <tr> <th>Risk Factor</th> <th>Ranking</th> <th>Score</th> </tr> </thead> <tbody> <tr><td>US Channel Morph</td><td>WETLAND</td><td>5</td></tr> <tr><td>DS Channel Morph</td><td>C</td><td>5</td></tr> <tr><td>DS Bank Alteration</td><td>HIGH</td><td>1</td></tr> <tr><td>Upstream Skew Angle</td><td>5-30°</td><td>3</td></tr> <tr><td>Crossing fill condition</td><td>Poor/Bare soil</td><td>1</td></tr> <tr><td>Inlet/Outlet Condition</td><td>Sed Islands/Scouring</td><td>3</td></tr> <tr><td>Road Approach Material</td><td>All Sand/Clay</td><td>3</td></tr> <tr><td>Potential Eroded Volume Mean</td><td><21 y³</td><td>5</td></tr> <tr><td>Approach Slope Mean</td><td>2.1-4%</td><td>3</td></tr> <tr><td>Soil K Factor</td><td>0.21-0.40</td><td>3</td></tr> <tr><td>Upstream Rt Outlet</td><td>Bare soil</td><td>0</td></tr> <tr><td>Upstream Lt Outlet</td><td>Bare soil</td><td>0</td></tr> <tr><td>Upstream Rt Ditch</td><td>Bare soil</td><td>0</td></tr> <tr><td>Upstream Lt Ditch</td><td>Bare soil</td><td>0</td></tr> <tr><td>Downstream Rt Outlet</td><td>Bare soil</td><td>0</td></tr> <tr><td>Downstream Lt Outlet</td><td>Bare soil</td><td>0</td></tr> <tr><td>Downstream Rt Ditch</td><td>Bare soil</td><td>0</td></tr> <tr><td>Downstream Lt Ditch</td><td>Bare soil</td><td>0</td></tr> <tr><td>Outlet Total</td><td>Unimproved Outlet System</td><td>1</td></tr> <tr><td>Ditches Total</td><td>Unimproved Drainage System</td><td>1</td></tr> <tr><td>SRI Total</td><td>High Risk</td><td>34</td></tr> </tbody> </table>		Risk Factor	Ranking	Score	US Channel Morph	WETLAND	5	DS Channel Morph	C	5	DS Bank Alteration	HIGH	1	Upstream Skew Angle	5-30°	3	Crossing fill condition	Poor/Bare soil	1	Inlet/Outlet Condition	Sed Islands/Scouring	3	Road Approach Material	All Sand/Clay	3	Potential Eroded Volume Mean	<21 y ³	5	Approach Slope Mean	2.1-4%	3	Soil K Factor	0.21-0.40	3	Upstream Rt Outlet	Bare soil	0	Upstream Lt Outlet	Bare soil	0	Upstream Rt Ditch	Bare soil	0	Upstream Lt Ditch	Bare soil	0	Downstream Rt Outlet	Bare soil	0	Downstream Lt Outlet	Bare soil	0	Downstream Rt Ditch	Bare soil	0	Downstream Lt Ditch	Bare soil	0	Outlet Total	Unimproved Outlet System	1	Ditches Total	Unimproved Drainage System	1	SRI Total	High Risk	34

Notes: Bare ditches and outlets influencing score. First order tributary.
