Atwell Pond		sr-0414-r-005	Sedimentation Risk Index <b>40</b>																																																																		
<u>Common:</u> 6.7mi S of Harold <u>Drainage:</u> Poplar Branch <u>GPS:</u> 30.561150, -86.873011 <u>Land owner:</u> US Government- Eglin AFB		<u>County:</u> Santa Rosa <u>State:</u> Florida <u>PLSS(T-R-S):</u> 1N-26-29 <u>Parcel No.:</u> 1 <u>Road Name:</u> RR 211-Eglin AFB

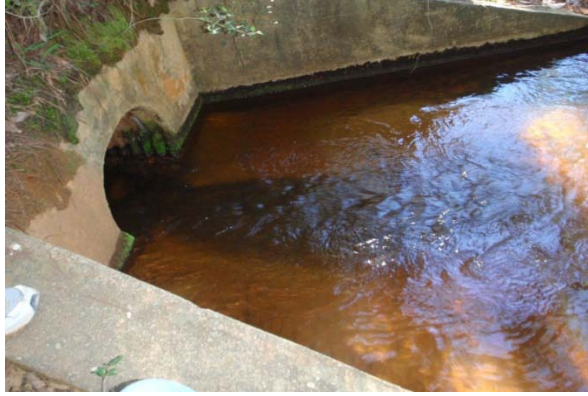
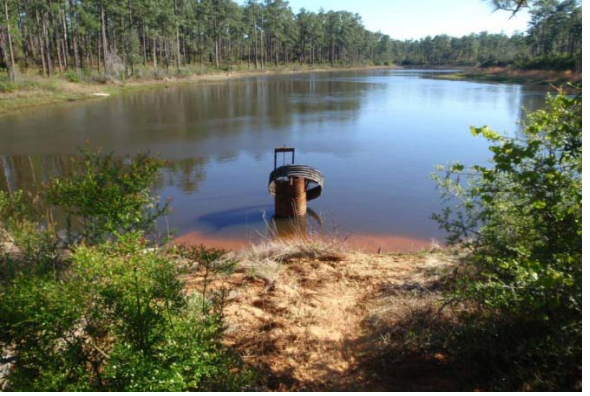
Crossing Structure: DS		US																																																																			
<table border="1"> <thead> <tr> <th>Risk Factor</th> <th>Ranking</th> <th>Score</th> </tr> </thead> <tbody> <tr><td>US Channel Morph</td><td>PONDED</td><td>1</td></tr> <tr><td>DS Channel Morph</td><td>E</td><td>5</td></tr> <tr><td>DS Bank Alteration</td><td>MINOR/PARTIAL</td><td>3</td></tr> <tr><td>Upstream Skew Angle</td><td>&lt;5°</td><td>5</td></tr> <tr><td>Crossing fill condition</td><td>Good/Vegetated</td><td>5</td></tr> <tr><td>Inlet/Outlet Condition</td><td>No Impairment</td><td>5</td></tr> <tr><td>Road Approach Material</td><td>All Sand/Clay</td><td>3</td></tr> <tr><td>Potential Eroded Volume Mean</td><td>&gt;40 y<sup>3</sup></td><td>1</td></tr> <tr><td>Approach Slope Mean</td><td>&lt;2%</td><td>5</td></tr> <tr><td>Soil K Factor</td><td>&lt;0.20</td><td>5</td></tr> <tr><td>Upstream Rt Outlet</td><td>Bare soil</td><td>0</td></tr> <tr><td>Upstream Lt Outlet</td><td>Bare soil</td><td>0</td></tr> <tr><td>Upstream Rt Ditch</td><td>Bare soil</td><td>0</td></tr> <tr><td>Upstream Lt Ditch</td><td>Bare soil</td><td>0</td></tr> <tr><td>Downstream Rt Outlet</td><td>Bare soil</td><td>0</td></tr> <tr><td>Downstream Lt Outlet</td><td>Bare soil</td><td>0</td></tr> <tr><td>Downstream Rt Ditch</td><td>Bare soil</td><td>0</td></tr> <tr><td>Downstream Lt Ditch</td><td>Bare soil</td><td>0</td></tr> <tr><td>Outlet Total</td><td>Unimproved Outlet System</td><td>1</td></tr> <tr><td>Ditches Total</td><td>Unimproved Drainage System</td><td>1</td></tr> <tr><td><b>SRI Total</b></td><td><b>Medium Risk</b></td><td><b>40</b></td></tr> </tbody> </table>		Risk Factor	Ranking	Score	US Channel Morph	PONDED	1	DS Channel Morph	E	5	DS Bank Alteration	MINOR/PARTIAL	3	Upstream Skew Angle	<5°	5	Crossing fill condition	Good/Vegetated	5	Inlet/Outlet Condition	No Impairment	5	Road Approach Material	All Sand/Clay	3	Potential Eroded Volume Mean	>40 y <sup>3</sup>	1	Approach Slope Mean	<2%	5	Soil K Factor	<0.20	5	Upstream Rt Outlet	Bare soil	0	Upstream Lt Outlet	Bare soil	0	Upstream Rt Ditch	Bare soil	0	Upstream Lt Ditch	Bare soil	0	Downstream Rt Outlet	Bare soil	0	Downstream Lt Outlet	Bare soil	0	Downstream Rt Ditch	Bare soil	0	Downstream Lt Ditch	Bare soil	0	Outlet Total	Unimproved Outlet System	1	Ditches Total	Unimproved Drainage System	1	<b>SRI Total</b>	<b>Medium Risk</b>	<b>40</b>
