Unnamed tributary		wa-0710-r-005	Sedimentation Risk Index 42																																																																																							
<u>Common:</u> 3.2mi NW of Mossy Head <u>Drainage:</u> Shoal River <u>GPS:</u> 30.781183, -86.345665 <u>Land owner:</u> J. Laden Dewrell-DS, Delmar & Marlene Walker-US		<u>County:</u> Walton <u>State:</u> Florida <u>PLSS(T-R-S):</u> 3N-21-04/09 <u>Parcel No.:</u> 1.004; 1.009 <u>Road Name:</u> Jones Rd

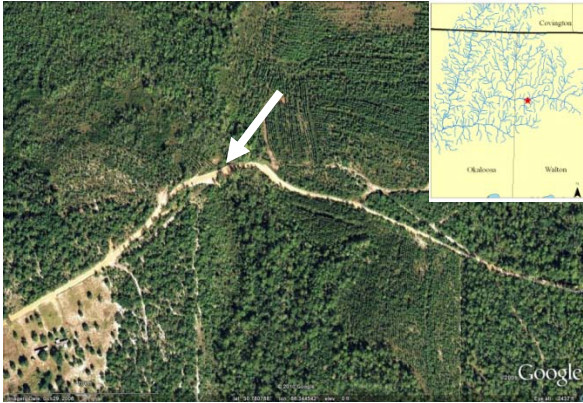
<p>US</p>																																																																																								
<table border="1"> <thead> <tr> <th>Risk Factor</th> <th>Ranking</th> <th>Score</th> </tr> </thead> <tbody> <tr><td>US Channel Morph</td><td>DA</td><td>3</td></tr> <tr><td>DS Channel Morph</td><td>DA</td><td>3</td></tr> <tr><td>DS Bank Alteration</td><td>MINOR/PARTIAL</td><td>3</td></tr> <tr><td>Upstream Skew Angle</td><td><5°</td><td>5</td></tr> <tr><td>Crossing fill condition</td><td>Poor/Bare soil</td><td>1</td></tr> <tr><td>Inlet/Outlet Condition</td><td>No Impairment</td><td>5</td></tr> <tr><td>Road Approach Material</td><td>All Aggregate</td><td>5</td></tr> <tr><td>Potential Eroded Volume Mean</td><td><21 y³</td><td>5</td></tr> <tr><td>Approach Slope Mean</td><td>>4%</td><td>1</td></tr> <tr><td>Soil K Factor</td><td><0.20</td><td>5</td></tr> <tr><td>Upstream Rt Outlet</td><td>Bare soil</td><td>0</td></tr> <tr><td>Upstream Lt Outlet</td><td>Bare soil</td><td>0</td></tr> <tr><td>Upstream Rt Ditch</td><td>Vegetated</td><td>1</td></tr> <tr><td>Upstream Lt Ditch</td><td>Bare soil</td><td>0</td></tr> <tr><td>Downstream Rt Outlet</td><td>Bare soil</td><td>0</td></tr> <tr><td>Downstream Lt Outlet</td><td>Vegetated</td><td>1</td></tr> <tr><td>Downstream Rt Ditch</td><td>Bare soil</td><td>0</td></tr> <tr><td>Downstream Lt Ditch</td><td>Bare soil</td><td>0</td></tr> <tr><td>Outlet Total</td><td>Partially Improved Outlet System</td><td>3</td></tr> <tr><td>Ditches Total</td><td>Partially Improved Drainage System</td><td>3</td></tr> <tr><td>SRI Total</td><td>Medium Risk</td><td>42</td></tr> </tbody> </table>		Risk Factor	Ranking	Score	US Channel Morph	DA	3	DS Channel Morph	DA	3	DS Bank Alteration	MINOR/PARTIAL	3	Upstream Skew Angle	<5°	5	Crossing fill condition	Poor/Bare soil	1	Inlet/Outlet Condition	No Impairment	5	Road Approach Material	All Aggregate	5	Potential Eroded Volume Mean	<21 y ³	5	Approach Slope Mean	>4%	1	Soil K Factor	<0.20	5	Upstream Rt Outlet	Bare soil	0	Upstream Lt Outlet	Bare soil	0	Upstream Rt Ditch	Vegetated	1	Upstream Lt Ditch	Bare soil	0	Downstream Rt Outlet	Bare soil	0	Downstream Lt Outlet	Vegetated	1	Downstream Rt Ditch	Bare soil	0	Downstream Lt Ditch	Bare soil	0	Outlet Total	Partially Improved Outlet System	3	Ditches Total	Partially Improved Drainage System	3	SRI Total	Medium Risk	42
